TOWN OF HOLLIS, NEW HAMPSHIRE

Farley Building

WEATHER TIGHT ENVELOPE/EXTERIOR CONDITION ASSESSMENT & STABILIZATION PLAN

Prepared by the Hollis Heritage Commission, Richard Brown & John Butler
July 2012, Revised December 2012

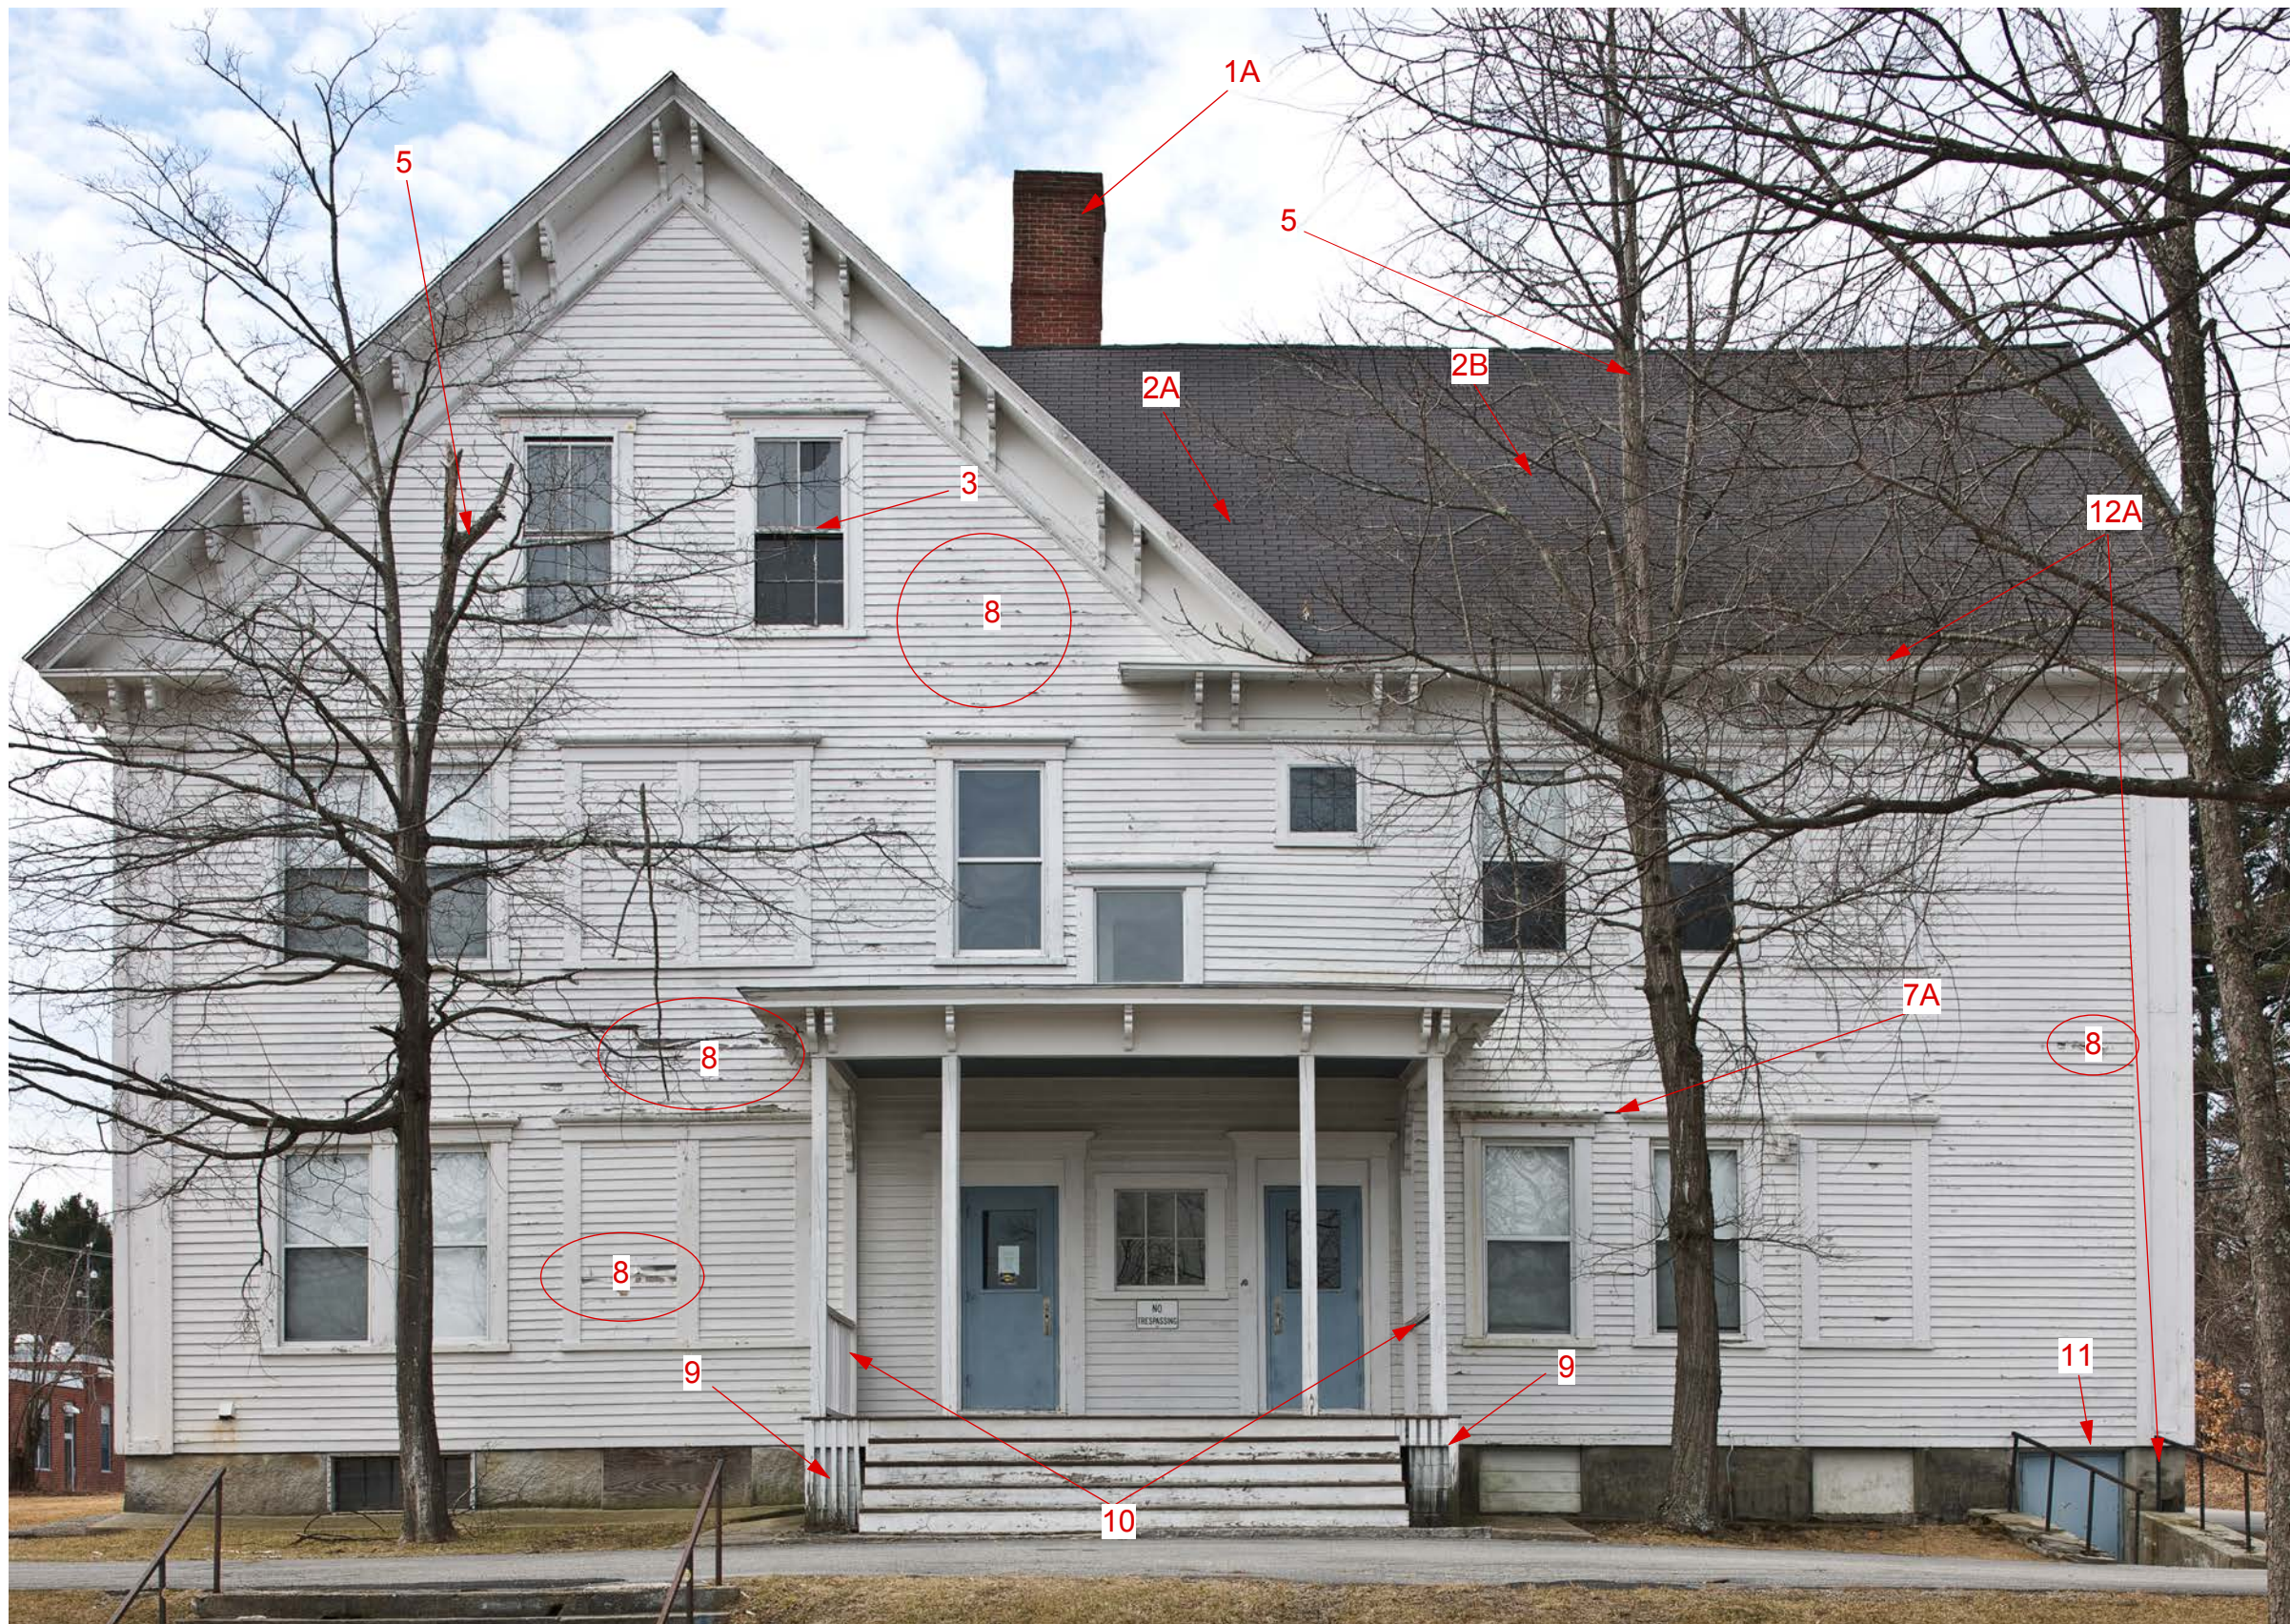
FARLEY BUILDING:
EAST ELEVATION,
CONDITION ASSESSMENT
JULY 2012
REVISED NOV. 2012
SHEET 1 OF 10

- 1A. CHIMNEY, MISSING MASONRY UNITS, CRACKING, MORTAR JOINT DETERIORATION, (SEE DETAIL IMAGE). NOTE: MOST DAMAGE OCCURS ABOVE LOWER DRIP/BELT COURSE.
STABILIZATION RECOMMENDATION: REMOVE CHIMNEY BRICKS TO THE DRIP COURSE LEVEL.

- 2A/2B. MISSING/DAMAGED ROOF SHINGLE, (SEE DETAIL IMAGE 2A).
STABILIZATION RECOMMENDATION: REPAIR/REPLACE MISSING/DAMAGED SHINGLE.
3. EAST ELEVATION, RIGHT GABLE WINDOW: LOWER STORM SASH MISSING, UPPER STORM SASH BROKEN, (SEE DETAIL IMAGE).
STABILIZATION RECOMMENDATION: INSTALL/REPAIR STORM SASH.

5. TREES IN TOO CLOSE PROXIMITY TO THE BUILDING.
STABILIZATION RECOMMENDATION: REMOVE BOTH TREES.
- 7A. MISSING/DAMAGED CLAPBOARD, (SEE DETAIL IMAGE).
STABILIZATION RECOMMENDATION: REPLACE/REPAIR CLAPBOARD.

8. SIGNIFICANT AREAS OF PAINT LOSS/FAILURE ON BOTH THE EAST & NORTH ELEVATIONS, IN MANY CASES PAINT FAILURE HAS EXPOSED THE WOOD SUBSTRATE.
STABILIZATION RECOMMENDATION: PAINT PRIME AREAS OF BARE WOOD WITH OIL BASED PRIMER.

9. DETERIORATED WOOD LATTICE SLATS SHOULD BE REMOVED OR REPLACED.
STABILIZATION RECOMMENDATION: NO ACTION AT THIS TIME.
10. MISSING BALASTRADE PARTS, REPLACE FOR POSSIBLE SAFETY ISSUES.
STABILIZATION RECOMMENDATION: NO ACTION AT THIS TIME.

11. BULKHEAD/CELLAR ACCESS OPEN TO THE WEATHER.
STABILIZATION RECOMMENDATION: ENCLOSE BULKHEAD/CELLAR ACCESS TO MAKE WEATHER TIGHT.
- 12A. GUTTER & DOWNSPOUT MISSING FROM THIS SECTION OF ROOF.
STABILIZATION RECOMMENDATION: INSTALL GUTTER & DOWNSPOUT.

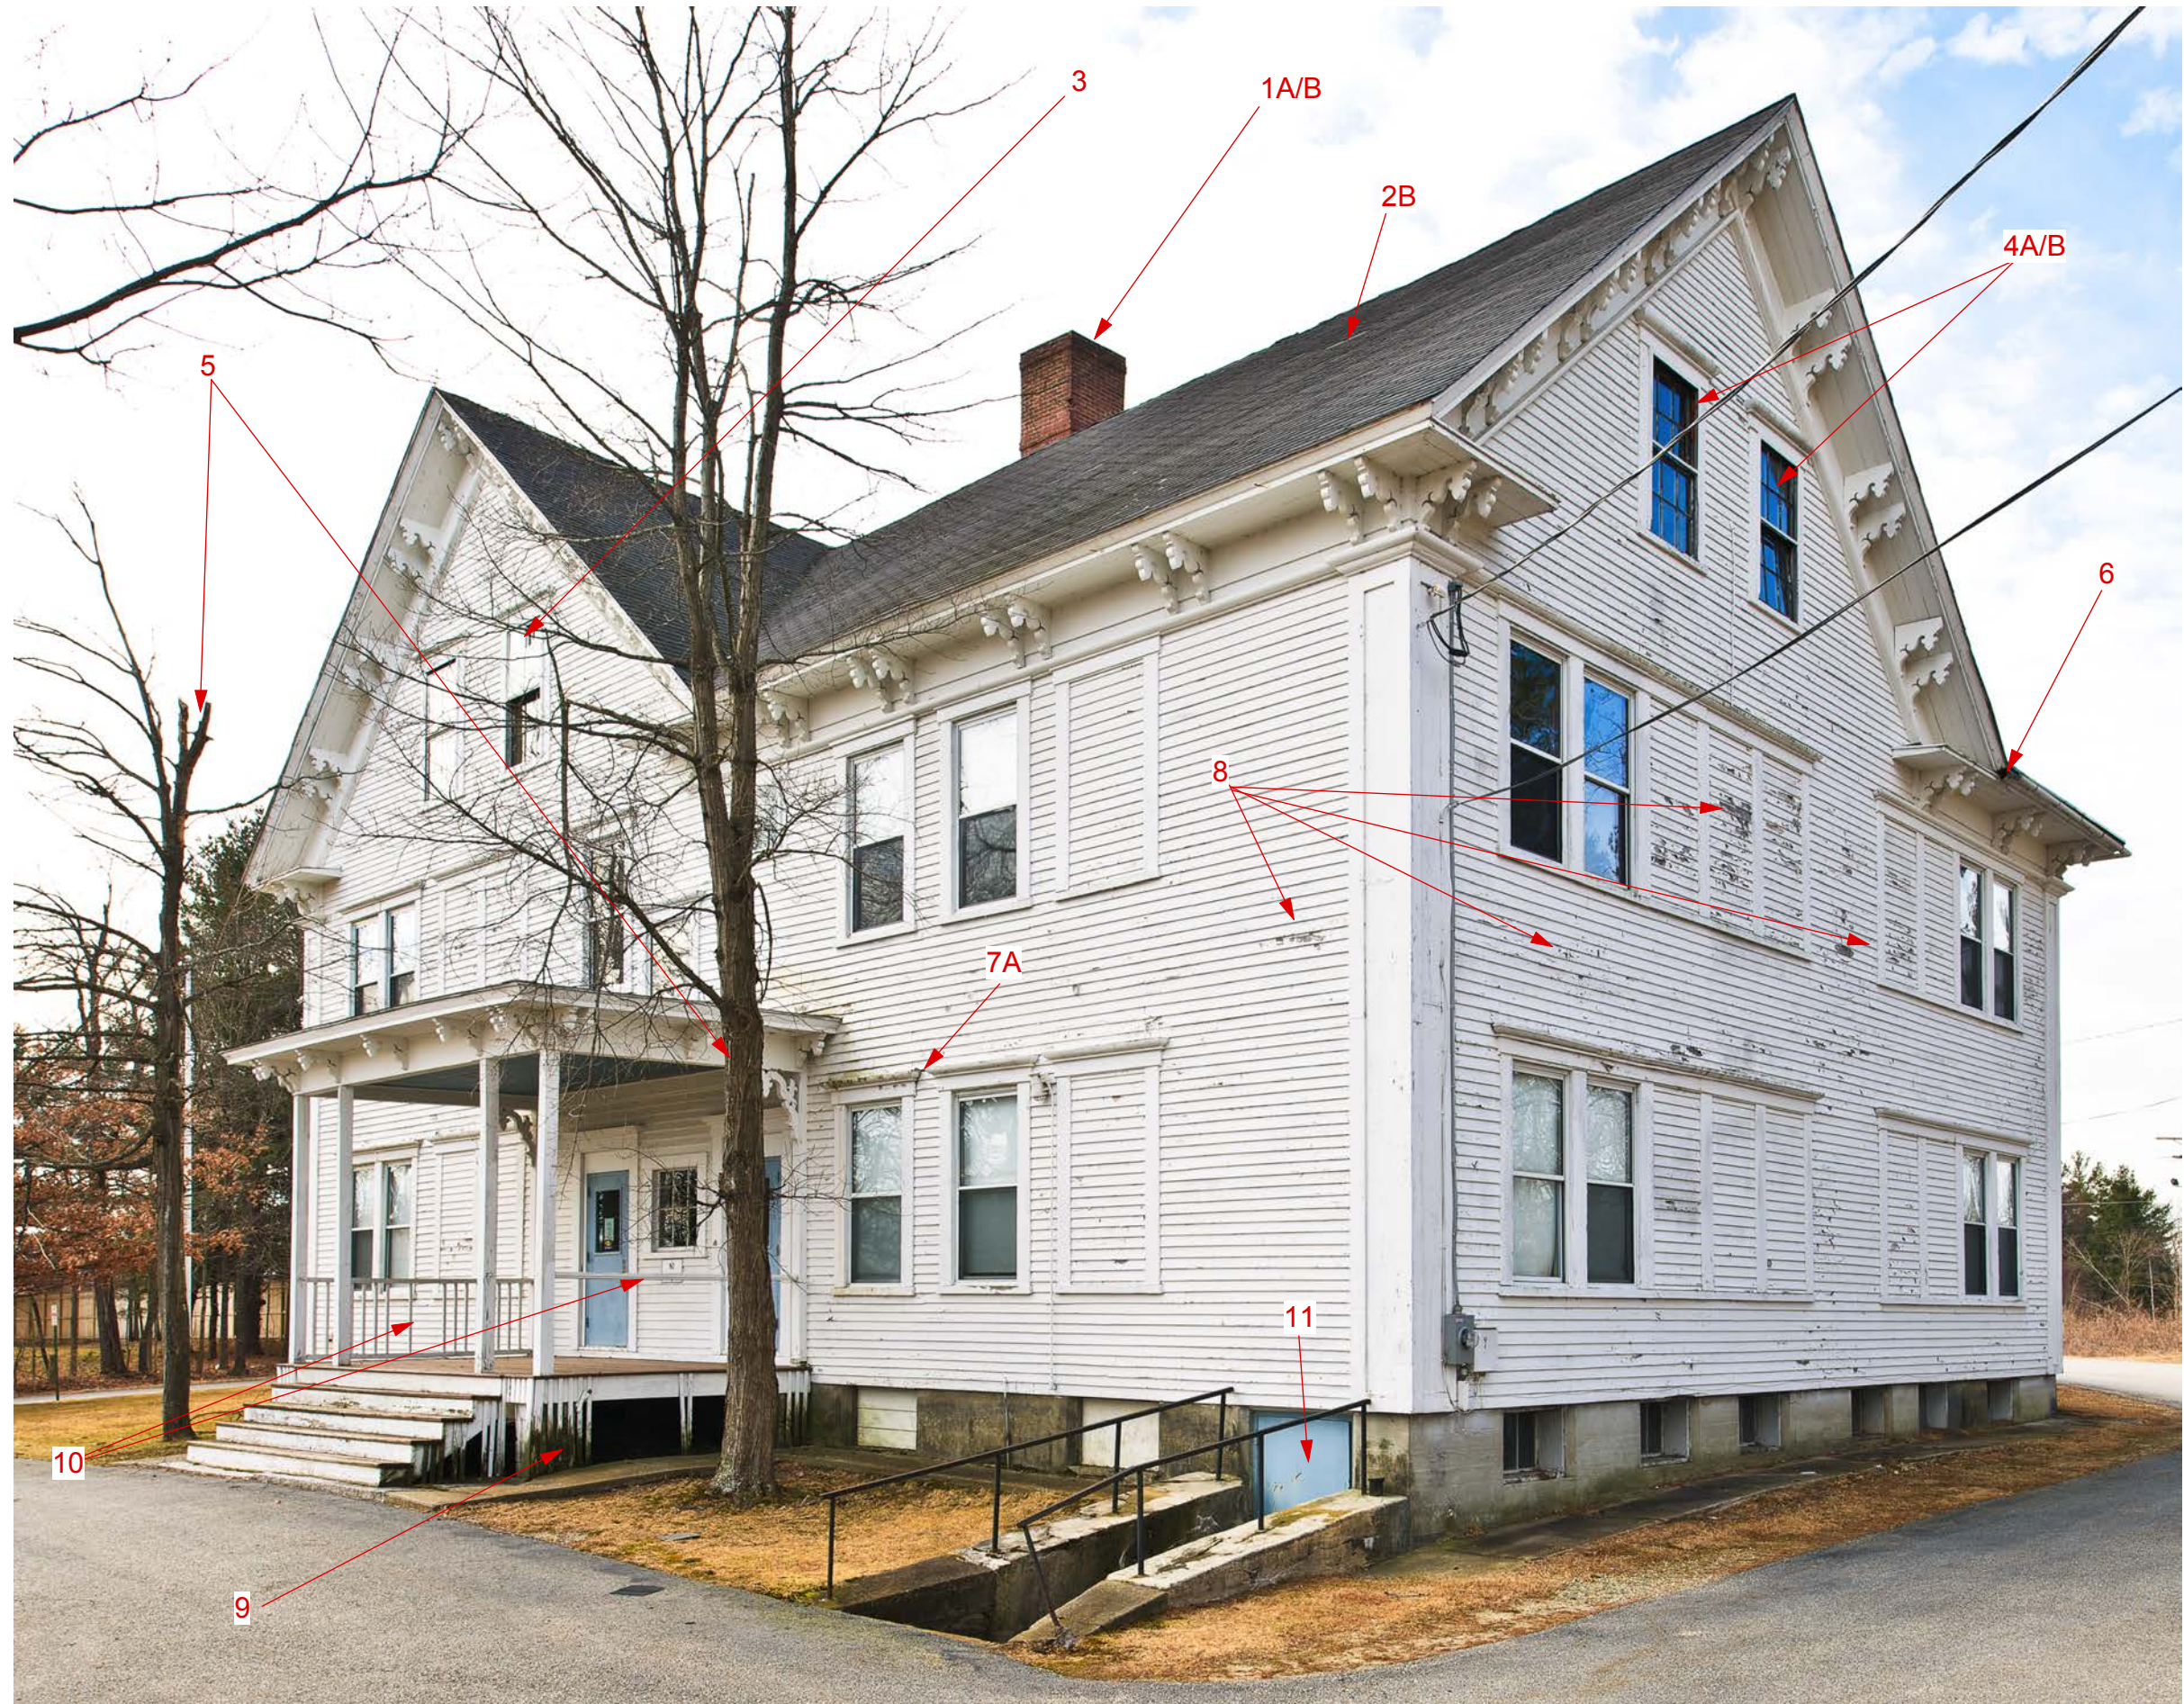
FARLEY BUILDING:
EAST & NORTH ELEVATIONS,
CONDITION ASSESSMENT
JULY 2012
REVISED NOV. 2012
SHEET 2 OF 10

1A/B. CHIMNEY, MISSING MASONRY UNITS, CRACKING, MORTAR JOINT DETERIORATION, (SEE DETAIL IMAGES). NOTE: MOST DAMAGE OCCURS ABOVE LOWER DRIP/BELT COURSE.

2B. MISSING/DAMAGED ROOF SHINGLE, (SEE DETAIL IMAGE).

3. EAST ELEVATION, RIGHT GABLE WINDOW: LOWER STORM SASH MISSING, UPPER STORM SASH BROKEN, (SEE DETAIL IMAGE).

4A/B. NORTH ELEVATION GABLE WINDOWS NOT PROTECTED BY STORM WINDOWS, LOWER SASH RIGHT WINDOW APPEARS TO TILT INWARDS, (SEE DETAIL IMAGE).

5. TREES IN TOO CLOSE PROXIMITY TO THE BUILDING.

6. JOINT AT INTERSECTION OF RAKING & LEVEL FASCIA BOARDS IS OPEN TO THE INTERIOR OF THE ROOF FRAMING & MORE THAN LARGE ENOUGH TO PERMIT PEST/RODENT ACCESS, (SEE DETAIL IMAGE).

7A. MISSING/DAMAGED CLAPBOARD(S), (SEE DETAIL IMAGE).

8. SIGNIFICANT AREAS OF PAINT LOSS/FAILURE ON BOTH THE EAST & NORTH ELEVATIONS, IN MANY CASES PAINT FAILURE HAS EXPOSED THE WOOD SUBSTRATE.

9. DETERIORATED WOOD LATTICE SLATS SHOULD BE REMOVED OR REPLACED.

10. MISSING BALASTRADE PARTS, REPLACE FOR POSSIBLE SAFETY ISSUES.

11. BULKHEAD/CELLAR ACCESS OPEN TO THE WEATHER.

STABILIZATION RECOMMENDATION: REMOVE CHIMNEY BRICKS TO THE DRIP COURSE LEVEL.

STABILIZATION RECOMMENDATION: REPAIR/REPLACE MISSING/DAMAGED SHINGLE.

STABILIZATION RECOMMENDATION: INSTALL/REPAIR STORM SASH.

STABILIZATION RECOMMENDATION: INSTALL STORM SASH.

STABILIZATION RECOMMENDATION: REMOVE BOTH TREES.

STABILIZATION RECOMMENDATION: REPAIR AS NEEDED.

STABILIZATION RECOMMENDATION: REPLACE/REPAIR CLAPBOARD.

STABILIZATION RECOMMENDATION: PAINT PRIME AREAS OF BARE WOOD WITH OIL BASED PRIMER.

STABILIZATION RECOMMENDATION: NO ACTION AT THIS TIME.

STABILIZATION RECOMMENDATION: ENCLOSE BULKHEAD/CELLAR ACCESS TO MAKE WEATHER TIGHT.

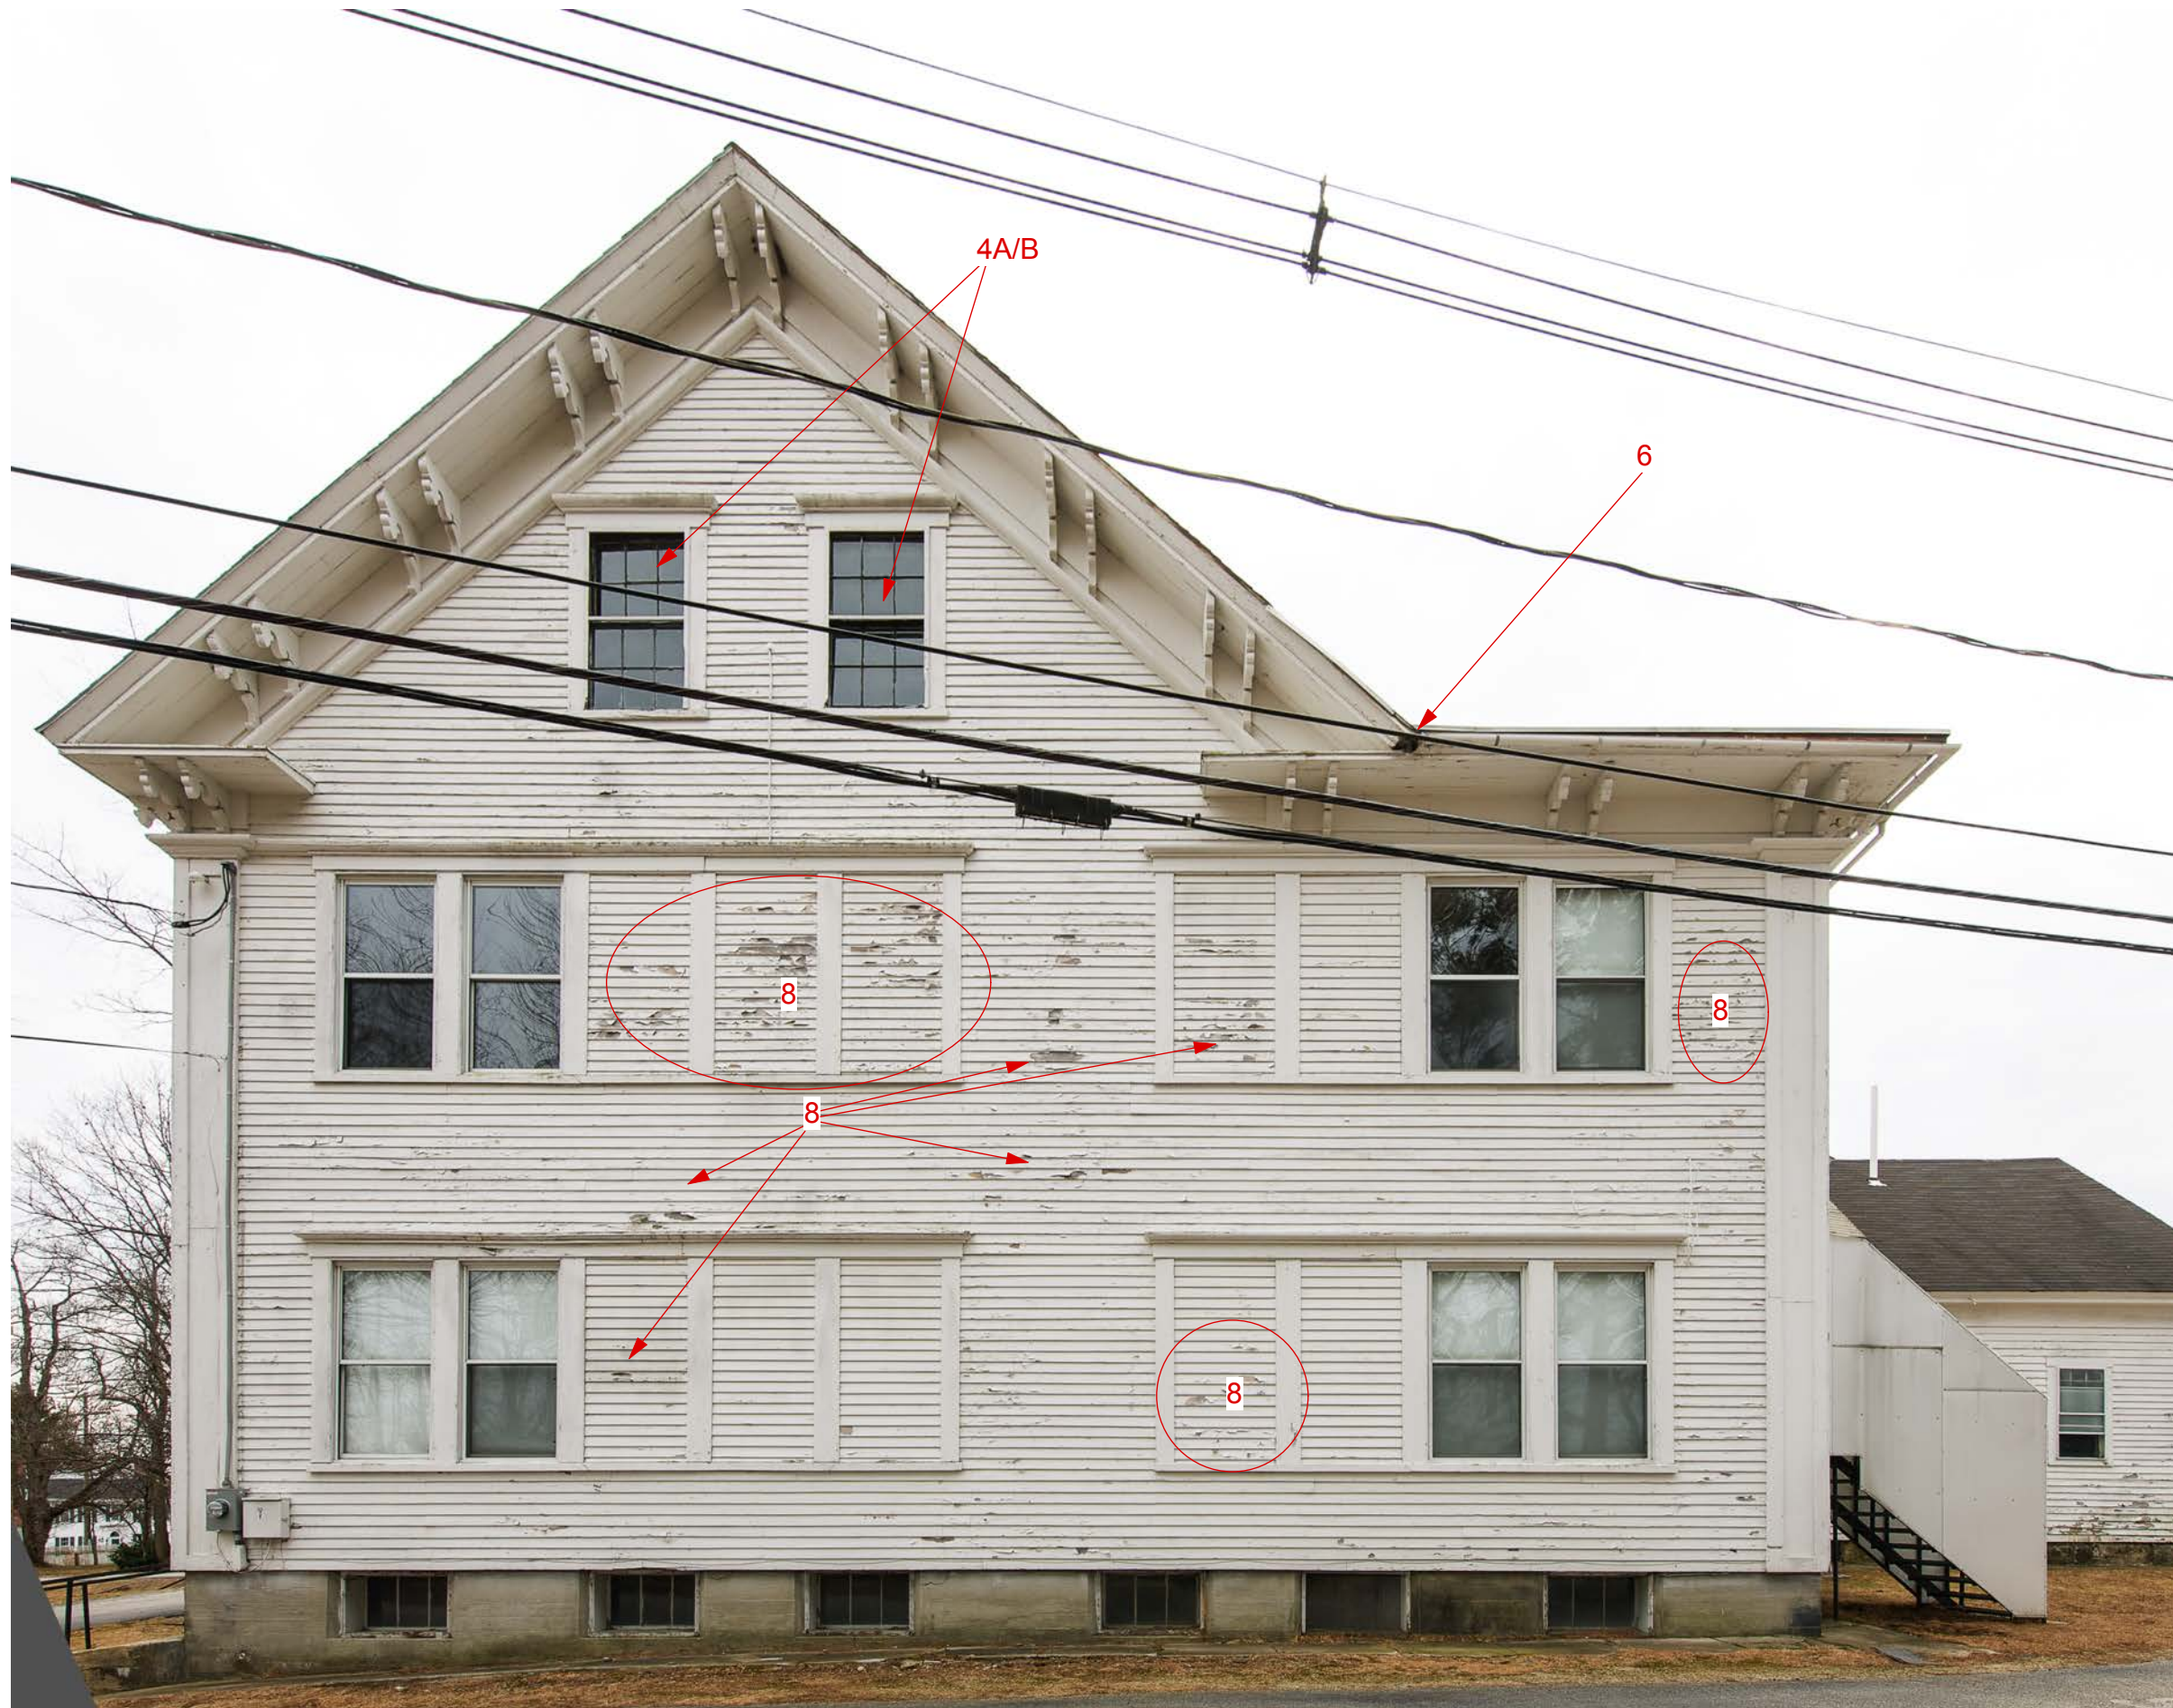
SHEET 3 OF 10

4A/B. NORTH ELEVATION GABLE
WINDOWS NOT PROTECTED BY
STORM WINDOWS, LOWER SASH
RIGHT WINDOW APPEARS TO TILT
INWARDS, (SEE DETAIL IMAGES).

6. JOINT AT INTERSECTION OF
RAKING & LEVEL FASCIA BOARDS IS
OPEN TO THE INTERIOR OF THE ROOF
FRAMING & MORE THAN LARGE
ENOUGH TO PERMIT PEST/RODENT
ACCESS, (SEE DETAIL IMAGE).

8. SIGNIFICANT AREAS OF PAINT
LOSS/FAILURE ON BOTH THE EAST &
NORTH ELEVATIONS, IN MANY CASES
PAINT FAILURE HAS EXPOSED THE
WOOD SUBSTRATE.

STABILIZATION RECOMMENDATION:
INSTALL STORM SASH.

STABILIZATION RECOMMENDATION:
REPAIR AS NEEDED.

STABILIZATION RECOMMENDATION:
**PAINT PRIME AREAS OF BARE WOOD
WITH OIL BASED PRIMER.**

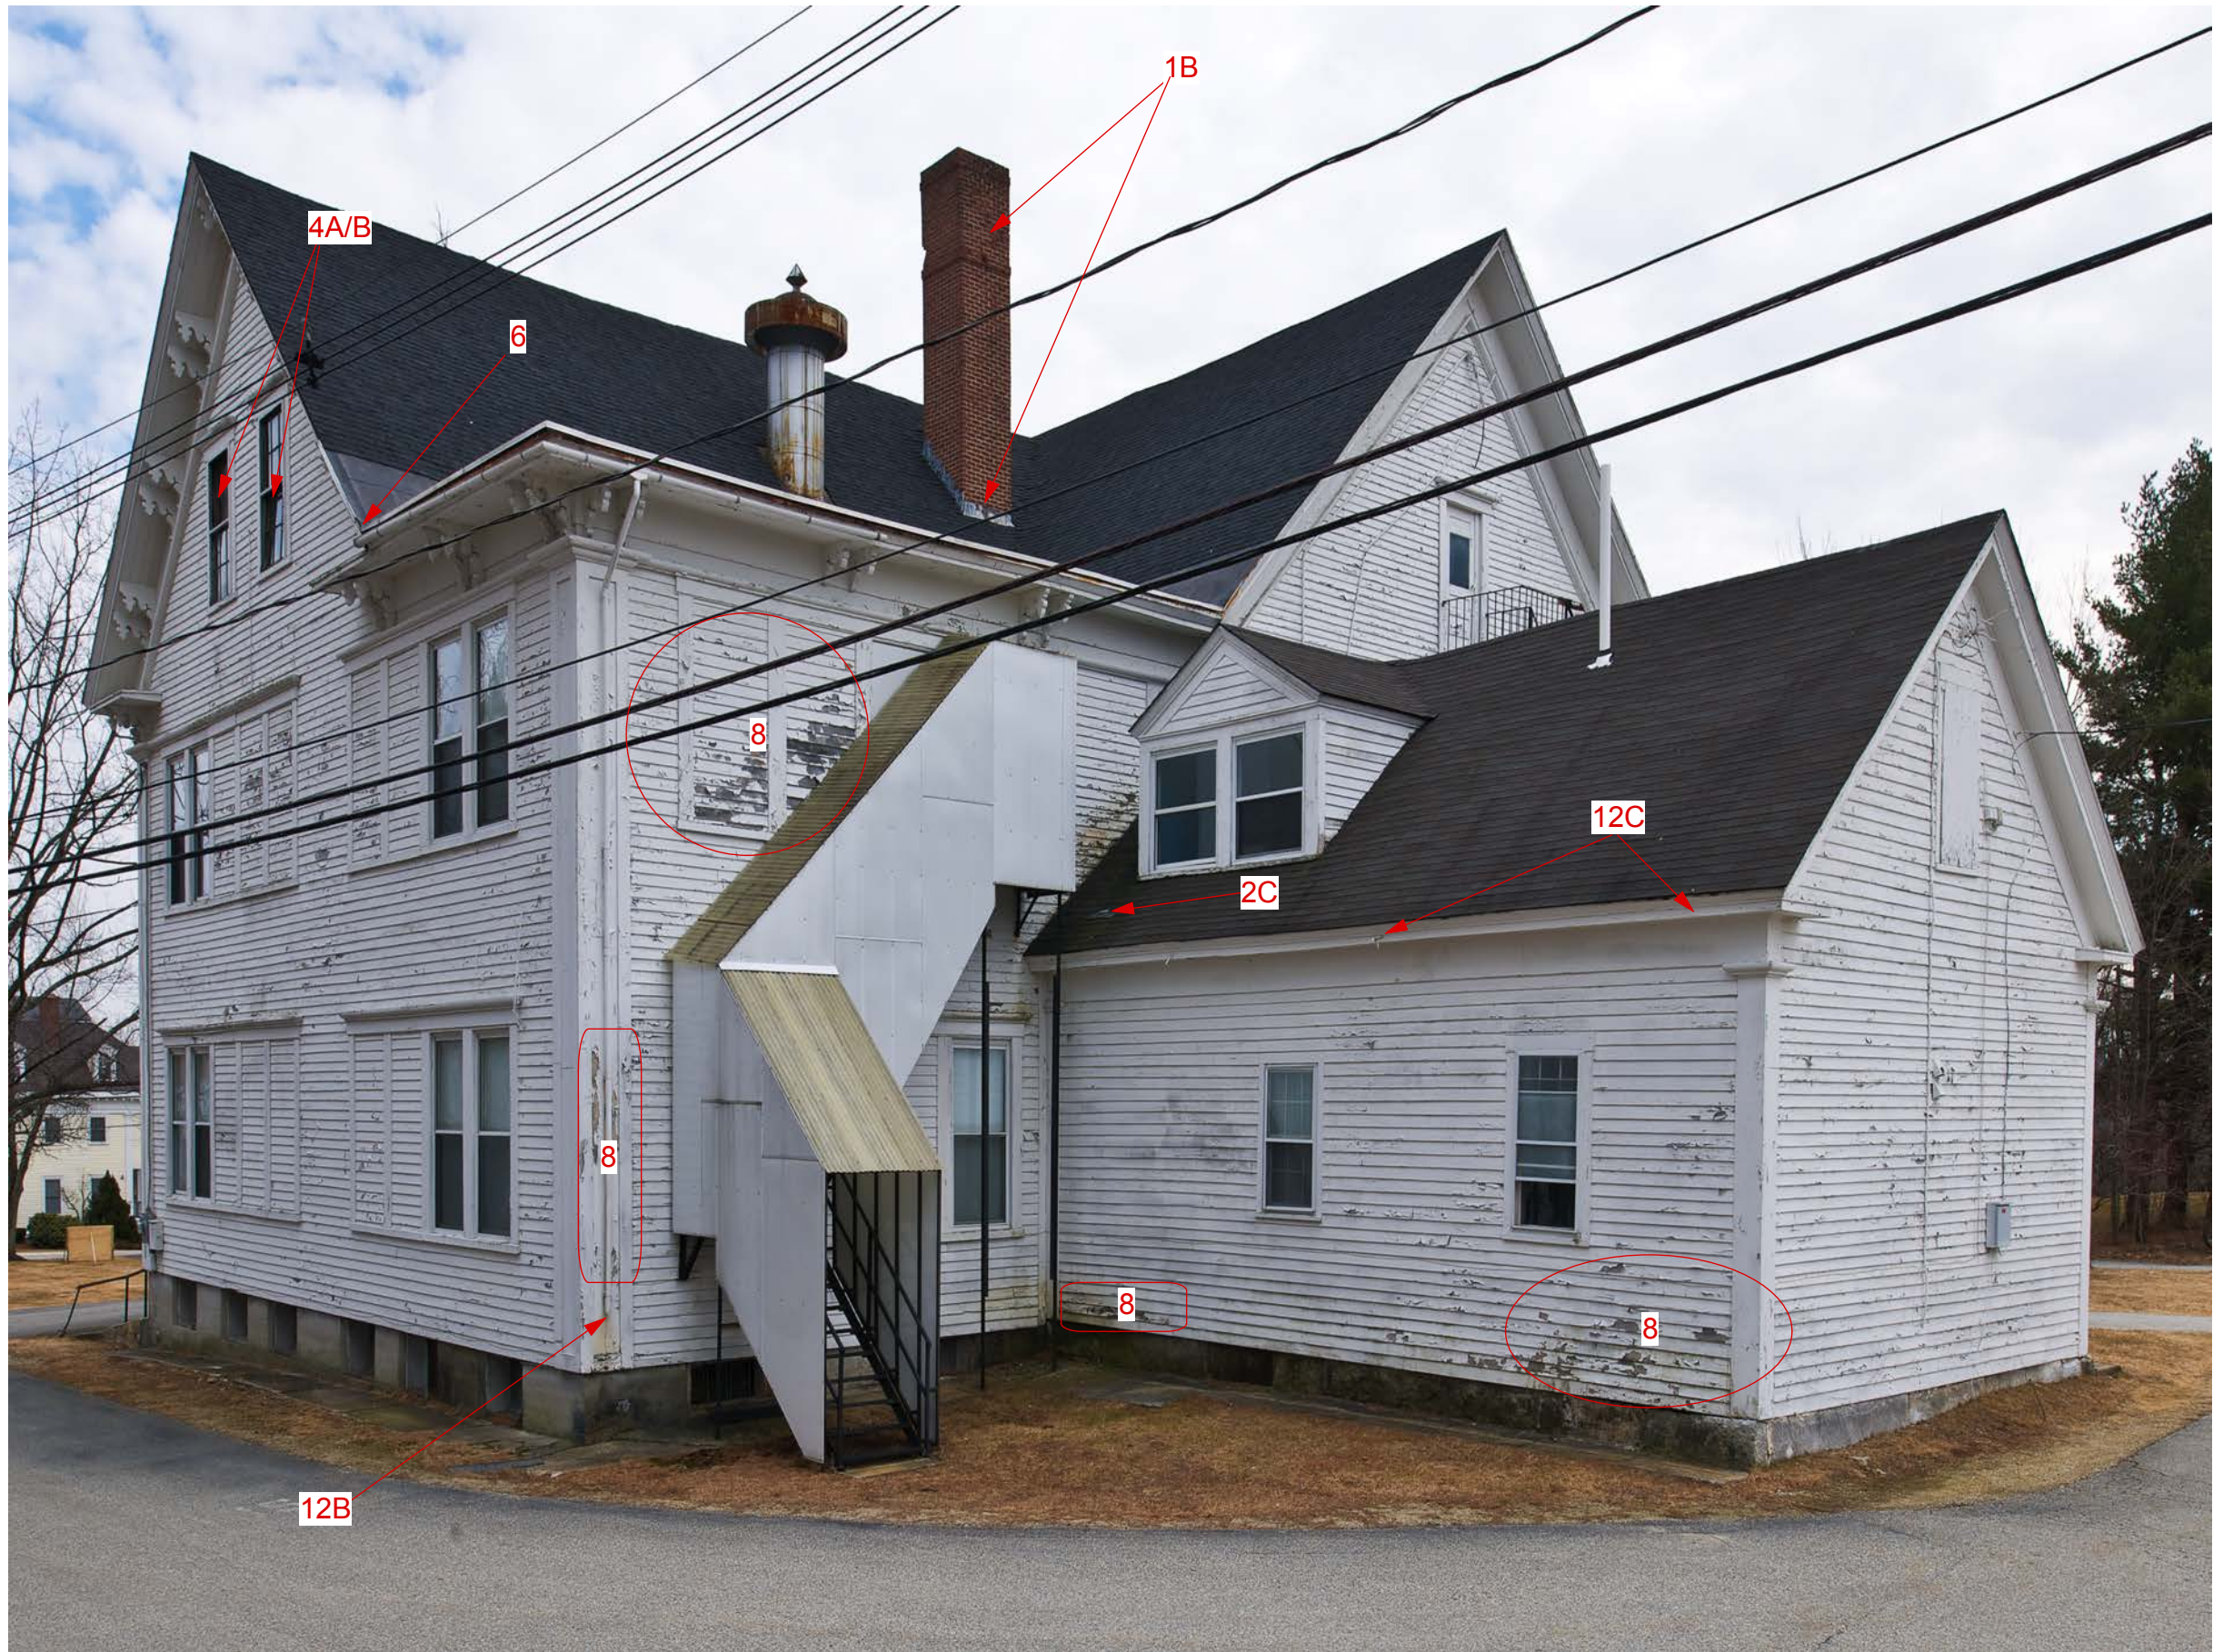
**FARLEY BUILDING:
NORTH & WEST ELEVATIONS,
CONDITION ASSESSMENT
JULY 2012
REVISED NOV. 2012
SHEET 4 OF 10**

1B. NORTH & WEST FACES OF CHIMNEY, MISSING MASONRY UNITS, CRACKING, MORTAR JOINT DETERIORATION, (SEE DETAIL IMAGES). NOTE: MOST DAMAGE OCCURS ABOVE LOWER DRIP/BELT COURSE. CHIMNEY STACK FLASHING/COUNTER FLASHING NEEDS INSPECTION.

2C. MISSING/DAMAGED ROOF SHINGLE. (NOTE THIS APPEARS TO BE A QUICKLY/INADEQUATELY DONE REPAIR FOR A MISSING/DAMAGED SHINGLE.)

4A/B. NORTH ELEVATION GABLE WINDOWS NOT PROTECTED BY STORM WINDOWS, LOWER SASH RIGHT WINDOW APPEARS TO TILT INWARDS, (SEE DETAIL IMAGES).

6. JOINT AT INTERSECTION OF RAKING & LEVEL FASCIA BOARDS IS OPEN TO THE INTERIOR OF THE ROOF FRAMING & MORE THAN LARGE ENOUGH TO PERMIT PEST/RODENT ACCESS, (SEE DETAIL IMAGE).

8. SIGNIFICANT AREAS OF PAINT LOSS/FAILURE ON BOTH THE EAST & NORTH ELEVATIONS, IN MANY CASES PAINT FAILURE HAS EXPOSED THE WOOD SUBSTRATE.

12B. DOWNSPOUT MISSING LOWER END/DIVERTER.

12C. GUTTER & DOWNSPOUT MISSING FROM THIS SECTION OF ROOF.

STABILIZATION RECOMMENDATION:
REMOVE CHIMNEY BRICKS TO THE DRIP COURSE LEVEL.

STABILIZATION RECOMMENDATION:
REPAIR/REPLACE MISSING/DAMAGED SHINGLE.

STABILIZATION RECOMMENDATION:
INSTALL STORM SASH.

STABILIZATION RECOMMENDATION:
REPAIR AS NEEDED.

STABILIZATION RECOMMENDATION:
PAINT PRIME AREAS OF BARE WOOD WITH OIL BASED PRIMER.

STABILIZATION RECOMMENDATION:
INSTALL LOWER END/DIVERTER & INSURE DISCHARGE WATER IS DIRECTED AWAY FROM THE BUILDING.

STABILIZATION RECOMMENDATION:
INSTALL GUTTER & DOWNSPOUT & INSURE DISCHARGE WATER IS DIRECTED AWAY FROM THE BUILDING.

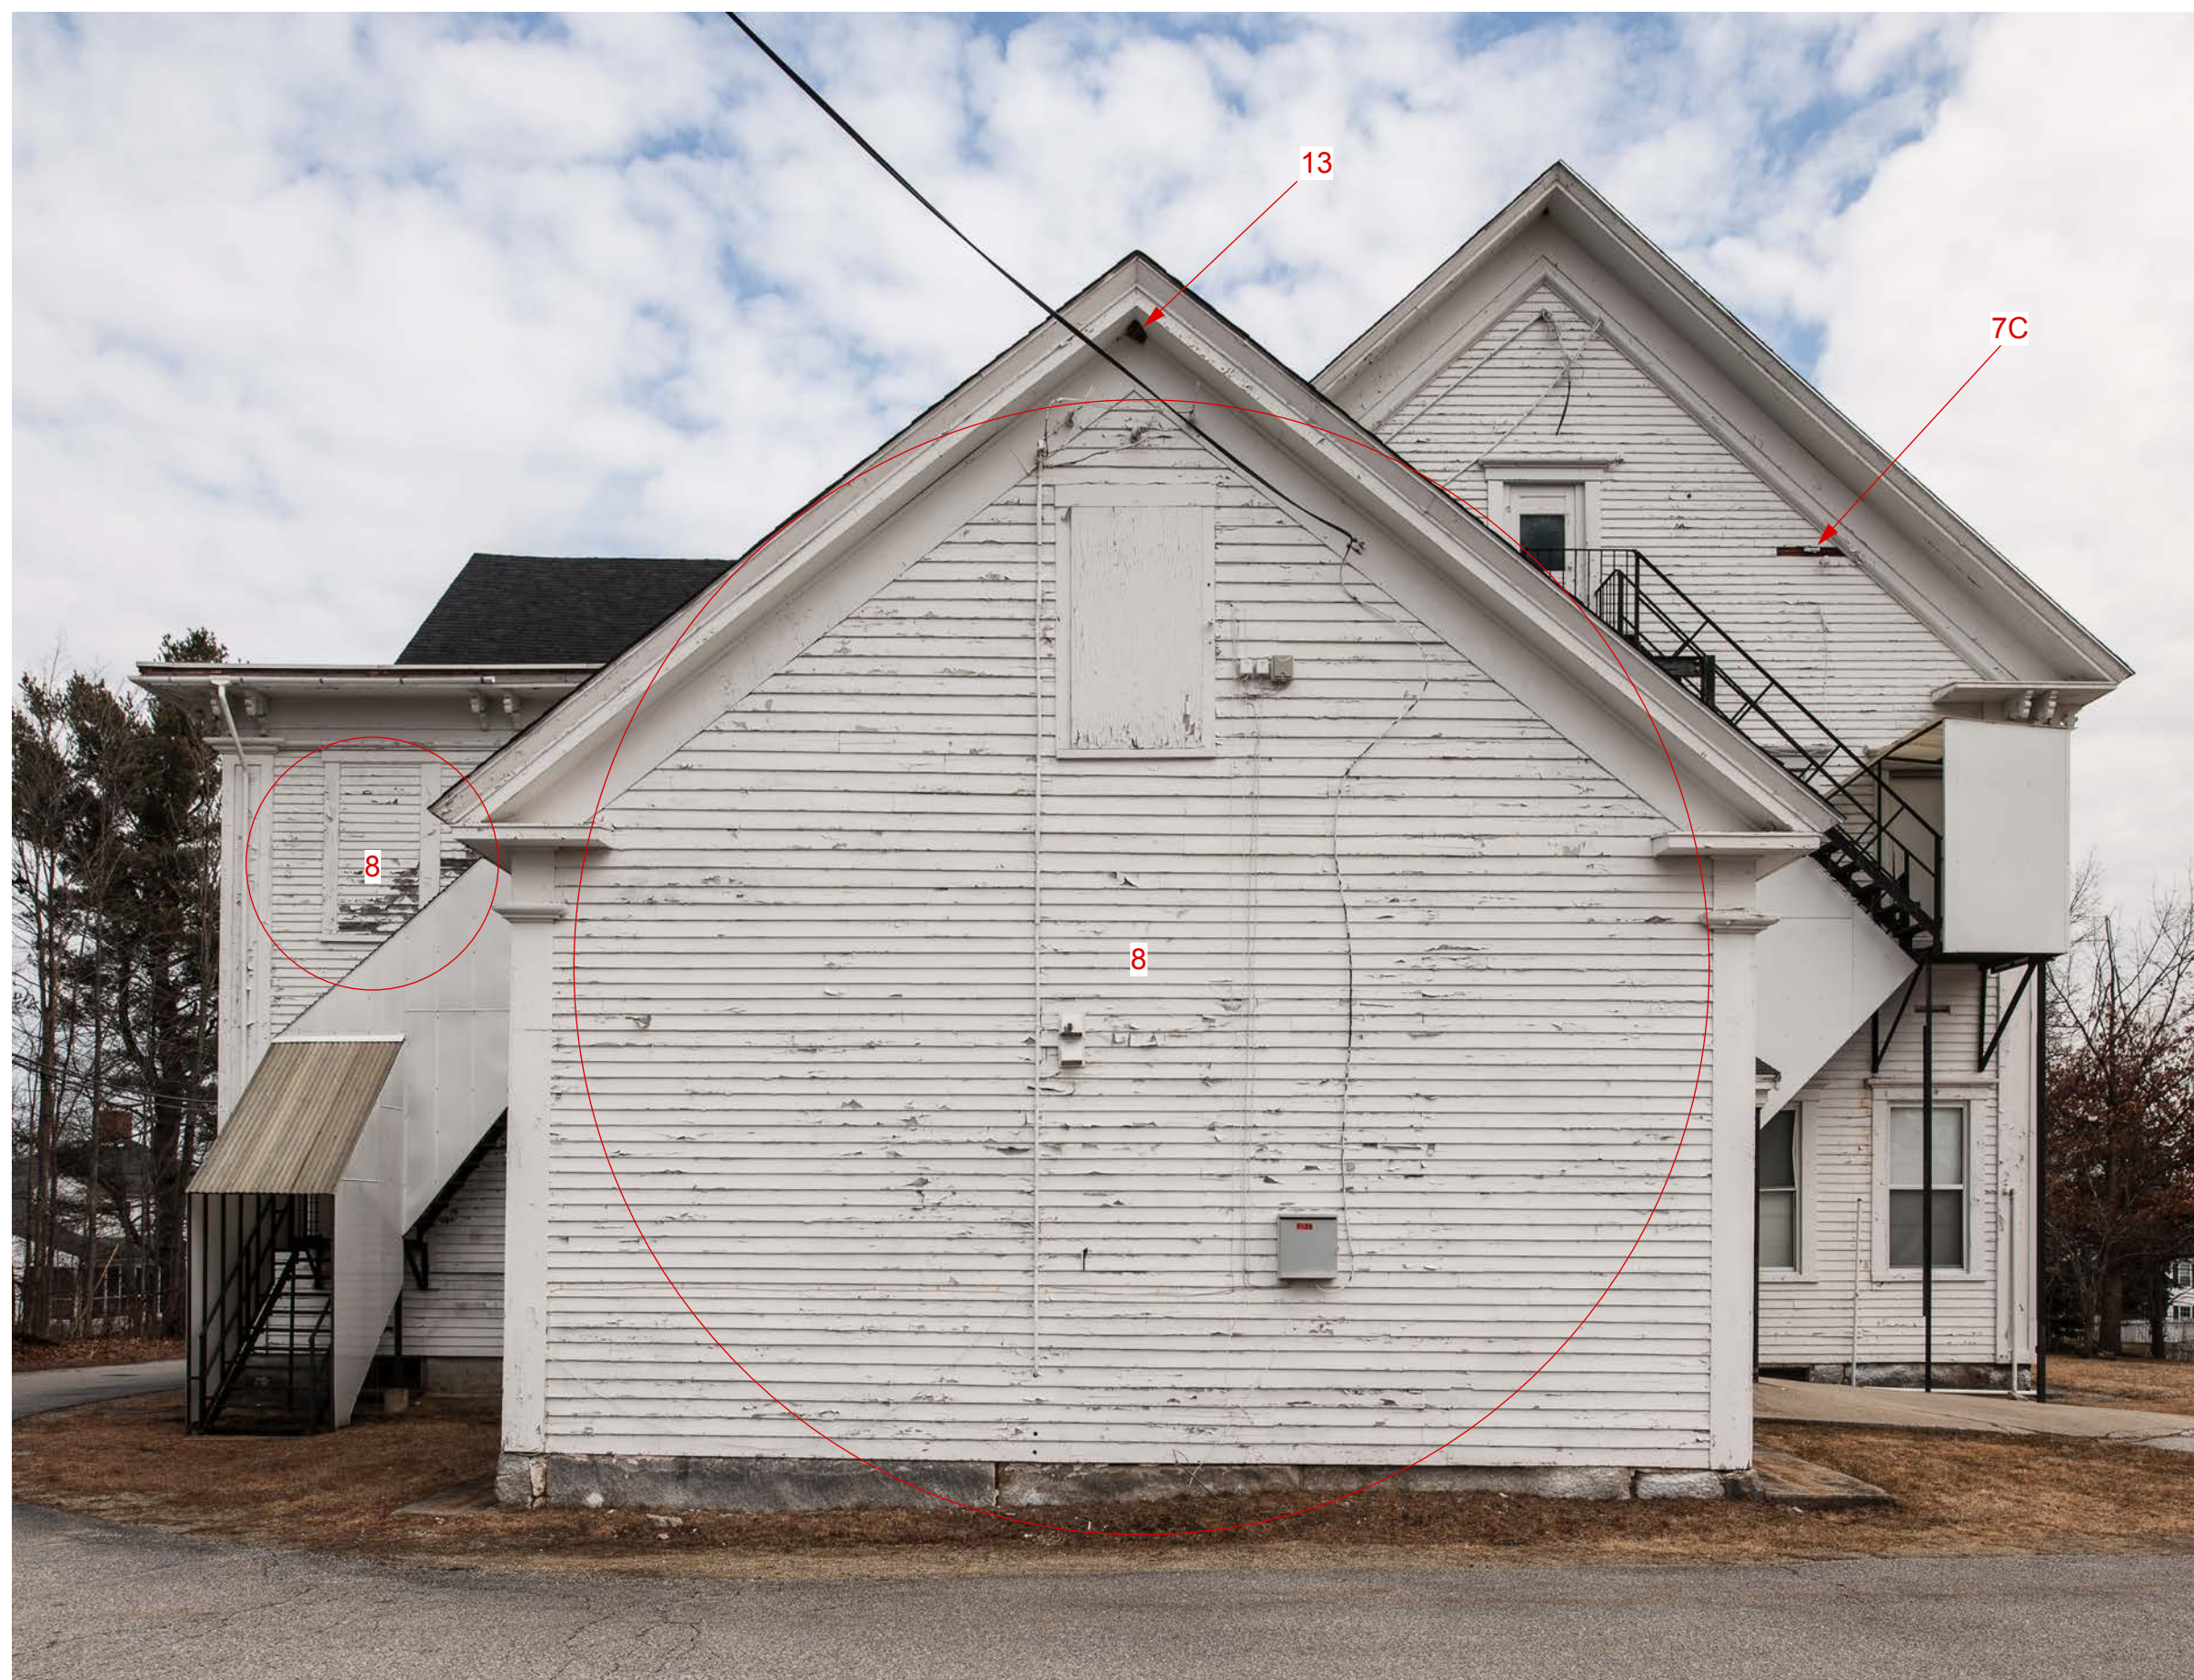
FARLEY BUILDING:
WEST ELEVATION,
CONDITION ASSESSMENT
JULY 2012
REVISED NOV. 2012
SHEET 5 OF 10

7C. DAMAGED/MISSING CLAPBOARD,
(SEE DETAIL IMAGE).

8. SIGNIFICANT AREAS OF PAINT
LOSS/FAILURE ON BOTH THE EAST &
NORTH ELEVATIONS, IN MANY CASES
PAINT FAILURE HAS EXPOSED THE
WOOD SUBSTRATE.

13. BEE/WASP/HORNET NEST.

STABILIZATION RECOMMENDATION:
REPLACE/REPAIR CLAPBOARD.

STABILIZATION RECOMMENDATION:
PAINT PRIME AREAS OF BARE WOOD
WITH OIL BASED PRIMER.

STABILIZATION RECOMMENDATION:
REMOVE NEST.
