TOWN OF HOLLIS, NEW HAMPSHIRE

Farley Building

WEATHER TIGHT ENVELOPE/EXTERIOR CONDITION ASSESSMENT & STABILIZATION PLAN

Prepared by the Hollis Heritage Commission, Richard Brown & John Butler
July 2012, Revised December 2012

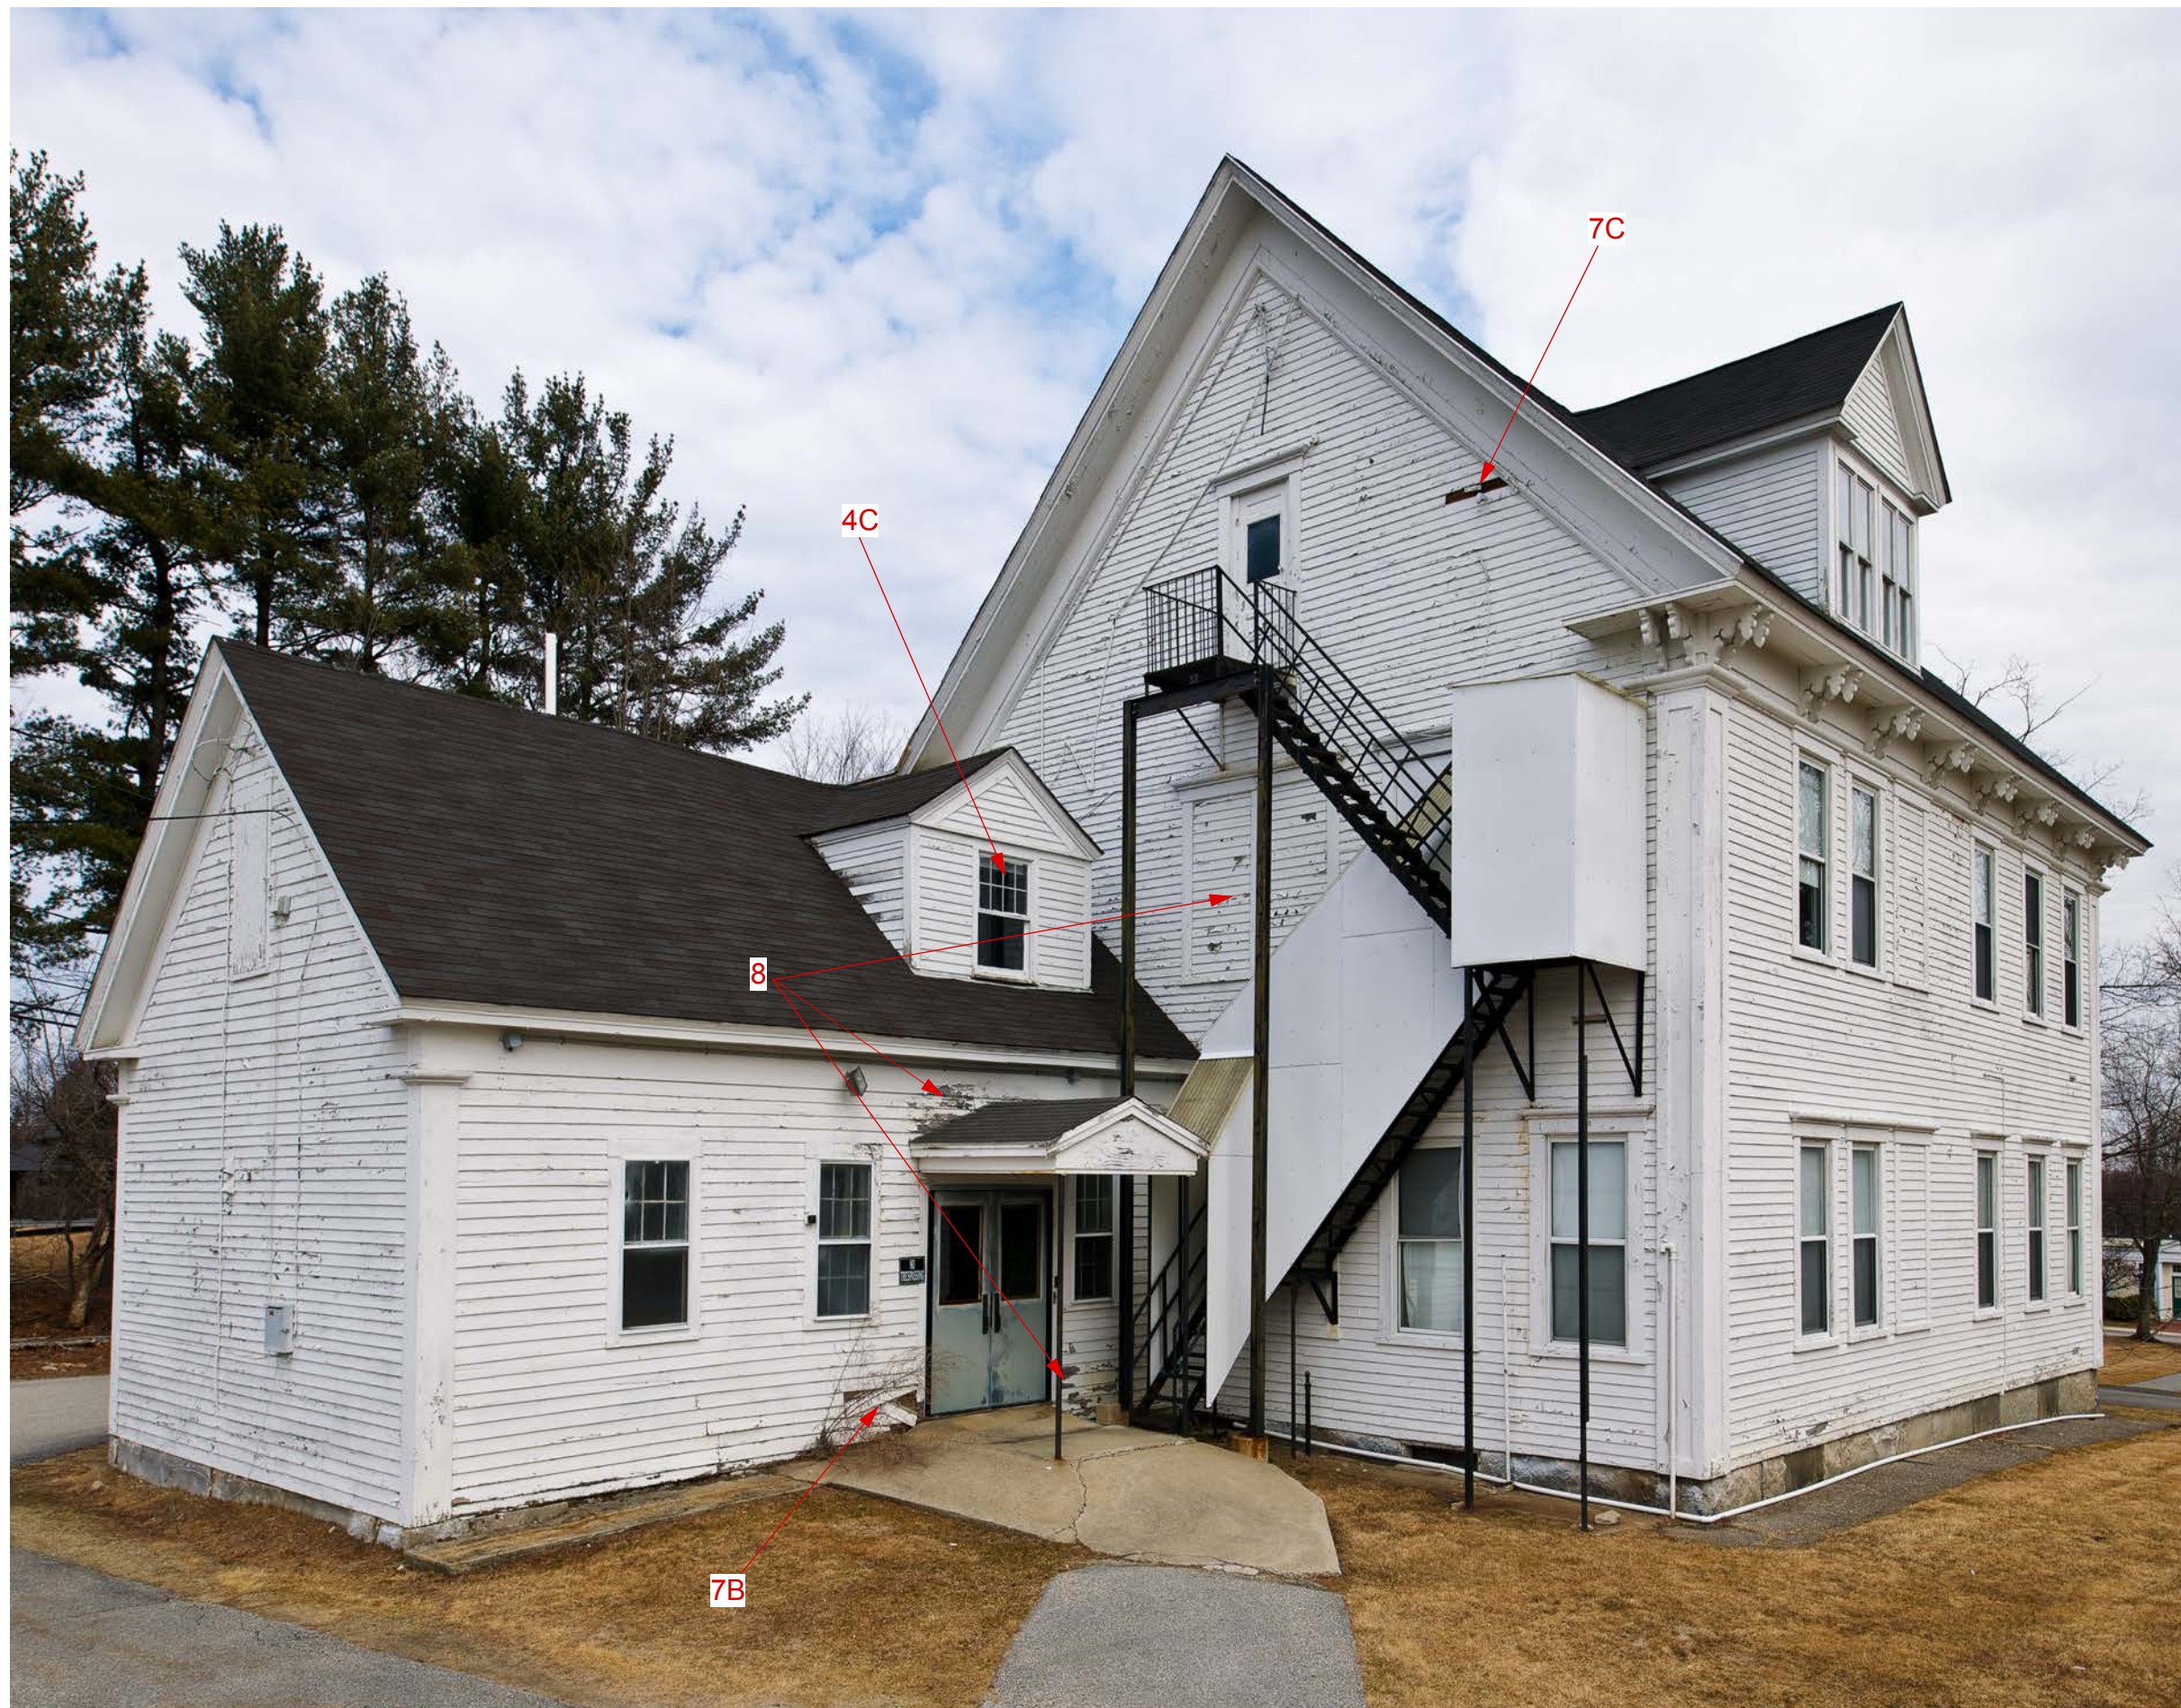
FARLEY BUILDING:
WEST & SOUTH ELEVATIONS,
CONDITION ASSESSMENT
JULY 2012
REVISED NOV.2012
SHEET 6 OF 10

4C. SOUTH ELEVATION DORMER
WINDOW HAS NO STORM WINDOW.
STABILIZATION RECOMMENDATION:
INSTALL STORM WINDOW.
7B/C. DAMAGED/MISSING
CLAPBOARD, (SEE DETAIL IMAGES).
STABILIZATION RECOMMENDATION:
REPLACE/REPAIR CLAPBOARD.
8. SIGNIFICANT AREAS OF PAINT
LOSS/FAILURE ON BOTH THE EAST &
NORTH ELEVATIONS, IN MANY CASES
PAINT FAILURE HAS EXPOSED THE
WOOD SUBSTRATE.
STABILIZATION RECOMMENDATION:
PAINT PRIME AREAS OF BARE WOOD
WITH OIL BASED PRIMER.

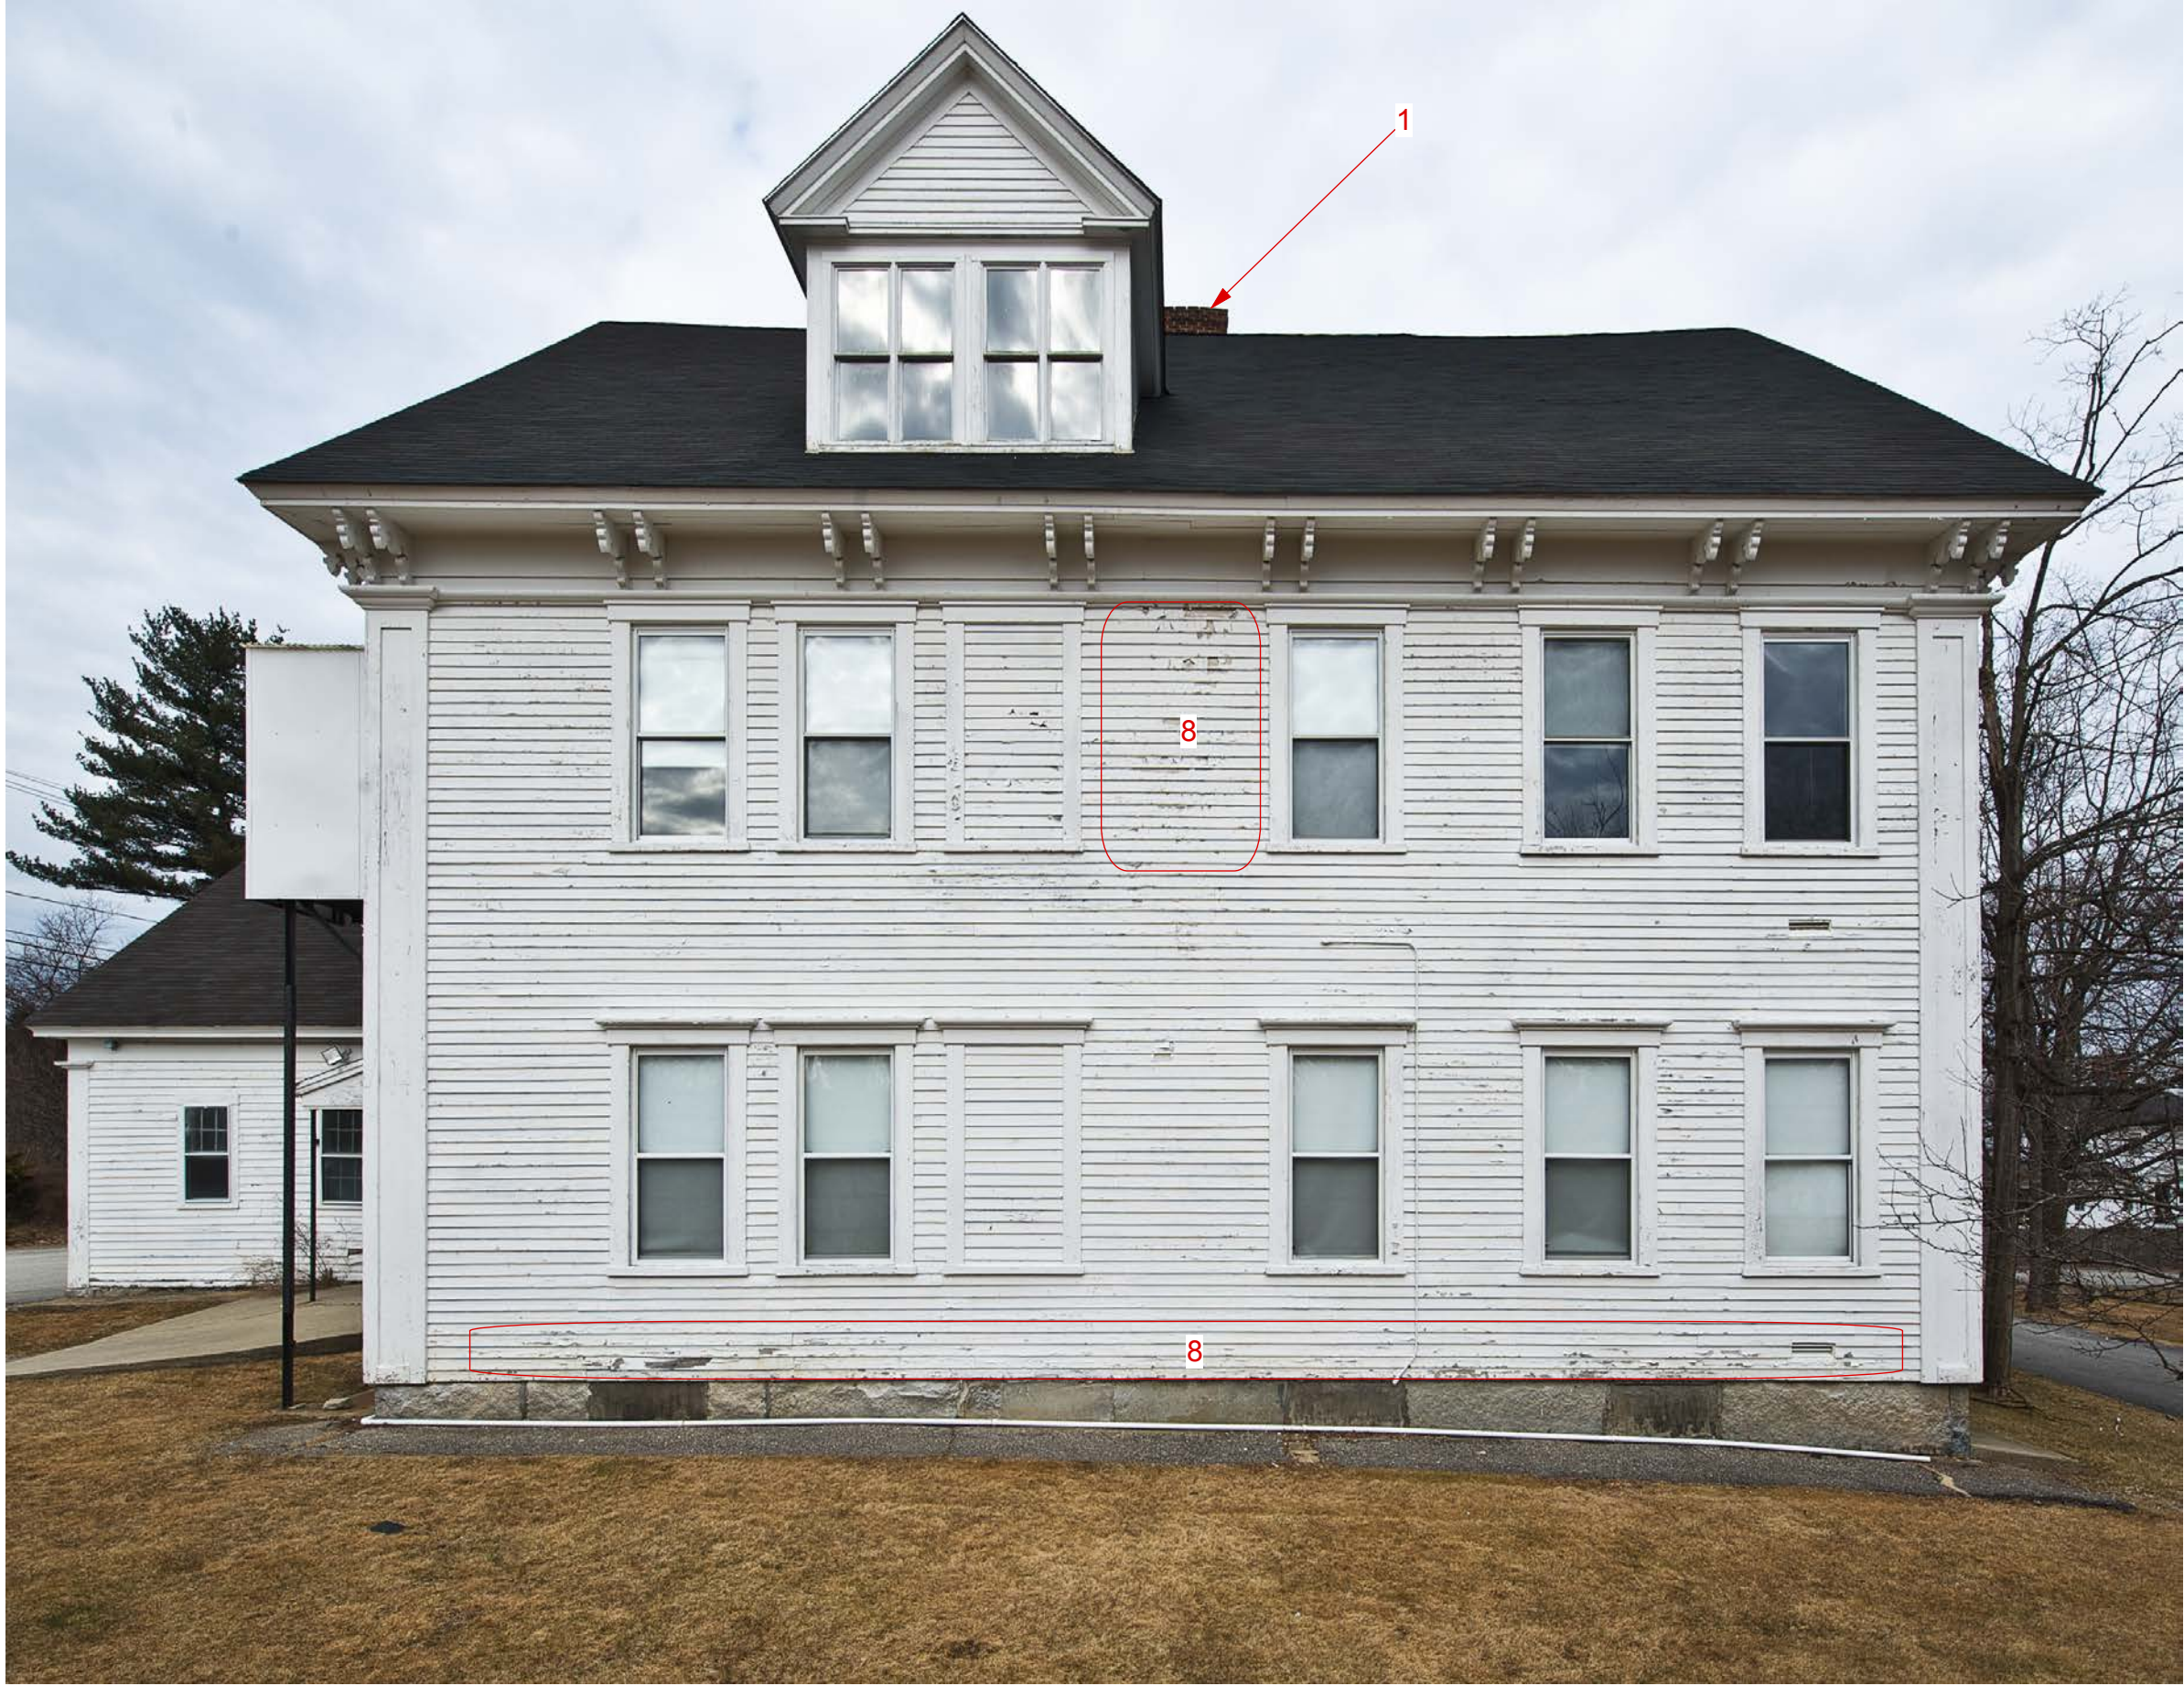
FARLEY BUILDING:
SOUTH ELEVATION,
CONDITION ASSESSMENT
JULY 2012
REVISED NOV. 2012
SHEET 7 OF 10

1. SOUTH FACE OF CHIMNEY, MISSING MASONRY UNITS, CRACKING, MORTAR JOINT DETERIORATION, (SEE DETAIL IMAGES). NOTE: MOST DAMAGE OCCURS ABOVE LOWER DRIP/BELT COURSE.

8. SIGNIFICANT AREAS OF PAINT LOSS/FAILURE ON BOTH THE EAST & NORTH ELEVATIONS, IN MANY CASES PAINT FAILURE HAS EXPOSED THE WOOD SUBSTRATE.

STABILIZATION RECOMMENDATION:
REMOVE CHIMNEY BRICKS TO THE DRIP COURSE LEVEL.

STABILIZATION RECOMMENDATION:
PAINT PRIME AREAS OF BARE WOOD WITH OIL BASED PRIMER.

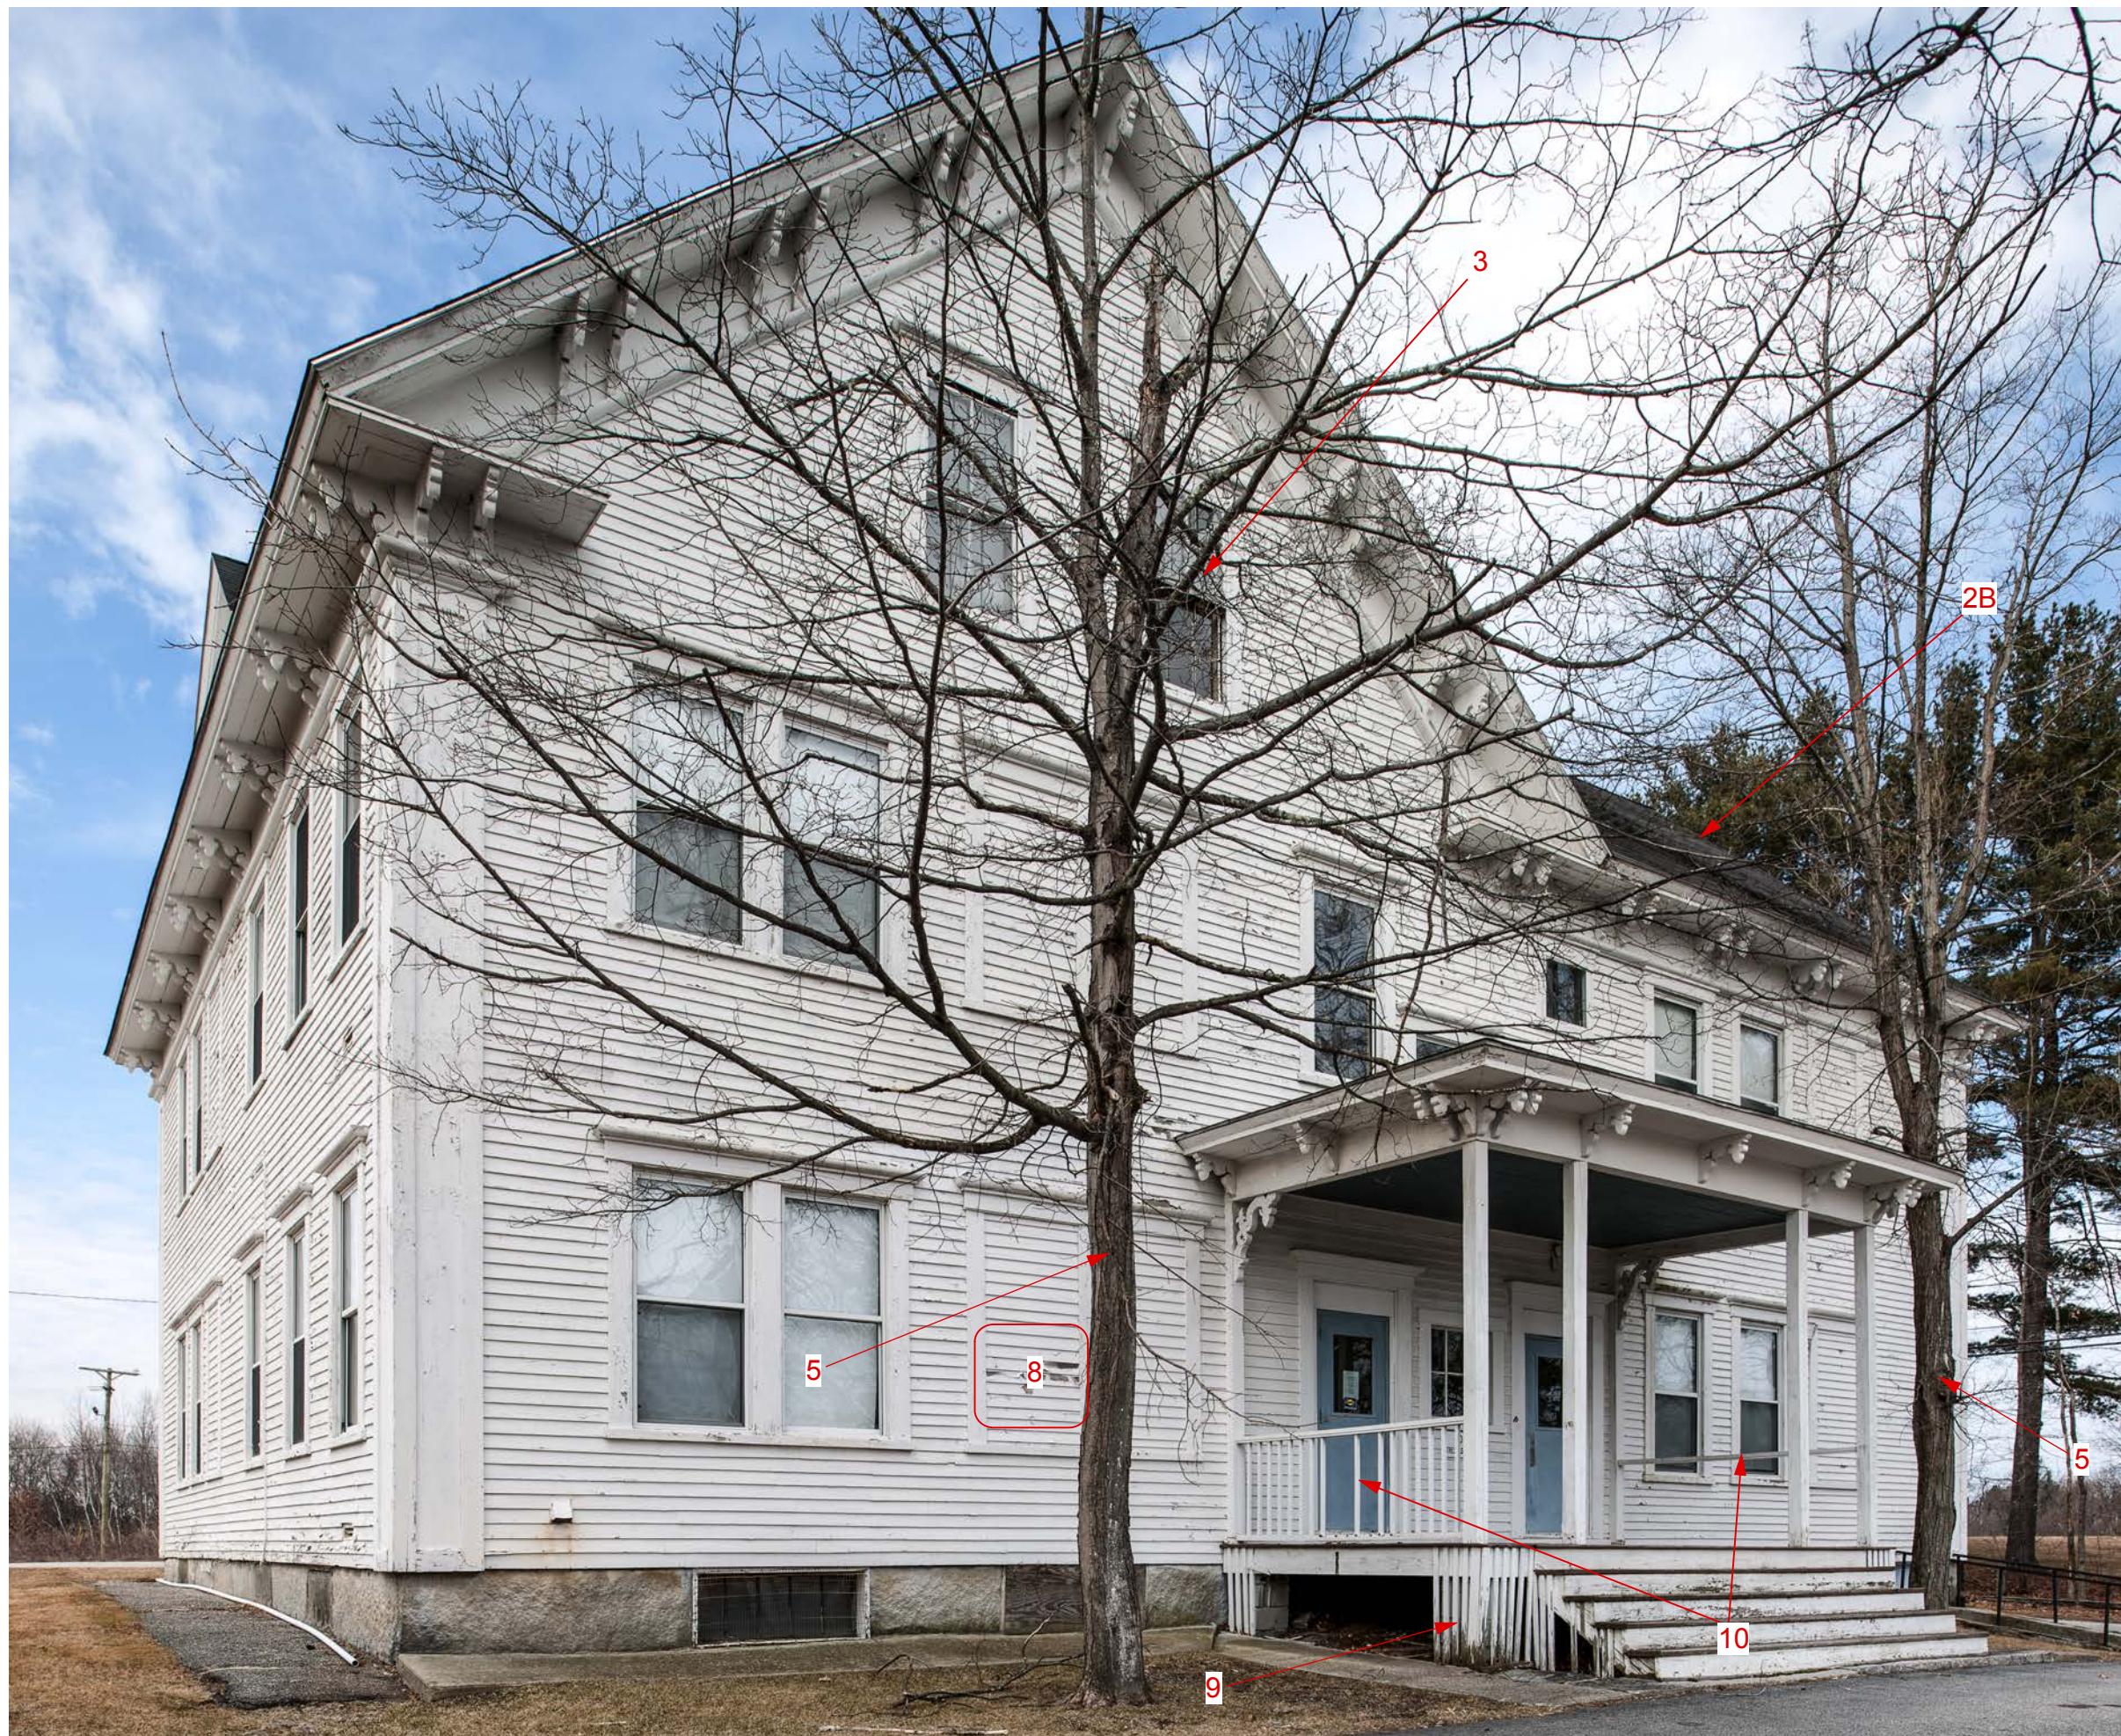
FARLEY BUILDING:
SOUTH & NORTH ELEVATIONS,
CONDITION ASSESSMENT
JULY 2012
REVISED NOV. 2012
SHEET 8 OF 10

2B. MISSING ROOF SHINGLE, (SEE
DETAIL IMAGE).

3. EAST ELEVATION GABLE WINDOWS:
RIGHT WINDOW; LOWER STORM SASH
MISSING, UPPER STORM SASH
BROKEN, (SEE DETAIL IMAGE).

5. TREES IN TOO CLOSE PROXIMITY
TO THE BUILDING.

8. SIGNIFICANT AREAS OF PAINT
LOSS/FAILURE ON BOTH THE SOUTH
& EAST ELEVATIONS, IN MANY CASES
PAINT FAILURE HAS EXPOSED THE
WOOD SUBSTRATE.

9. DETERIORATED WOOD LATTICE
SLATS SHOULD BE REMOVED OR
REPLACED.

10. MISSING BALASTRADE PARTS,
REPLACE FOR POSSIBLE SAFETY
ISSUES.

STABILIZATION RECOMMENDATION:
**REPAIR/REPLACE MISSING/DAMAGED
SHINGLE.**

STABILIZATION RECOMMENDATION:
INSTALL/REPAIR STORM SASH.

STABILIZATION RECOMMENDATION:
REMOVE BOTH TREES.

STABILIZATION RECOMMENDATION:
**PAINT PRIME AREAS OF BARE WOOD
WITH OIL BASED PRIMER.**

STABILIZATION RECOMMENDATION:
NO ACTION AT THIS TIME.

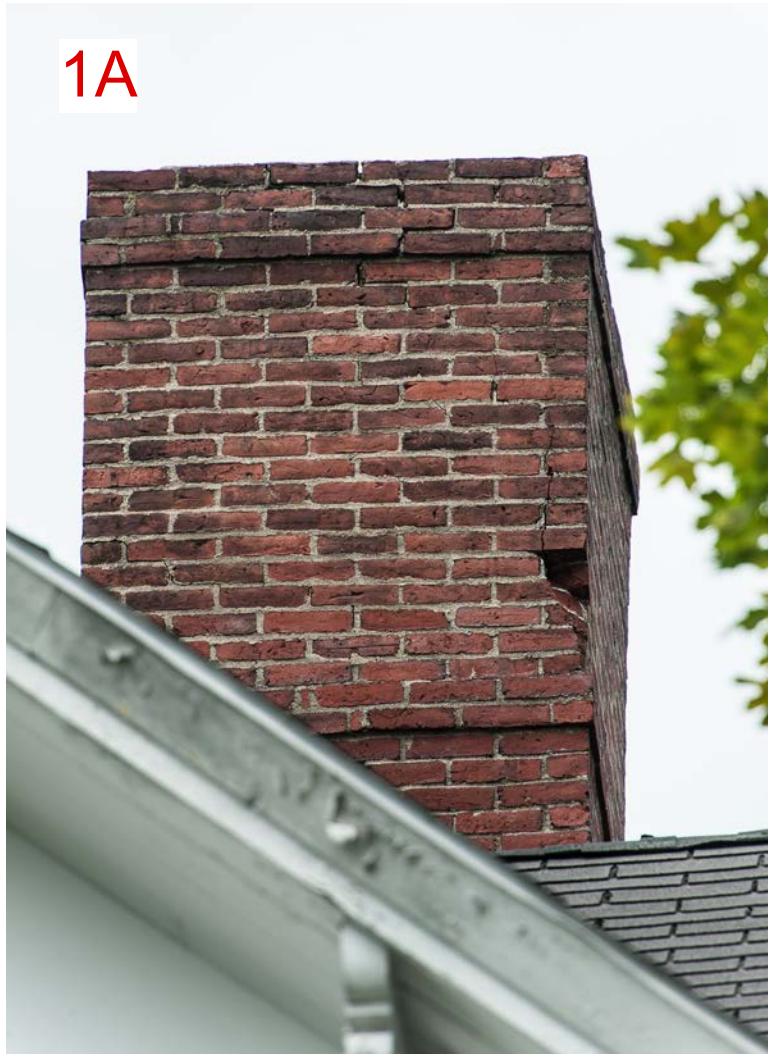
1A

1A. EAST FACE OF CHIMNEY, SHOWING MISSING MASONRY UNITS, CRACKING, MORTAR JOINT DETERIORATION, NOTE: MOST DAMAGE OCCURS ABOVE LOWER DRIP/BELT COURSE.

STABILIZATION RECOMMENDATION:
REMOVE CHIMNEY BRICKS TO THE DRIP COURSE LEVEL.

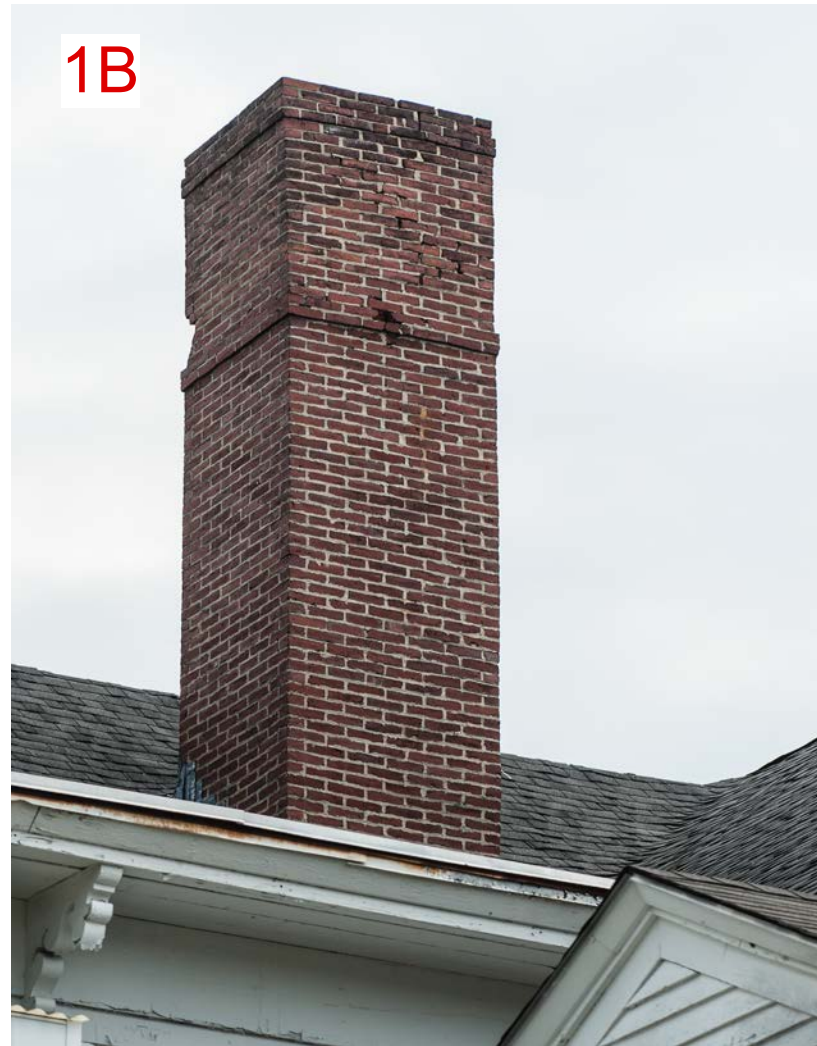
1B

1B. NORTH & WEST FACES OF CHIMNEY SHOWING CONDITIONS AS IN 1A.

STABILIZATION RECOMMENDATION:
REMOVE CHIMNEY BRICKS TO THE DRIP COURSE LEVEL.

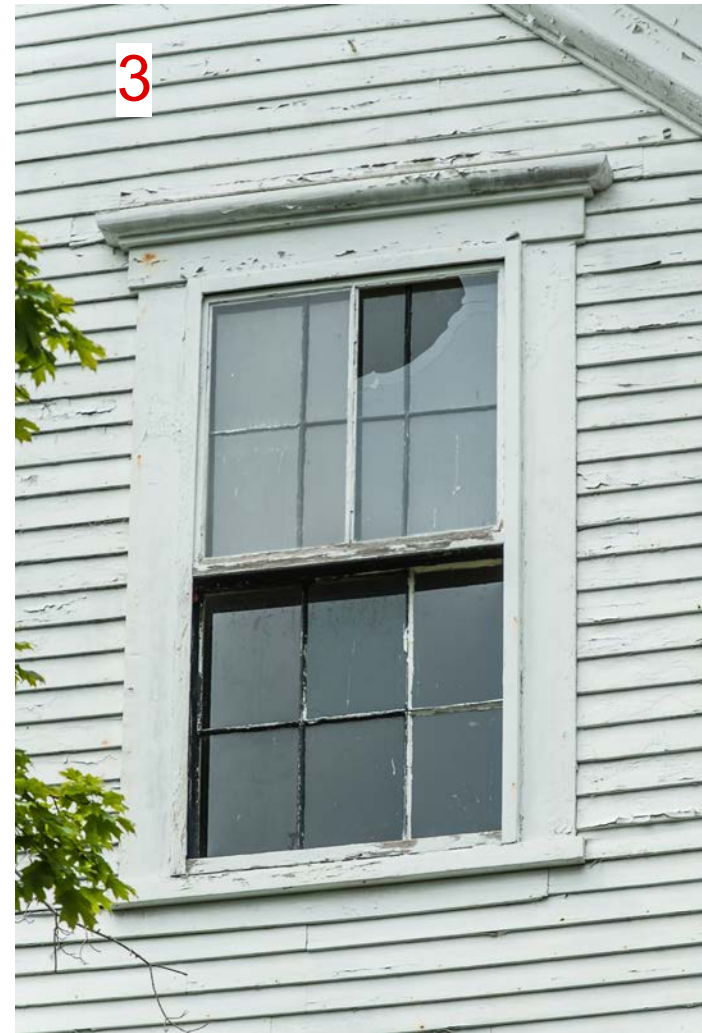
3

3. EAST ELEVATION, RIGHT GABLE WINDOW: LOWER STORM SASH MISSING, UPPER STORM SASH BROKEN, (SEE DETAIL IMAGE).

STABILIZATION RECOMMENDATION:
INSTALL/REPAIR STORM SASH.

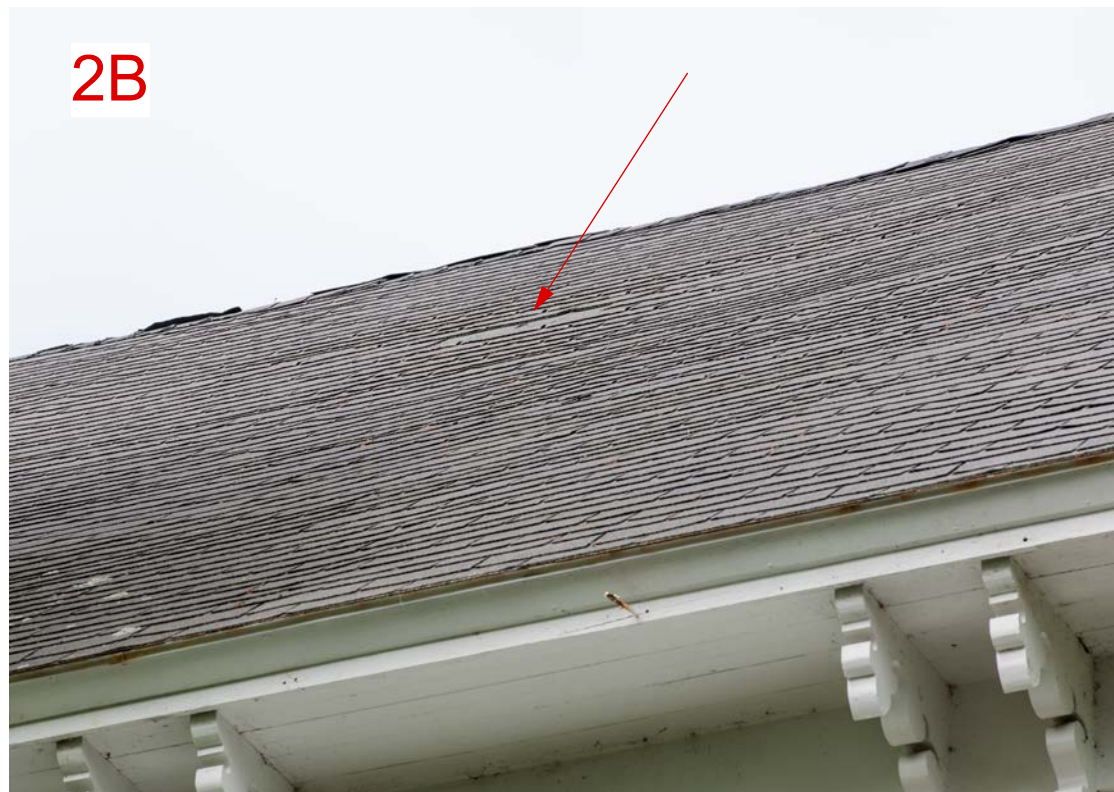
2B

2B. EAST ELEVATION, MISSING ROOF SHINGLE.

STABILIZATION RECOMMENDATION:
REPAIR/REPLACE MISSING/DAMAGED SHINGLE.

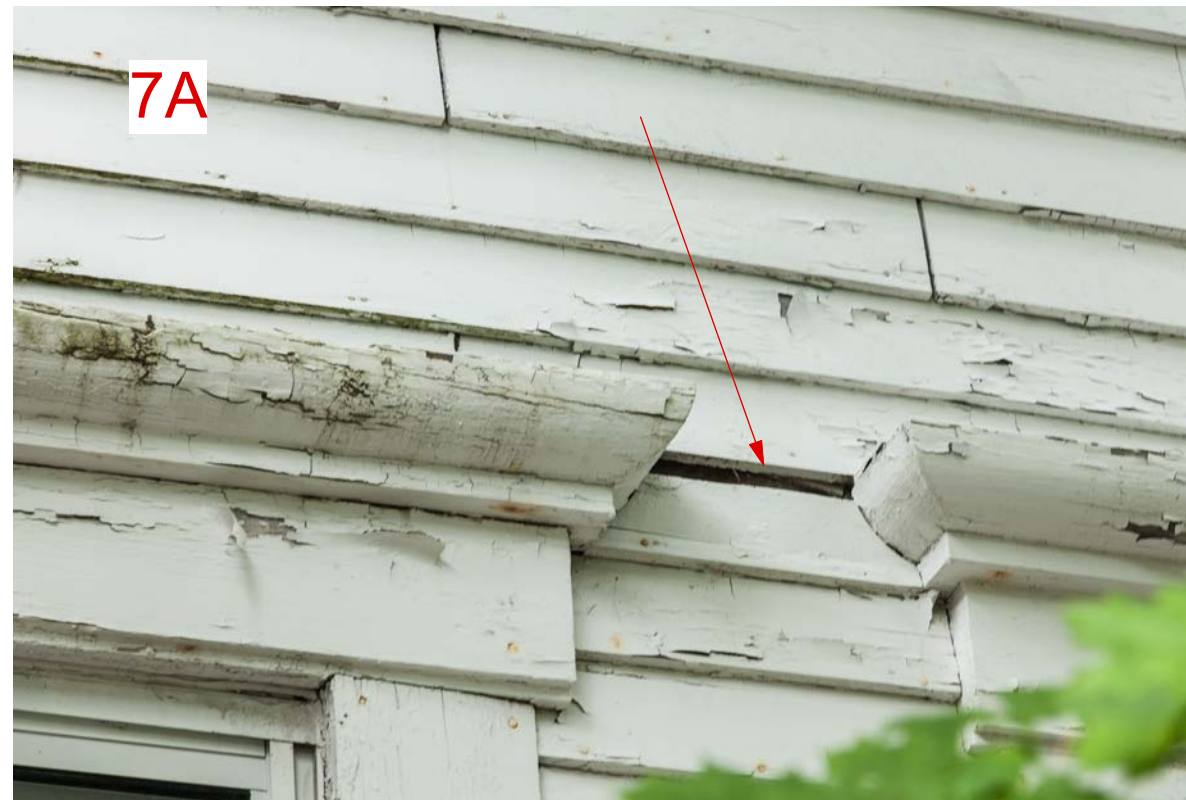
7A

7A. EAST ELEVATION, DAMAGED/MISSING CLAPBOARD(S).

STABILIZATION RECOMMENDATION:
REPLACE/REPAIR CLAPBOARD.

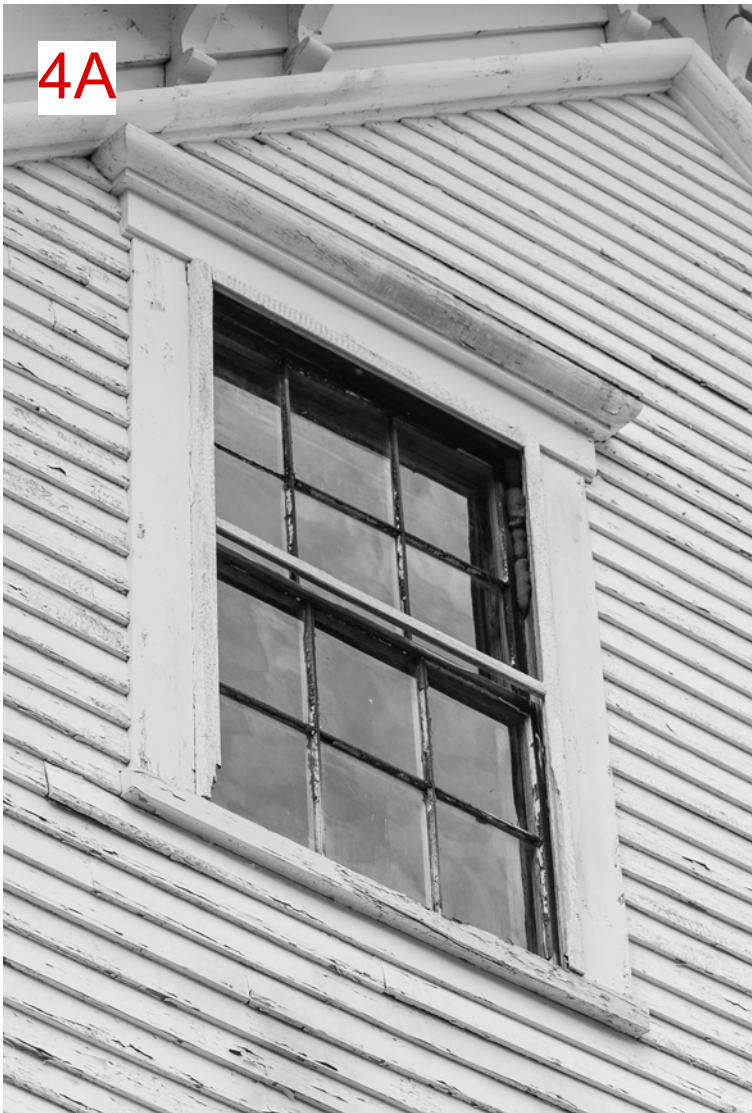
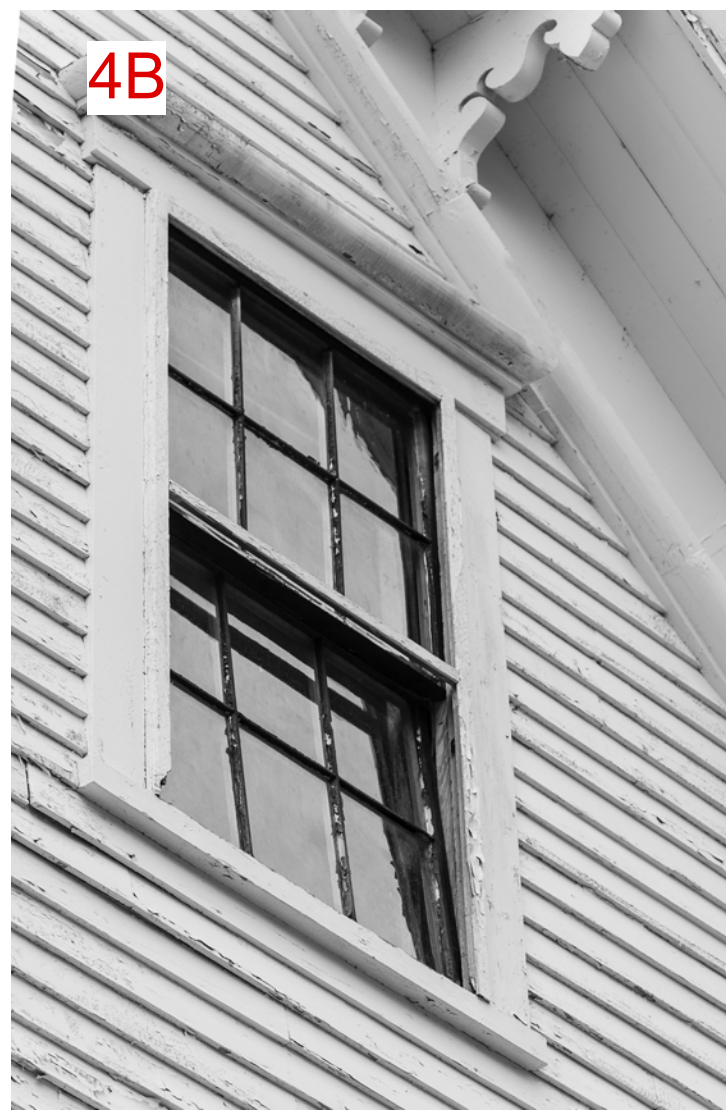
4A/B. NORTH ELEVATION GABLE
WINDOWS NOT PROTECTED BY
STORM WINDOWS, LOWER SASH
RIGHT WINDOW (4B) APPEARS TO TILT
INWARDS.

STABILIZATION RECOMMENDATION:
INSTALL STORM SASH.
