# TOWN OF HOLLIS, NEW HAMPSHIRE

## Farley Building

## OVERVIEW OF PROCEDURES FOR PREPARING AN HISTORIC BUILDING FOR LONG TERM DEACTIVATION

Prepared by the Hollis Heritage Commission, Richard Brown & John Butler  
December 2012

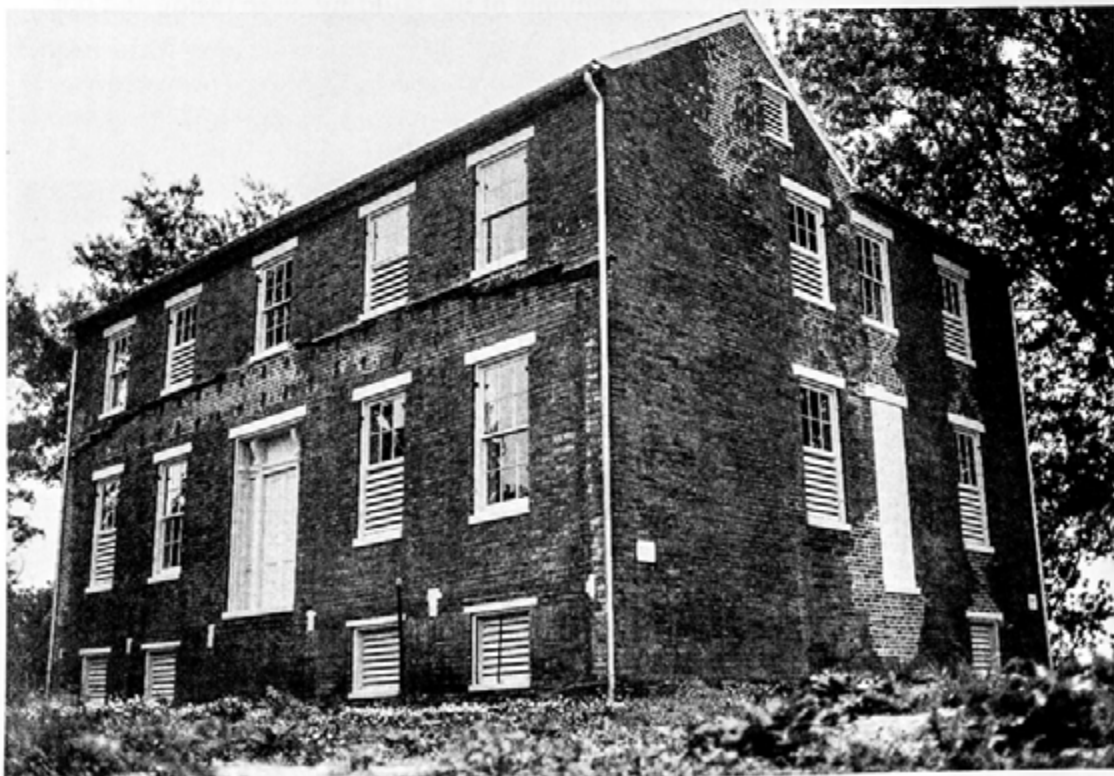
Figure 1. Proper mothballing treatment: This building has been successfully mothballed for 10 years because the roof and walls were repaired and structurally stabilized, ventilation louvers were added, and the property is maintained. Photo: Charles E. Fisher, NPS.

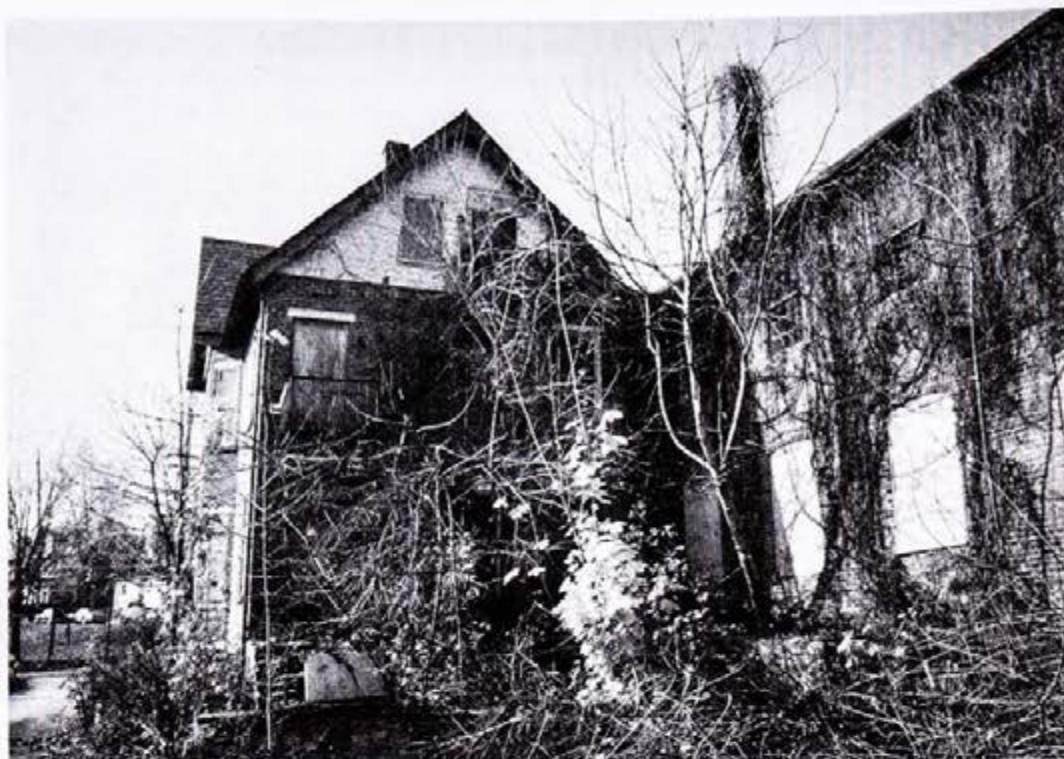
Figure 2. Improper treatment: Boarding up without adequate ventilation, lack of maintenance, and neglect of this property have accelerated deterioration. Photo: NPS file.

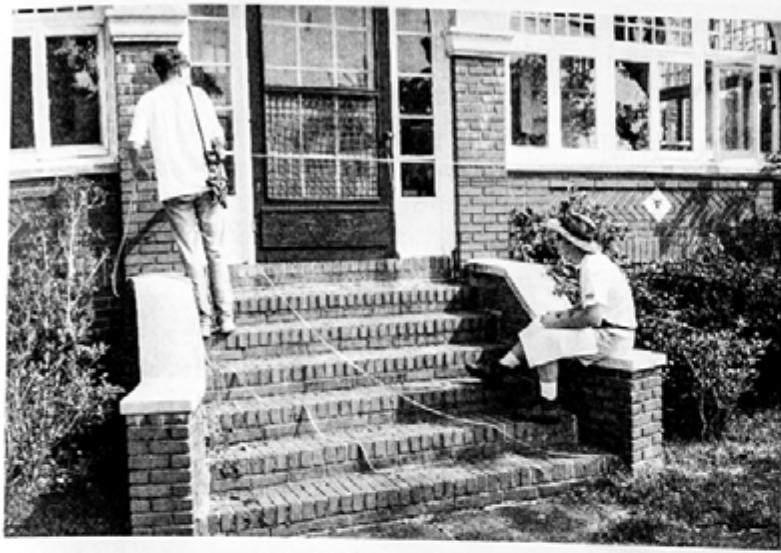
Figure 4. Documenting the building's history, preparing schematic plans, and assessing the condition of the building will provide necessary information on which to set priorities for stabilization and repair prior to securing the building. Photo: Frederick Lindstrom, HABS.

Old photographs can be helpful in identifying early or original features that might be hidden under modern materials. On a walk-through, the architect, historian, or preservation specialist should identify the architecturally significant elements of the building, both inside and out (see fig. 4).

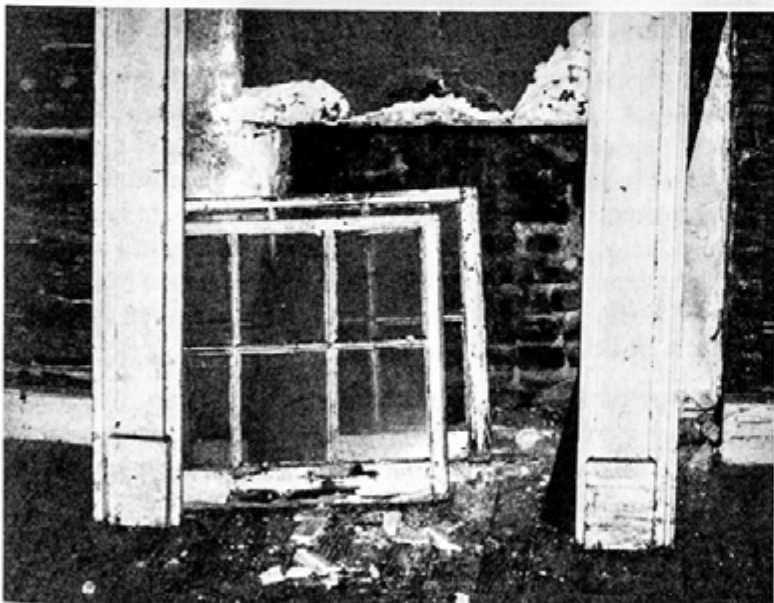
Figure 5. Loose or detached elements should be identified, tagged and stored, preferably on site. Photo: NPS files.

By understanding the history of the resource, significant elements, even though deteriorated, may be spared the trash pile. For that reason alone, any materials removed from the building or site as part of the stabilization effort should be carefully scrutinized and, if appearing historic, should be photographed, tagged with a number, inventoried, and safely stored, preferably in the building, for later retrieval (see fig. 5).

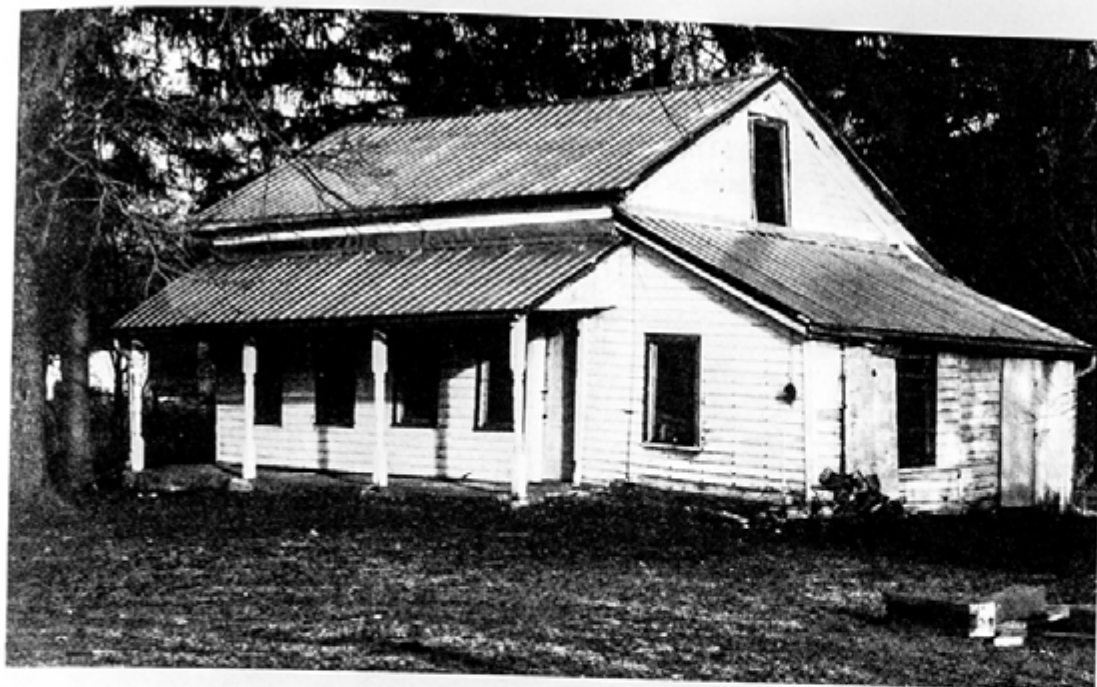
Figure 7. Non-historic materials are appropriate for mothballing projects when they are used to protect historic evidence remaining for future preservation. This lightweight aluminum channel frame and roofing covers the historic wooden shingle roof. Galvanized mesh panels secure the window openings from intrusion by raccoons and other unwanted guests. Photo: Williamsport Preservation Training Center, NPS.

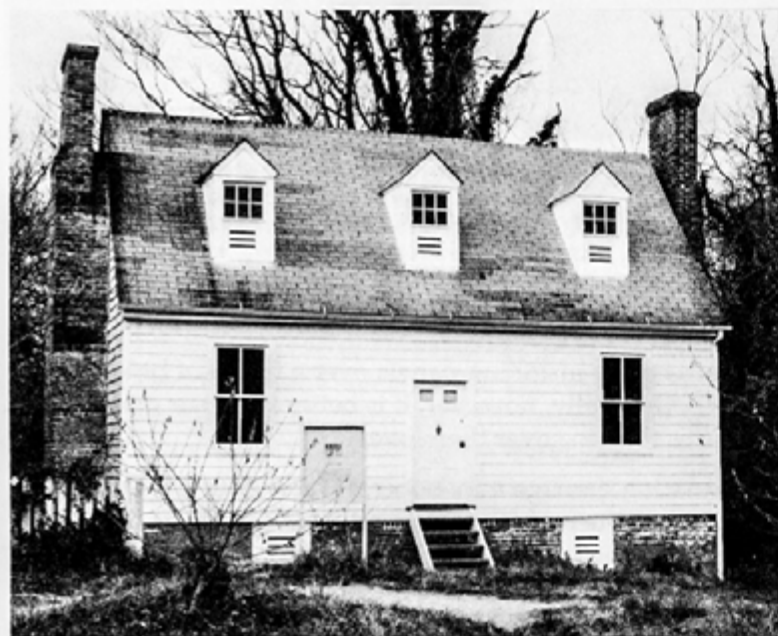
Figure 10. Regrading around the Booker Tenement at Colonial Williamsburg has protected the masonry foundation wall from excessive damp. This building has been successfully mothballed for over 10 years. Note the attic and basement vents, the temporary stairs, and the informative sign interpreting the history of this building.

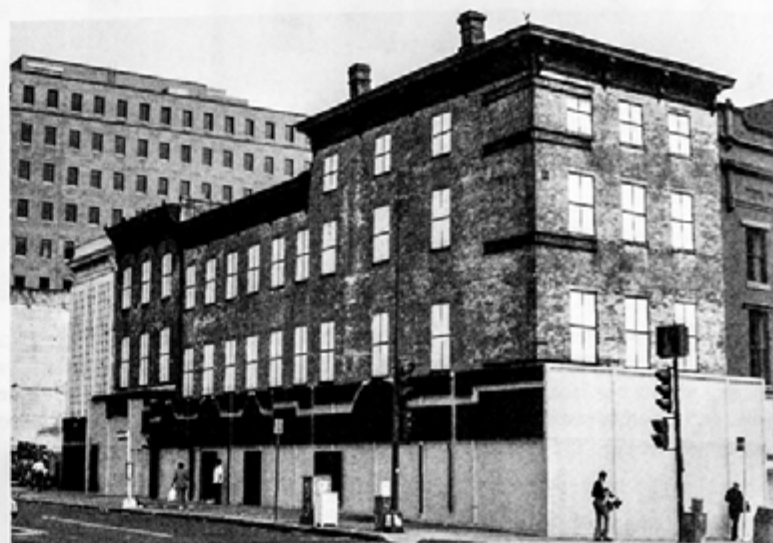
Figure 11. Urban buildings often need additional protection from unwanted entry and graffiti. This commercial building uses painted plywood panels to cover expansive glass storefronts and chain link fencing is applied on top of the panels. The upper windows on the street sides have been covered and painted to resemble 19th century sash. Photo: Thomas Jester, NPS.

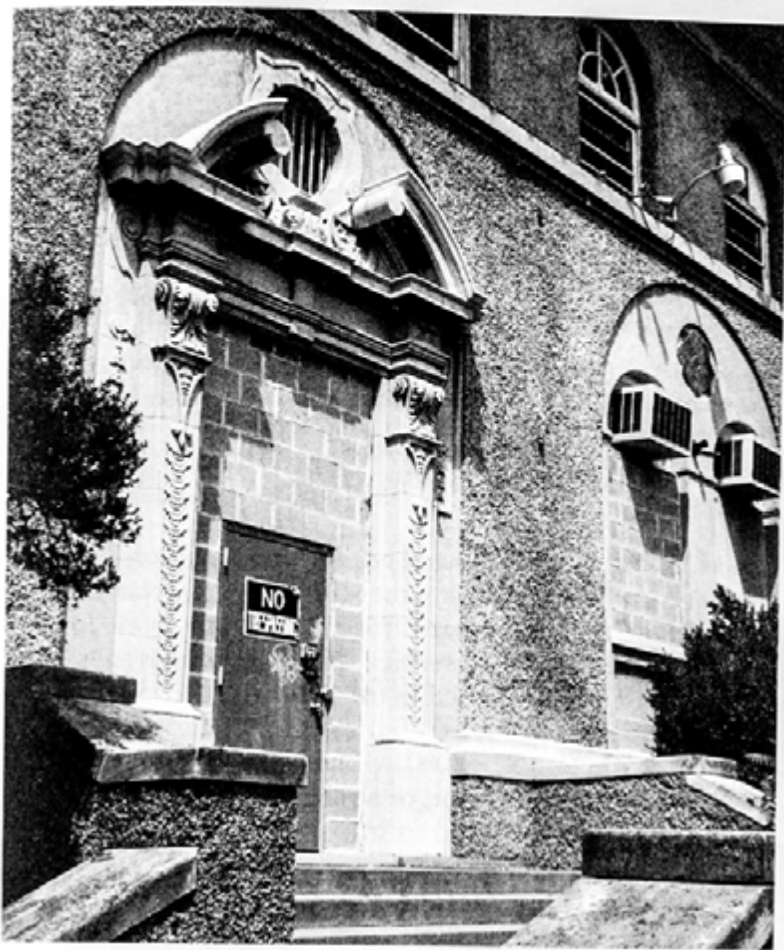
Figure 12. First floor openings have been filled with cinderblocks and doors, window sash and frames have been removed for safe keeping. Note the security light over the windows and the use of a security metal door with heavy duty locks. Photo: H. Ward Jandl, NPS.

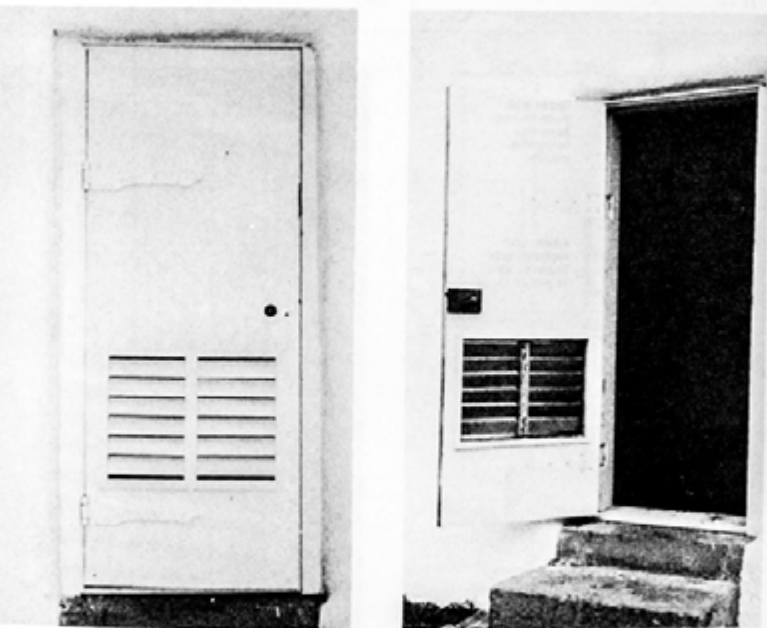
Figure 13. If historic doors would be damaged by adding extra locks, they should be removed and stored and new security doors added. At this lighthouse, the historic door has been replaced with a new door (seen both inside and outside) with an inset vent and new deadbolt locks. The heavy historic hinges have not been damaged. Photo: Williamsport Preservation Training Center, NPS.

Generally exterior doors are reinforced and provided with strong locks, but if weak historic doors would be damaged or disfigured by adding reinforcement or new locks, they may be removed temporarily and replaced with secure modern doors (see fig. 13). Alternatively, security gates in a new metal frame can be installed within existing door openings, much like a storm door, leaving the historic door in place. If plywood panels are installed over door openings, they should be screwed in place, as opposed to nailed, to avoid crowbar damage each time the panel is removed. This also reduces pounding vibrations from hammers and eliminates new nail holes each time the panel is replaced.

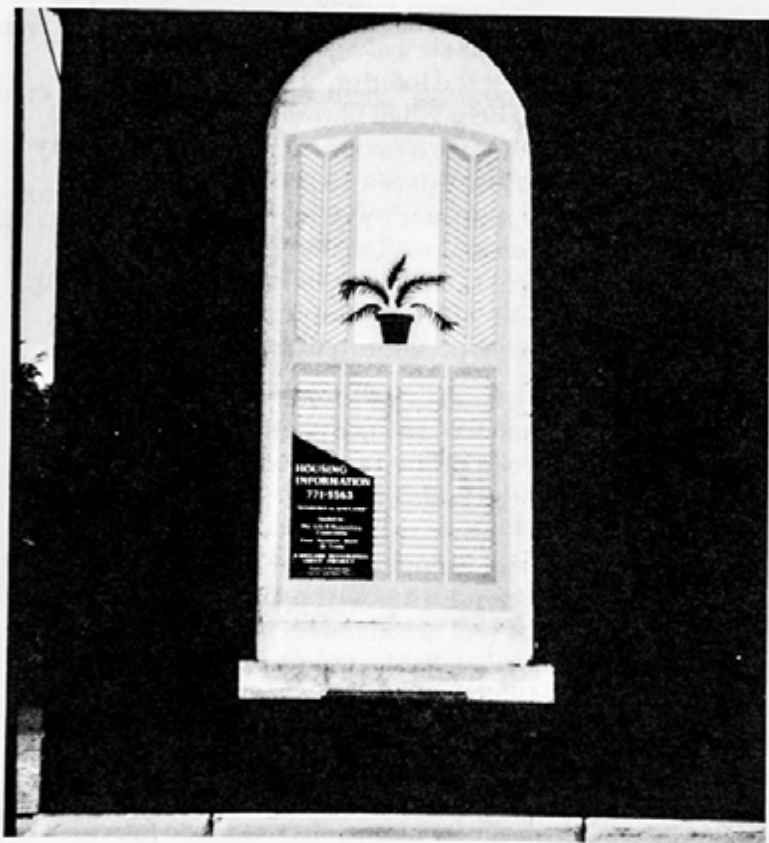
Figure 15. Painting trompe l'oeil scenes on plywood panels is a neighborhood friendly device. In addition, the small sign at the bottom left corner gives information for contacting the organization responsible for the care of the mothballed building. Photo: Lee H. Nelson, FAIA.

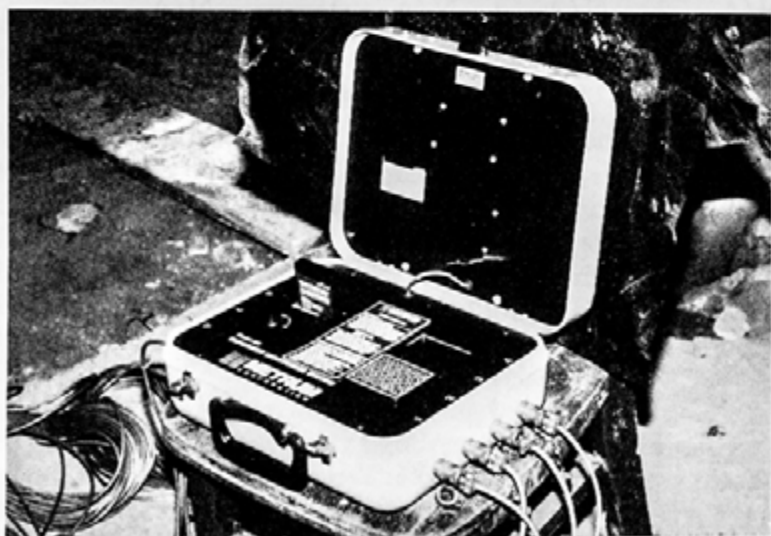
Figure 20. Portable monitors used to record temperature and humidity conditions in historic buildings during mothballing can help identify ventilation needs. This data can be downloaded directly into a lap top computer on site. These monitors are especially helpful over the long term for buildings with significant historic interiors or which are remaining furnished. If interiors are remaining damp or humid, additional ventilation should be added or the source of moisture controlled.

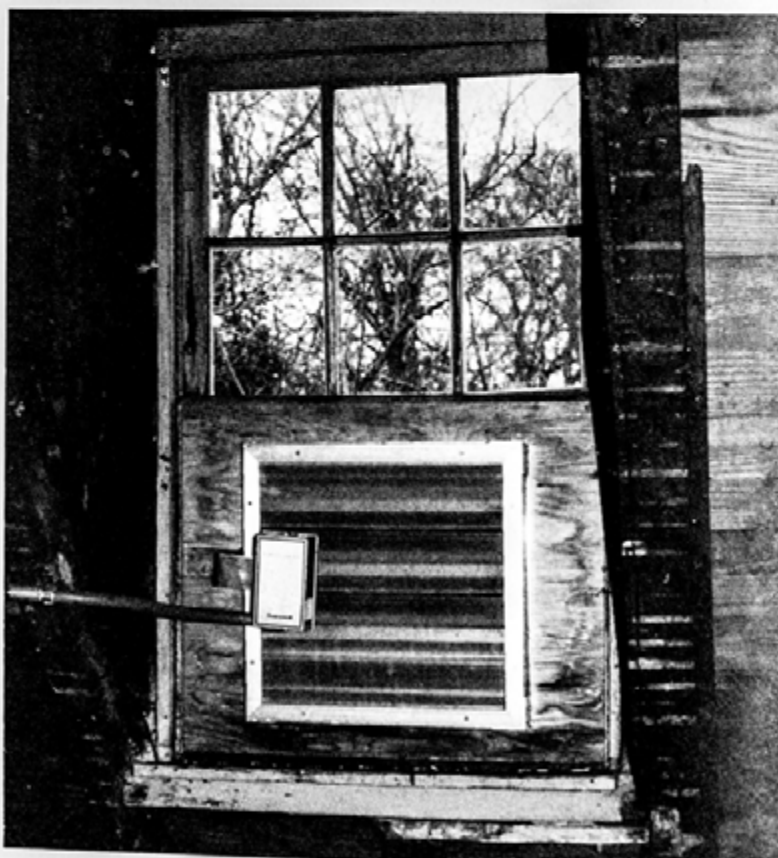
Figure 21. This electric thermostat/humidistat mounted in the attic vent controls a modified ducted air/fan system. The unit uses temporary exposed sheet metal ducts to pull air through the building and exhaust it out of the basement. For over ten years this fan system in combination with 18" x 18" preformed louvers in selective windows has kept the interior dry and with good air exchanges.

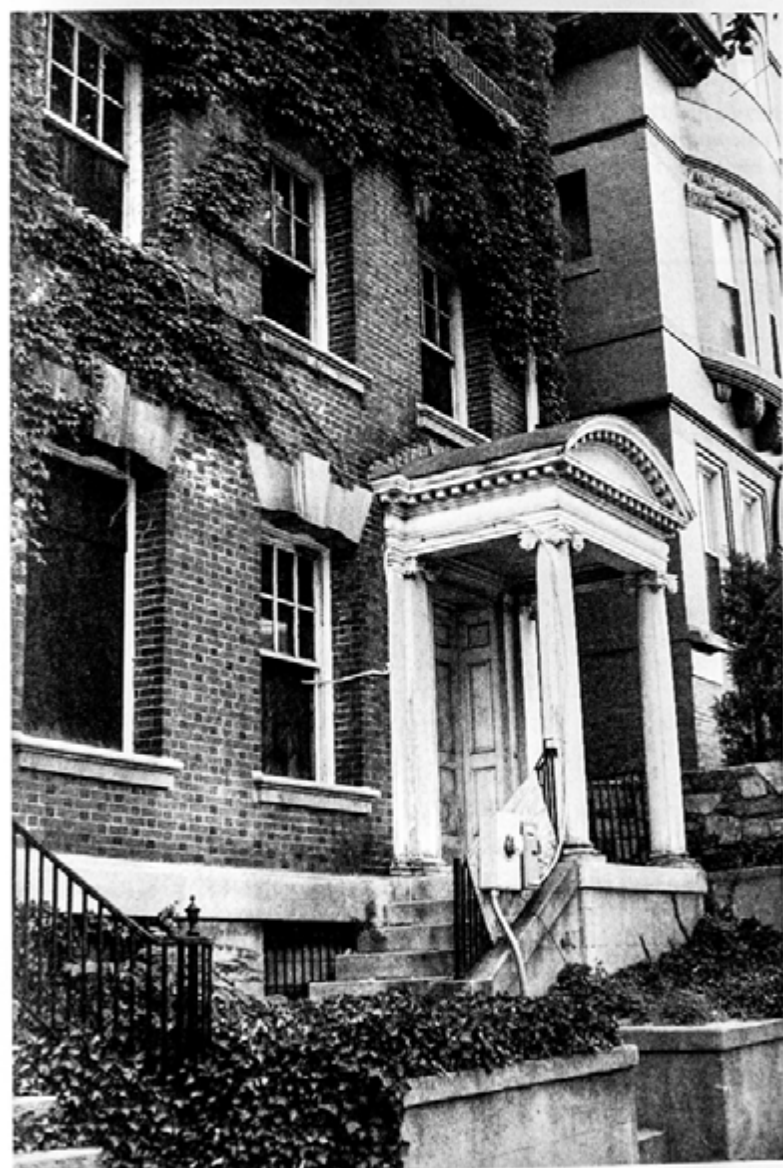
Figure 22. All systems except temporary electric have been shut off at this residence which has been mothballed over 20 years. An electric meter and 100 amp panel box have been set on a plywood panel at the front of the building. It is used for interior lighting and various alarm systems. The building, however, is showing signs of moisture problems with efflorescent stains on the masonry indicating the need for gutter maintenance and additional ventilation for the interior. The vegetation on the walls, although picturesque, traps moisture and is damaging to the masonry. Photo: H. Ward Jandl, NPS.

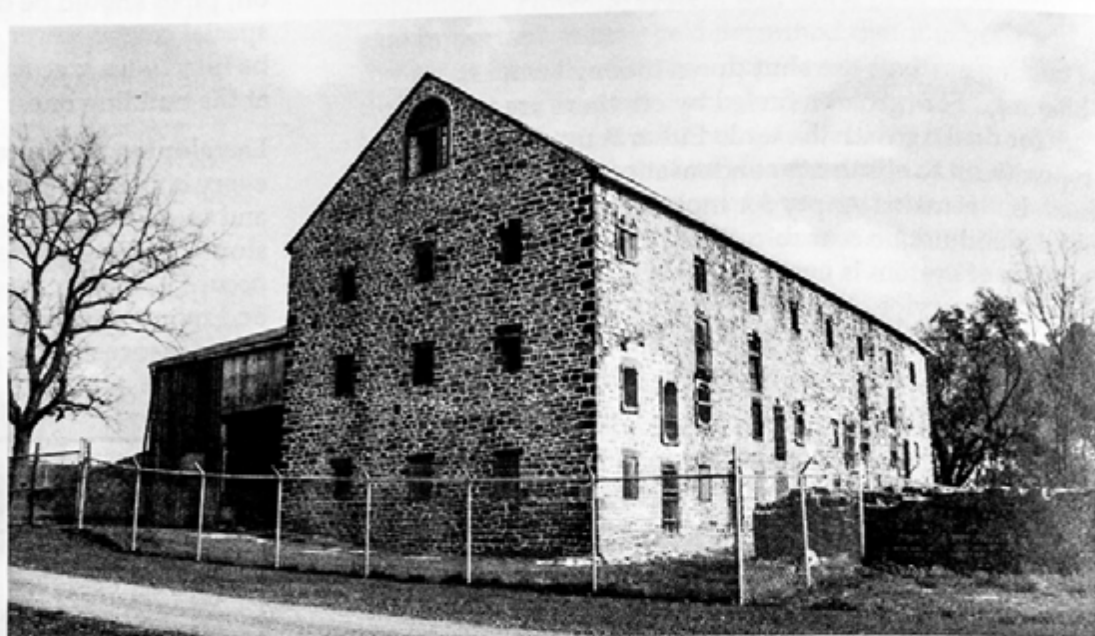
Figure 24. Once mothballed, a property must still be monitored and maintained. The openings in this historic barn have been modified with a combination of wood louvers and metal mesh panels which require little maintenance. The grounds are regularly mowed, even inside the chain link security fence. Photo: Williamsport Preservation Training Center, NPS.

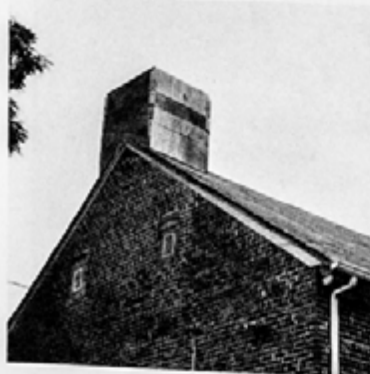
b. Plywood panels stabilize the chimneys. Note the gable vents.

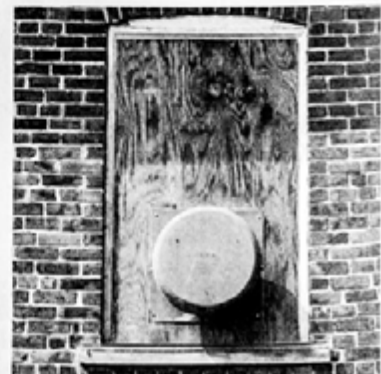
c. The exhaust fan has tamper-proof housing.

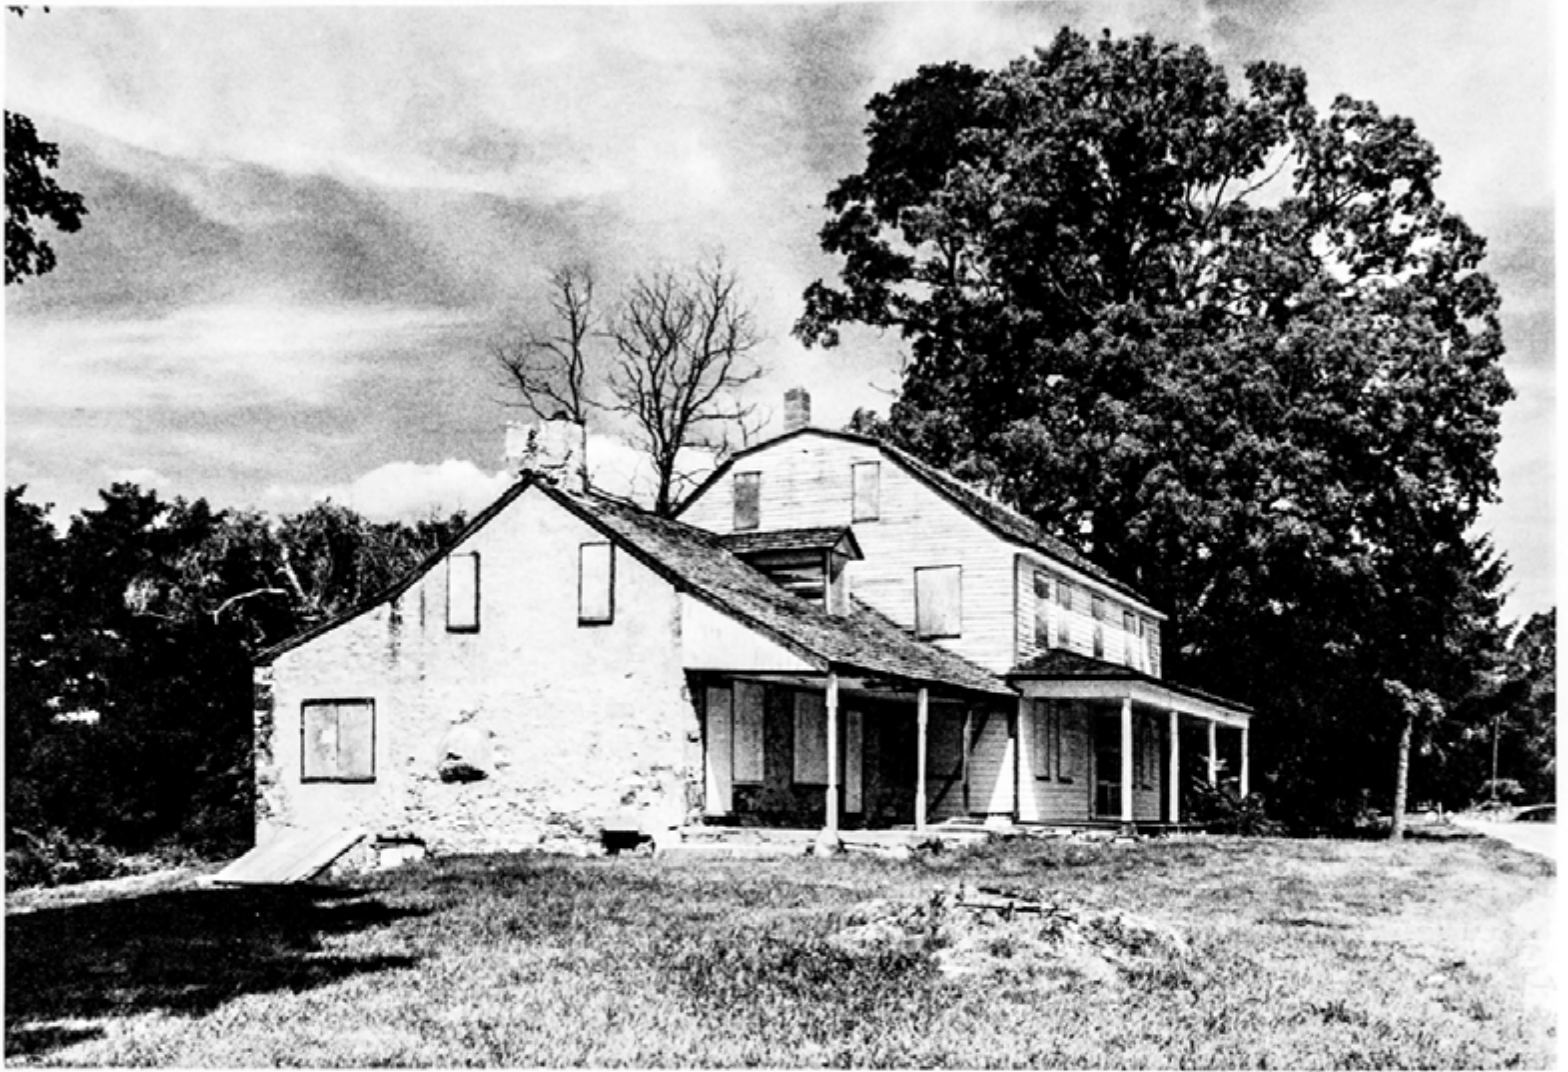
1. Foster-Armstrong House, Sussex County, New Jersey (c. 1790-1812), photo taken in 1982 before stabilization. (photo by author)

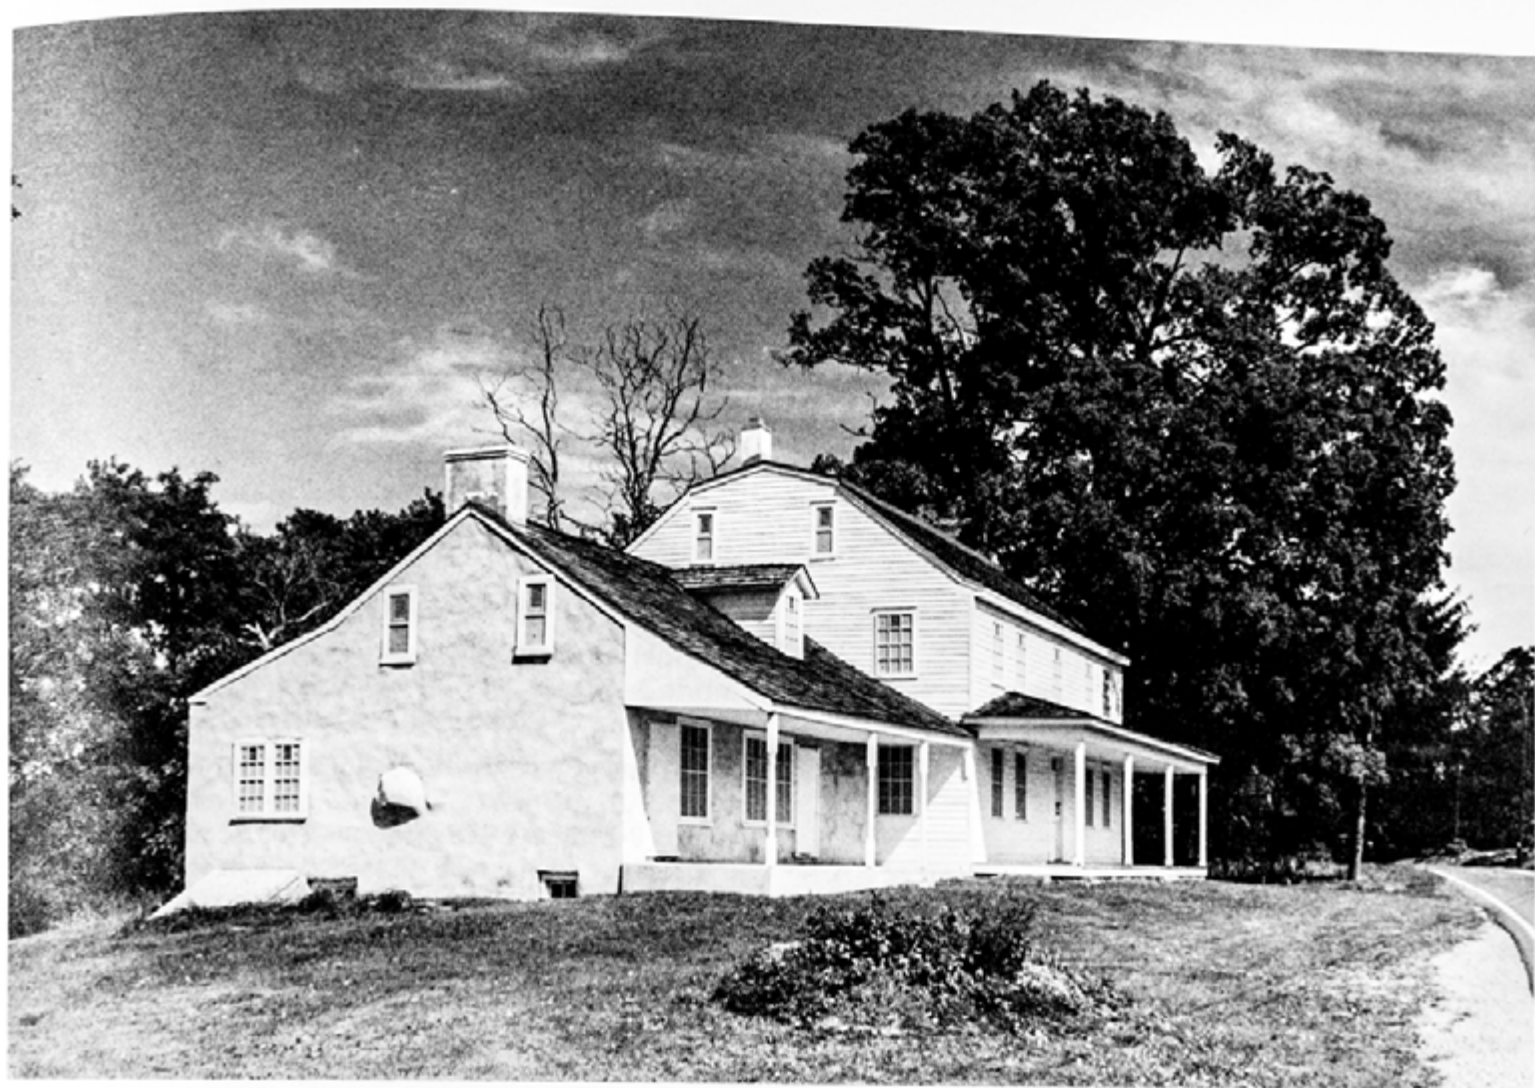
5. The Foster-Armstrong House after stabilization was completed in 1983. (photo by author)
