Facility Audit Report Hollis Fire Department

May 2012

Prepared by:
Acadia Engineers & Constructors
90 Main Street
Newmarket, NH 03857

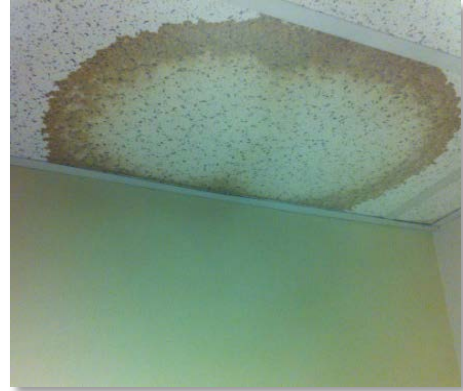
Figure 4: Water Stain from Roof Leak

In general, the building envelope is in satisfactory condition. The roof is in fair condition however there is a persistent leak on the east side of the building resulting in damage to interior materials.

- A persistent roof leak occurs at section between the apparatus garage and the 2006 second floor addition (Figure 4).
- Spots “bleed up” through the floor tiles in the kitchen.
- Drifting snow accumulates in the main entrance way.

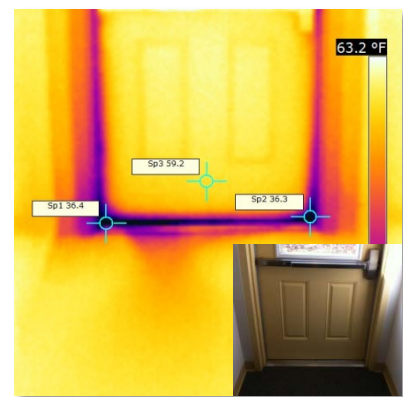
Figure 9: Air Leakage at Door Frame

The door units in HFD building include insulated steel doors and insulated fiberglass doors with partial top window glaze which were installed as part of the renovation project. The east entry door and frame to the high bay were replaced during the renovation with an insulated steel door. Based on visual observations and thermal imaging, the insulation values of the door units is satisfactory however the seals on door jambs, partings, and thresholds are incomplete allowing air leakage (Figure 9).

Based on the thermal imaging survey and visual observations, air leakage occurs through windows and entry doors. Although this is typical even for a modern building, simple measures can significantly reduce air leakage. Recommended measures for windows include: 1) adjusting jamb seals on operating windows; 2) adding weather-stripping; 3) caulking interior frames and moldings; and, 4) locking/clasping windows to maintain a complete seal.

Air sealing of all door units can be improved with commercial weather-stripping. All door and window units should be regularly inspected (every 2 to 3 years) to ensure proper operation, identify faulty seals, and to identify any deteriorated caulking requiring replacement.

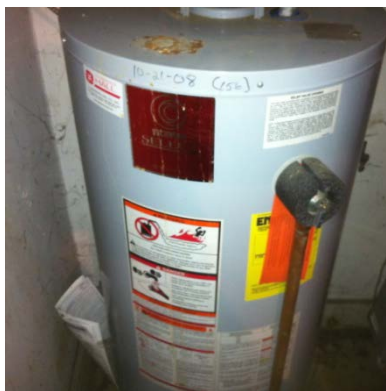
Figure 15: DHW Heater

Domestic hot water is provided by one (1) propane fired hot water heater located in the mechanical room (Figure 15). The unit was installed in 2008 and has an AFUE rating of 80%. Compared to current technologies this unit is relatively inefficient. It is recommended that this unit be replaced with a LP-fired mini-tank unit or a condensing tank unit. Other options include installing a combination tank as part of a new heating boiler system.

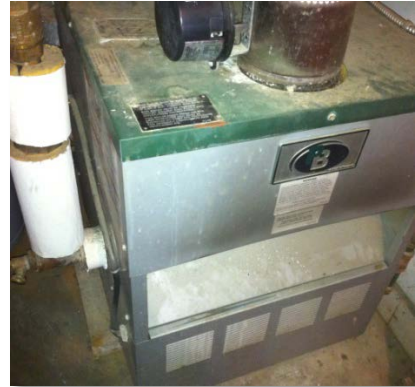
Figure 16: Hot Water Boiler

Heat is provided to the office space of the building by one (1) LP-fire Peerless Boiler® (Figure 16). The rated efficiency of this unit when new is 80% and the de-rated efficiency is estimated at less than 75%. Low boiler combustion efficient results in a substantial amount of heat loss, reduced system inefficiency, and CO₂ emissions. The boiler supplies the hydronic system including zoned fin-tube baseboards and heating coils in five (5) AHUs located in the attic.

With a rated output of 172 MBH the residential boiler appears to be grossly undersized for the building. Prior to replacing the boiler, the building heating loads should be calculated to ensure that the replacement unit is appropriately sized.

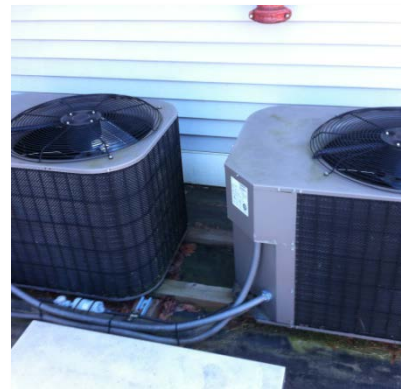
Figure 17: AC Units

Cooling is provided to the building with exception of the apparatus garage. Five three-ton condensers located on the west and rear of the building provide cooling (Figure 17). The Seasonal Energy Efficiency Ratio (SEER) of these units is rated at 12 when new and the de-rated SEER is estimated at 10. Condensers are charged with R-22 refrigerant. It is noted that the use of refrigerant R-22 is no longer permitted (per USEPA) based on its high ozone depletion potential.

The Energy Efficiency Ratio (EER) for the larger condensing units is 12 or less. Operating efficiency tends to decrease with system age. As cooling condensing units fail, they should be replaced with the highest rated equipment available. All exterior condenser piping insulation should be rated for outdoor exposure. Other recommendations include replacing the multiple residential size units with two larger commercial rated units.

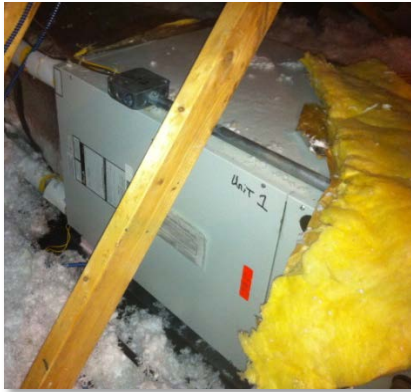
Figure 19: Attic Air Handling Unit

The five (5) air handling units in the attic are estimated to consume the most amount of energy of all the mechanical loads (Figure 19). These are used throughout the year to condition and provide fresh air to the building. Each unit is fitted with a hydronic heating coil and an air conditioning evaporator coil.

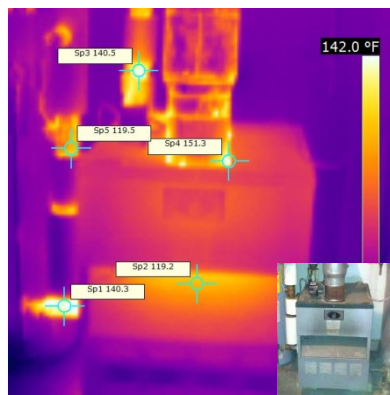
Figure 24: Peerless Boiler IR

The Peerless Boiler® is nearing the end of its useful life (Figure 24) and replacing this with a high efficiency LP-fired modulating condensing unit or an automated wood-pellet would significantly reduce energy consumption (Figure 25). The unit also appears to be significantly under-sized for the expected heat loading of the building. A wood based pellet unit is a practical alternative to a fossil-fuel fired boiler. Costs for these units is typically higher than conventional units however the fuel cost (per Btu) is significantly less than fossil-fuels and they have lower CO₂e emissions. As part of the system replacement NEMA rated circulation pumps with VFD controllers are recommended. The dated five (5) split A/C units have low efficiency ratings.

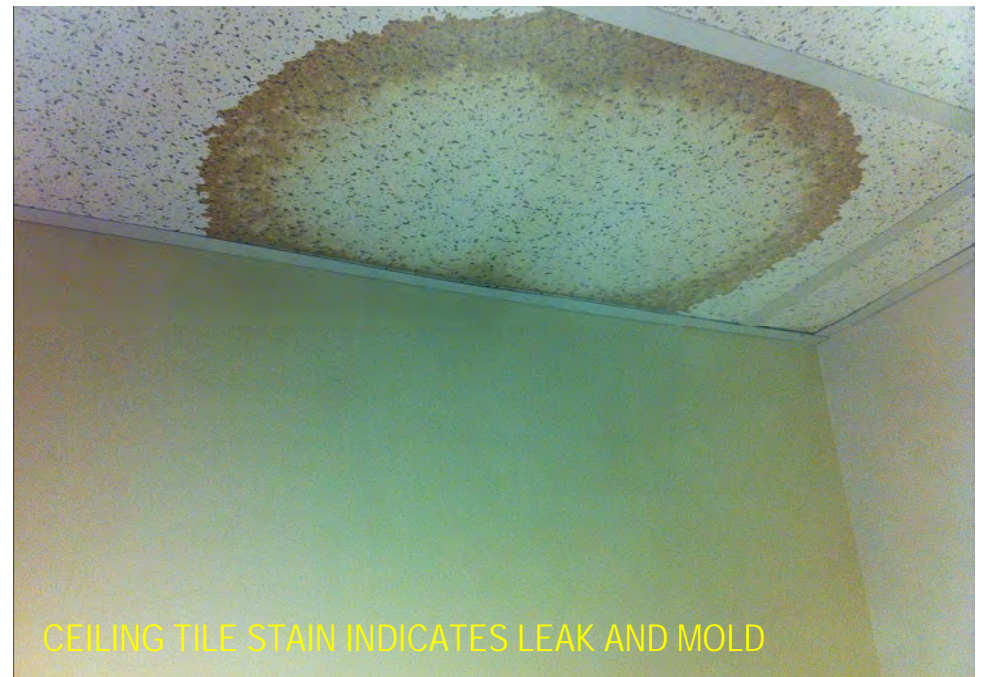
CEILING TILE STAIN INDICATES LEAK AND MOLD
