# Facility Audit Report

## Hollis-Brookline High School

May 2012

*Prepared by:*  
Acadia Engineers & Constructors  
90 Main Street  
Newmarket, NH 03857

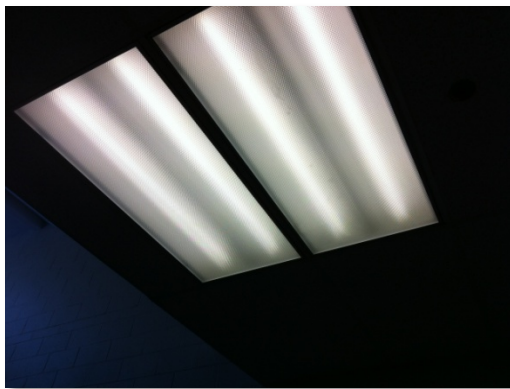
Figure 15: T8 Light Fixtures in Vestibule

Lighting densities were recorded at twenty-nine (29) representative locations. Seventeen (17) of the measurements exceed IESNA recommended standards. Most of the common areas such as hallways, vestibules and the cafeteria significantly exceed recommended standards. Other spaces which exceeded recommended standards include the main office, guidance office, and a few classrooms. Classroom fixtures have multi-lamp (3) settings and most had partial lighting (1 or 2 of the 3 lamps on). Full lighting densities (3 lamps) in classrooms significantly exceed recommended lighting densities. Motion controllers are installed in many of the first floor classrooms. As part of the

lighting upgrade project of 2011 the lamps were designed to output higher densities than recommended with the intention of losing densities over time to their recommended levels. While this will ensure proper densities are always met it is not the most efficient way of providing lighting. Methods to reduce frequency of lighting and how many lamps are illuminated have been implemented in some areas which is recommended for all areas.

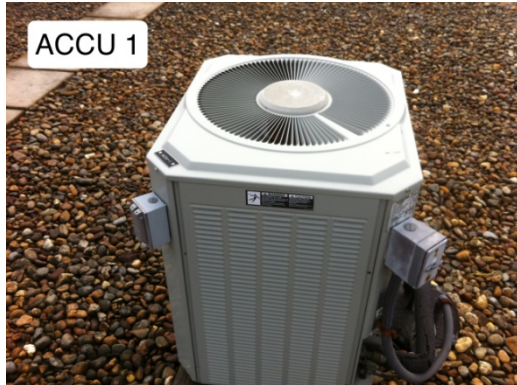
Figure 19: Air Condition Condensing Unit 1 on Roof

Cooling is provided to sections of the building by rooftop units and condensers. There are two (2) Trane® rooftop units which are for air conditioning only. There are three (3) AHUs on the roof which are connected to air conditioning condensing units (ACCU) 1-3 (Figure 19). ACCU-1 is a 4-ton Trane® unit and ACCU-2 and ACCU-3 are 6-ton Trane® units. In addition there are two (2) Mitsubishi® ACCU units on the rooftop. Condensers are charged with R-22 refrigerant. It is noted that the use of refrigerant R-22 is no longer permitted (per USEPA) based on its high ozone depletion potential. The Seasonal Energy Efficiency Ratio (SEER) of these units is not available however based on age and condition the estimated de-rated SEER is at 10.

Modern cooling systems can achieve SEERs up to 24. As example, replacing a unit with a SEER rating of 8 with a new unit rated at 16 would reduce energy consumption by 50% and provide an equivalent cooling capacity.

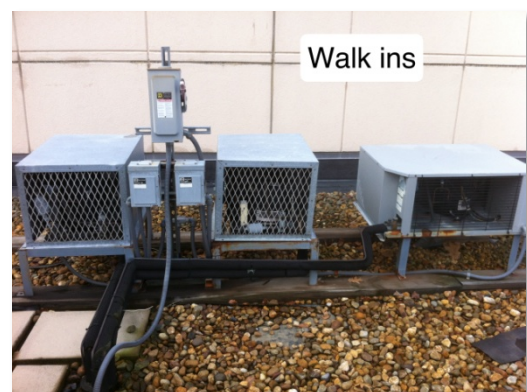
Figure 20: Walk-in Freezer Condensers on Roof

Three (3) walk-in commercial refrigeration units are located in the kitchen with roof-mounted condensers (Figure 20). These units consume a significant amount of energy annually. Recommendations include replacing failed condensers with high efficiency units (SEER/EER). Other recommendations include installing eCube® food temperature sensing thermostat controls. By measuring constant food temperature instead of more variable air temperatures, eCube® controllers significantly reduce the frequency of condenser operation ([www.getecube.com](http://www.getecube.com)).

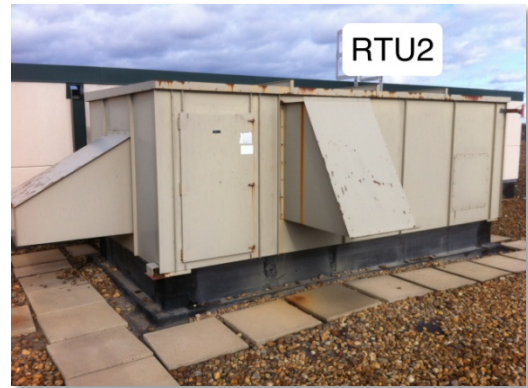
Figure 21: Rooftop AHU

Exchange air ventilation in the HBHS building is provided by eleven (11) rooftop AHUs and an AHU (RTU-2) with an energy recovery unit (ERU) (Figure 21). CO<sub>2</sub> concentrations in the HBHS building revealed that the building was adequately ventilated in most areas.

The AHUs are equipped with economizers which control the minimum percentage of outside air introduced to the conditioned space. Control of the units is provided by the schedule-based DDC system. Installing demand controllers would significantly reduce operation frequency and energy consumption –this is a current mechanical code requirement (IMC and ASHRAE 90.1).

Replacement AHUs should be commercial rated units with economizers, VFD motor controllers, ERUs, and demand controllers to optimize system efficiency.

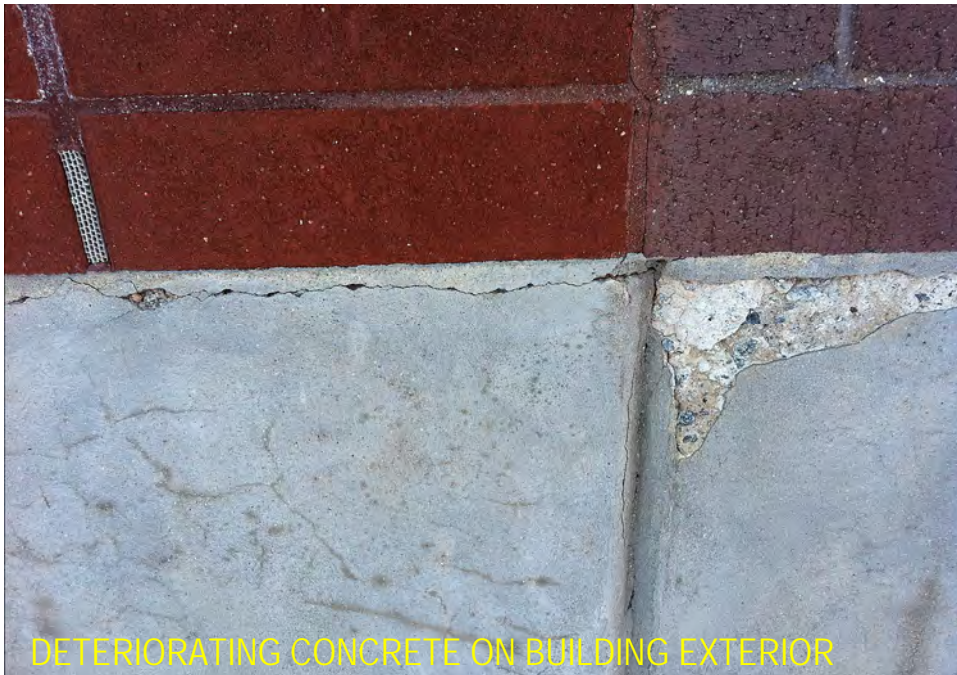
DETERIORATING CONCRETE ON BUILDING EXTERIOR

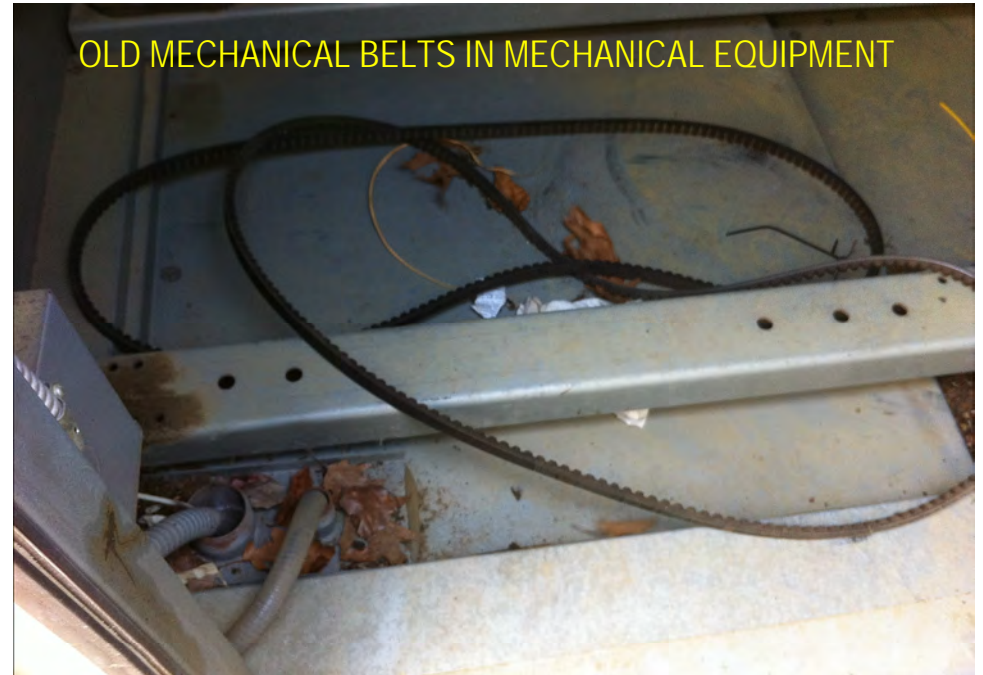
OLD MECHANICAL BELTS IN MECHANICAL EQUIPMENT

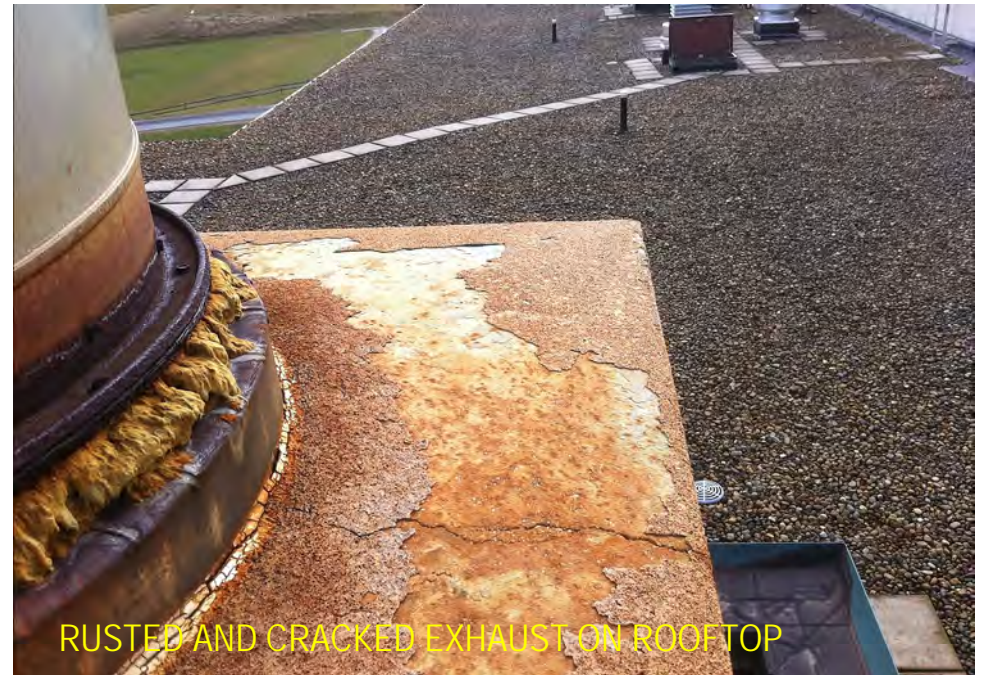
RUSTED AND CRACKED EXHAUST ON ROOFTOP

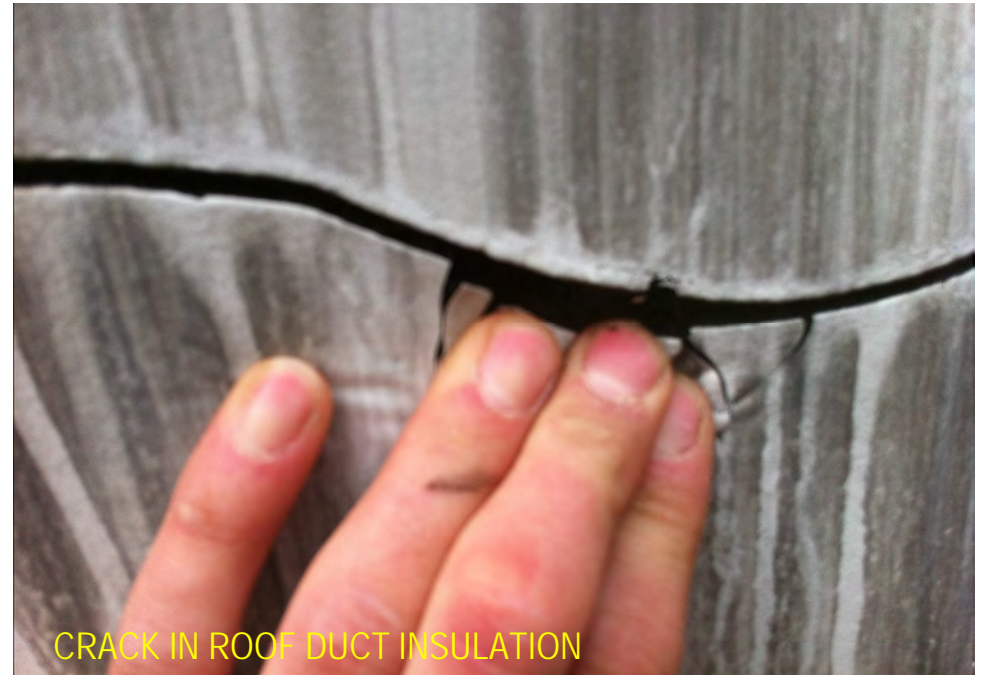
CRACK IN ROOF DUCT INSULATION

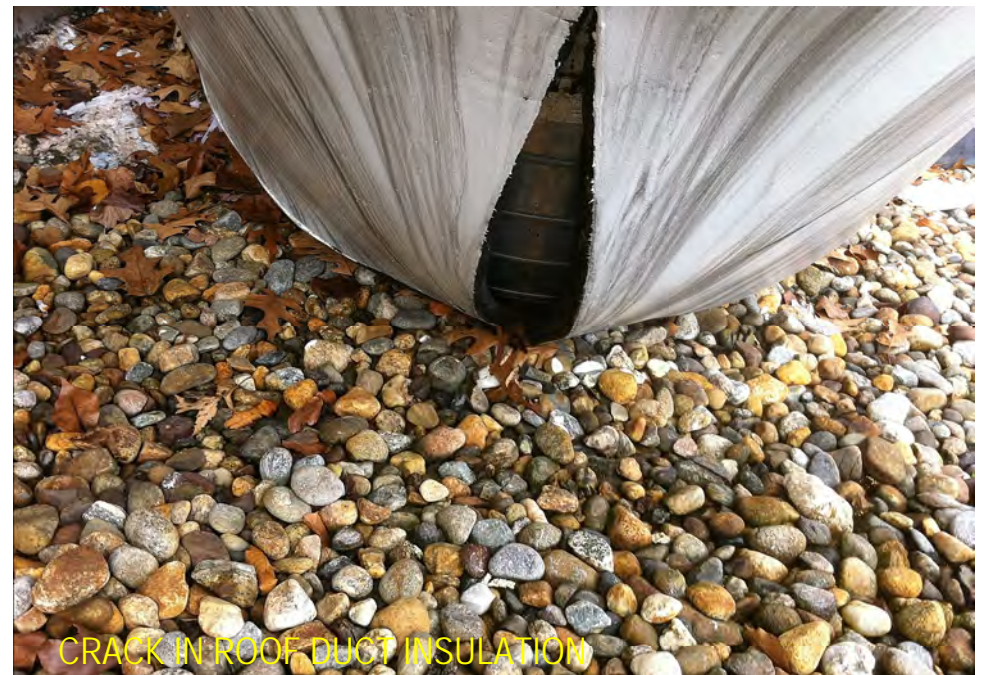
CRACK IN ROOF DUCT INSULATION
