Facility Audit Report

Hollis-Brookline Middle School

May 2012

Prepared by:
Acadia Engineers & Constructors
90 Main Street
Newmarket, NH 03857

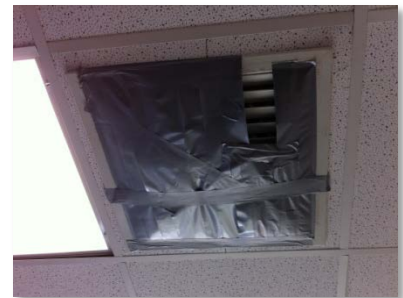
Figure 5: Blocked Vent in Room 144

- Air conditioning is provided to the newer wing of the building only. Some rooms are too cold when cooling systems are operating. This is evidenced by a covered vent in Classroom 144 to reduce air flow (Figure 5).
- Air in the Library is uncomfortable ("stuffy") in the mornings and staff open windows to increase ventilation.
- Several staff-members indicated that the Classrooms are consistently cold or consistently too warm.
- The boilers are shut down by mid-May. At this time the domestic hot water system is configured to allow the smaller hot water tank to provide hot water for the building.

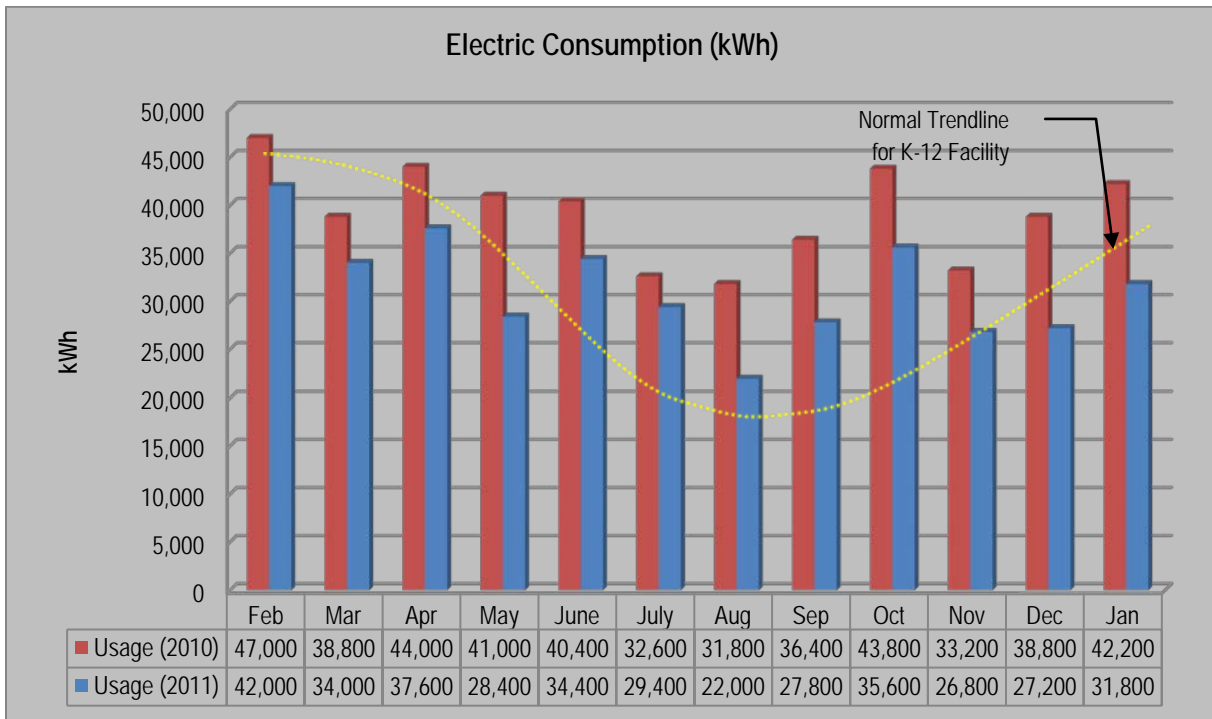
Figure 6: Electric Consumption (2010 - 2012)

Average annual electric usage for the HBMS (February 2010 through January 2012) is 423,500 kWh at an average cost of \$67,364. Based on the building size and function, this usage is as expected. However, optimizing the cooling and ventilation systems during the unoccupied summer session would substantially reduce electrical consumption.

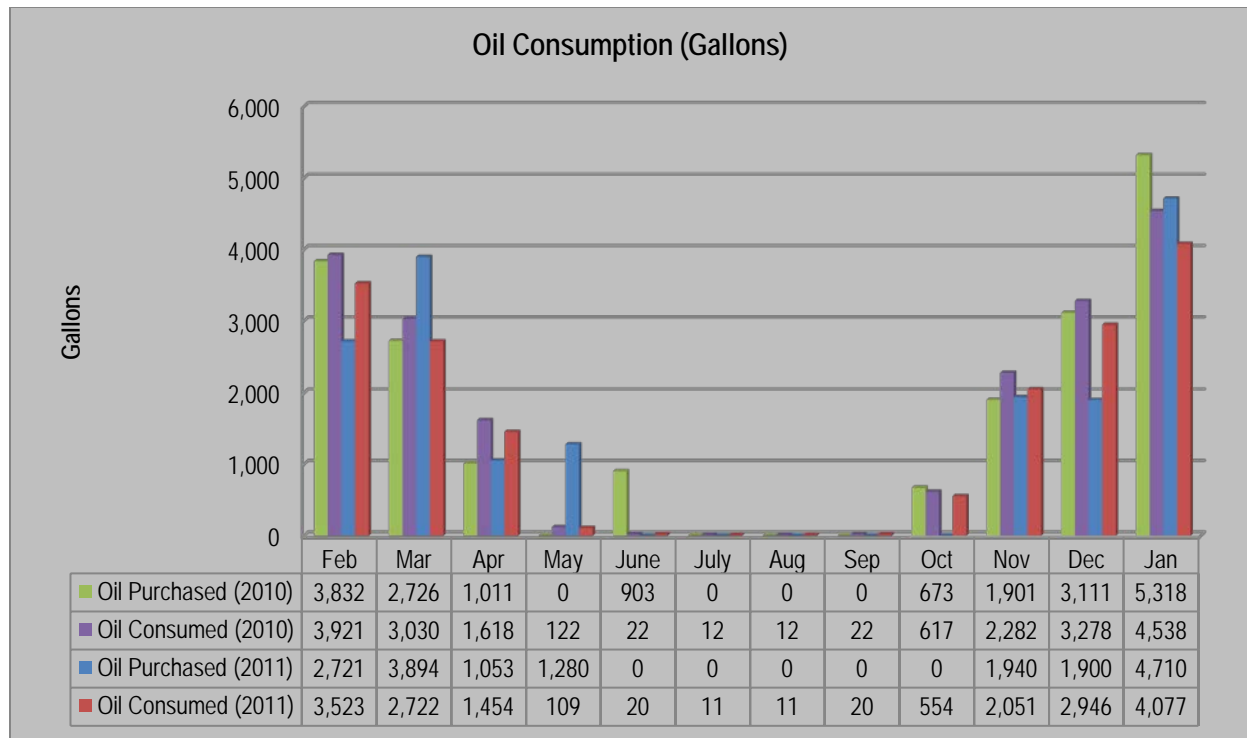
Figure 8: Fuel Oil Consumption (2010 - 2012)

Heating fuel for space heating and domestic hot water heating at the Hollis Brookline Middle School is provided by a local supplier (Table 9, Figure 8). The building consumed a total of 19,475 gallons of No. 2 oil between February 2010 and January 2011 and 17,499 gallons of No. 2 oil between February 2011 to January 2012. The average annual heating fuel cost for the Hollis Brookline Middle School is \$45,510 (2010-2012). The peak months of oil purchased and expected consumption for each twelve month period were in January (2011 and 2012), purchasing 5,318 and 4,710 gallons of fuel, respectively, with an expected usage of 4,538 and 4,077 gallons of fuel.

Considering the building systems including the envelope integrity (insulation and air leakage), mechanical equipment, and use of the facility, the heating fuel usage is expectedly high. Heating of the building is supplied by two (2) H.B. Smith® 81% efficient boilers which were installed in 1994. Domestic hot water (DHW) is supplied by one (1) John Wood® 80% efficient hot water heater installed in 2009. Efficiencies of these units decrease with age and both are considered moderately low efficient units.

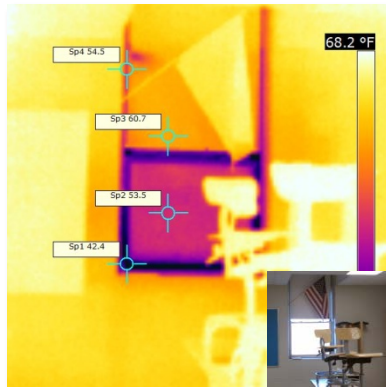
Figure 11: Window IR in Shop Classroom

Thermal transfer and air leakage commonly occurs at the seals of operable windows and the interface between the window and the wall opening which was observed using infrared imaging.

Recommendations include exterior and interior inspection and re-caulking of window jambs, headers, and sills as needed. If the operable window units have adjustable jambs, they should be inspected and adjusted as necessary to maintain a complete air seal.

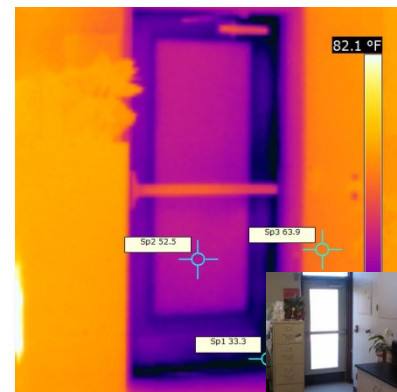
Figure 12: IR of Exterior Door to Classroom 107

The door units in HBMS building include metal doors with full window glazing for all main and side entrances as well as steel solid doors with small window glazing for secondary entrances for building personnel and emergency exits. Based on visual observations and thermal imaging, thermal transfer occurs through the hollow metal doors as well as the seals on door jambs, partings, and thresholds which are incomplete allowing air leakage. Recommendations

include exterior and interior inspection, weather stripping and re-caulking around windows as needed. Recommendations for hollow doors include injecting them with polyurethane foam insulation.

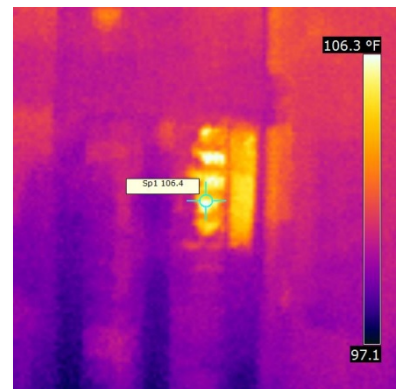
Figure 13: Possible Overloaded Electric Circuit

- Lights in the gymnasium operate at very high temperatures.
- Circuit temperatures on some electrical panels are elevated indicating they may be overloaded (Figure 13).

- Gaps in entry doors and windows provide a significant amount of thermal energy transfer (typical of older K-12 facility).
- Electrical panels in corridors are outdated and some are not secure. It is recommended that a licensed electrician inspect all panels and replace or restrict access to the panels per current code standards.

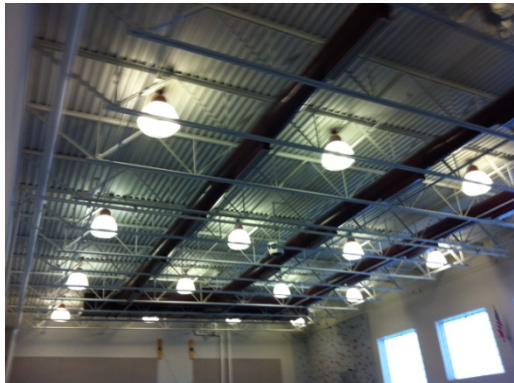
Figure 15: High Wattage CFL Fixtures in Multi-Purpose Room

Lighting densities were recorded at fifty-five (55) representative locations. Forty-nine (49) of the measurements exceed IESNA recommended standards. Common areas such as hallways, vestibules and the cafeteria greatly exceed recommended standards. These areas are occupied only briefly between class periods and remain illuminated while the building is occupied. Recommended lighting densities in these areas are also much lower than classroom space. Most classroom spaces exceeded recommended standards as well with natural sunlight increasing these measurements. For example, Classroom 17 and Teacher Room T3 (both on the east side of the building) had their lights off and natural lighting exceeded recommended standards. As part of the lighting upgrade project in 2011 these lights were designed to be over-lit with the intention of reducing densities over the life of the bulb. This will ensure proper lighting densities are always met, however is not the most efficient way of lighting.

Methods to reduce lighting densities include reducing the quantity of fixtures, replacing them with lower-wattage fixtures, and installing lower wattage bulbs in the existing fixtures. Other methods to reduce lighting density include replacing overhead lighting with task lighting, adding multiple control zones, adding daylight controls and adding dimming controls. Newer technology fixtures provide higher lighting density per watt than the existing older fixtures and provide improved lighting quality. Motion controllers are installed in many of the first floor classrooms. The lighting density data is included in Appendix C.

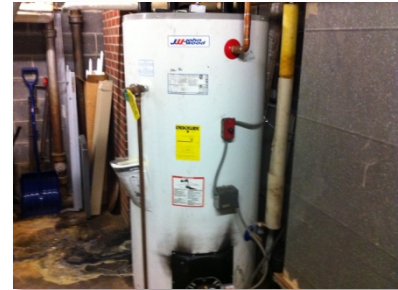
Figure 17: Domestic Hot Water Heater

Domestic hot water is provided by two (2) systems. During the heating season the two boilers fired boilers provide domestic hot water by an indirect fired system. When the large boilers are not running there is a 50 gallon, oil fired hot water heat (Figure 17). These two systems are interconnected with valves but function independently. It is recommended that the oil fired hot water tank heater be replaced with a more efficient tankless unit.

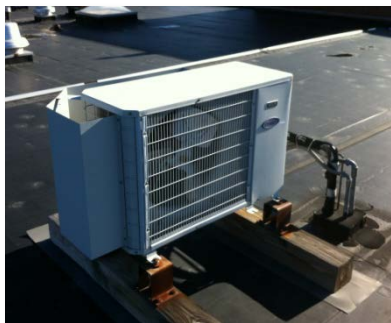
Figure 19: Split AC Unit No. 5

Cooling is provided throughout the building by rooftop units and condensers. There are three (3) McQuay® 8-ton rooftop air conditioning (AC) units and four (4) Carrier® 4-ton split AC units (Figure 19). Based on the annual electrical energy consumption curve, the AC units operate more frequently during summer school break than expected. Condensers are charged with R-22 refrigerant. It is noted that the use of refrigerant R-22 is no longer permitted (per USEPA) based on its high ozone depletion potential. The Seasonal Energy Efficiency Ratio (SEER) of these units is not available however based on age and condition the estimated de-rated SEER less than 10.

Operating efficiency tends to decrease with system age. As cooling condensing units fail, they should be replaced with the highest rated equipment available. All exterior condensers piping insulation should be rated for outdoor exposure. As prescribed by the 2009 IECC, the current minimum SEER for smaller cooling systems is 13 and larger units are rated at a minimum SEER of 11.2. Modern cooling systems can achieve SEERs up to 24. As example, replacing a unit with a SEER rating of 8 with a new unit rated at 16 would reduce energy consumption by 50% and provide an equivalent cooling capacity.

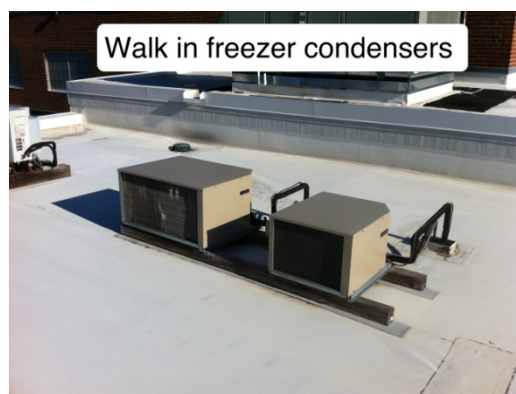
Figure 20: Walk-in Freezer Condensers

Walk-in commercial refrigerator and freezer units are located in the kitchen with rooftop mounted condensers (Figure 20). These units consume a significant amount of energy annually. Recommendations include replacing failed condensers with high efficiency units. Other recommendations include installing eCube® food temperature sensing thermostat controls. By measuring constant food temperature instead of more variable air temperatures, eCube® controllers significantly reduce the frequency of condenser operation (www.getecube.com).

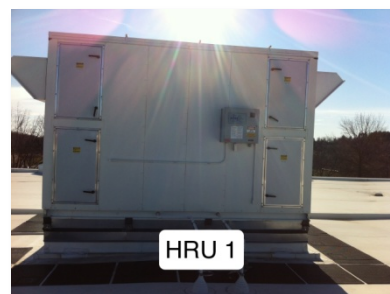
Figure 22: Energy Recovery Unit 1

The HBMS has two (2) Bossaire® energy recovery ventilation (ERV) units on the roof serving the modern addition. These units use exhaust air to pre-condition intake air thereby reducing the energy required to condition the incoming air. It is recommended that all new AHU units have energy recovery units, or ERVs.

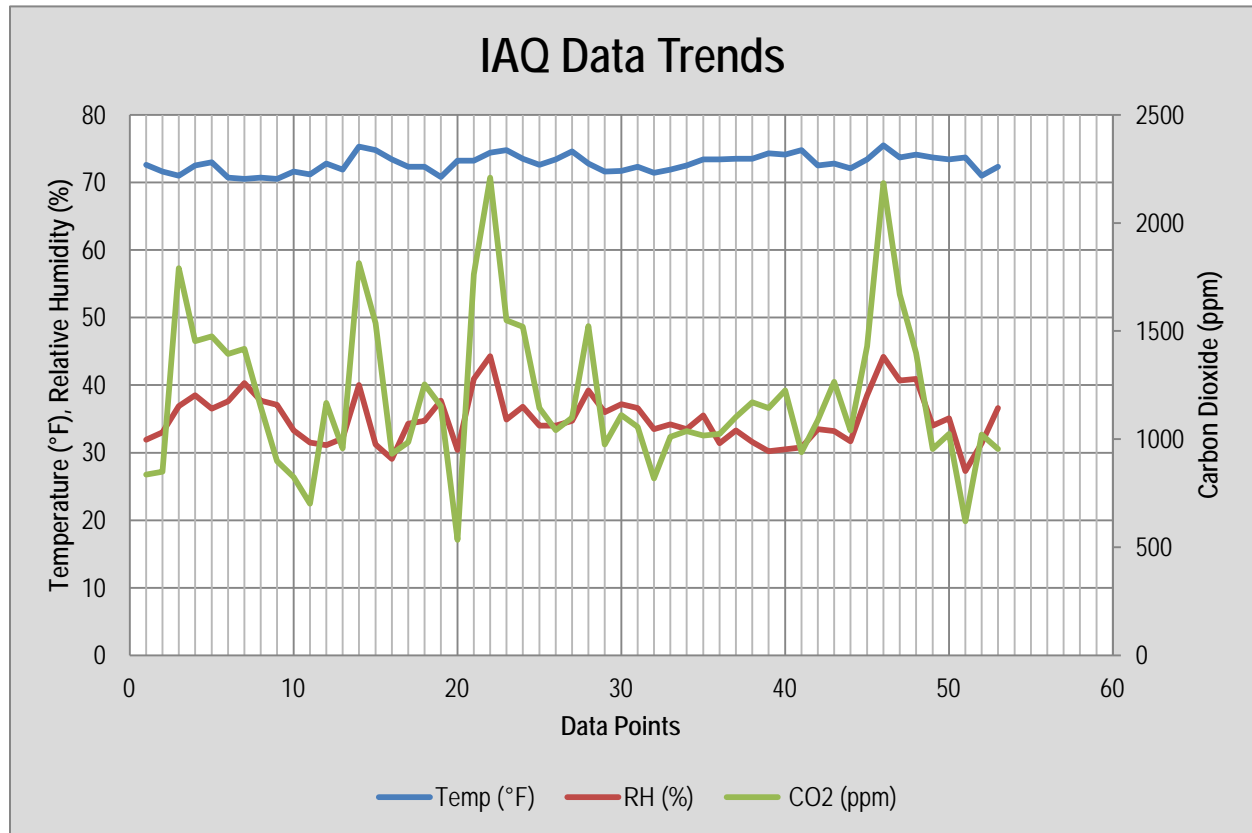
Figure 23: Indoor Air Quality Data Trends

the modern addition. Figure 23 below graphically depicts the relationships between temperature, relative humidity and CO₂ concentrations.

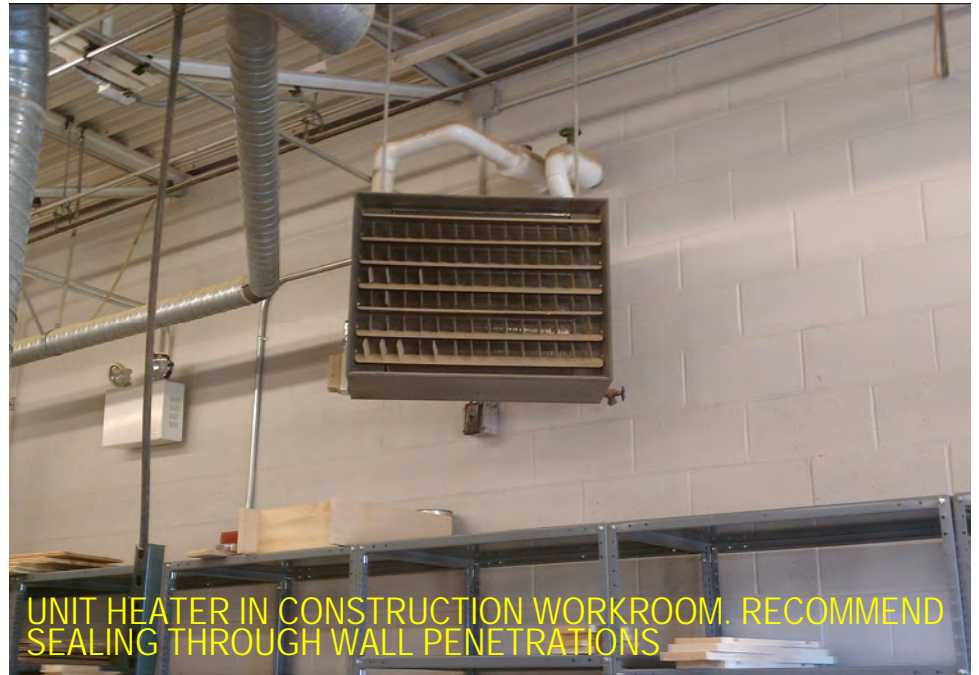
UNIT HEATER IN CONSTRUCTION WORKROOM. RECOMMEND SEALING THROUGH WALL PENETRATIONS

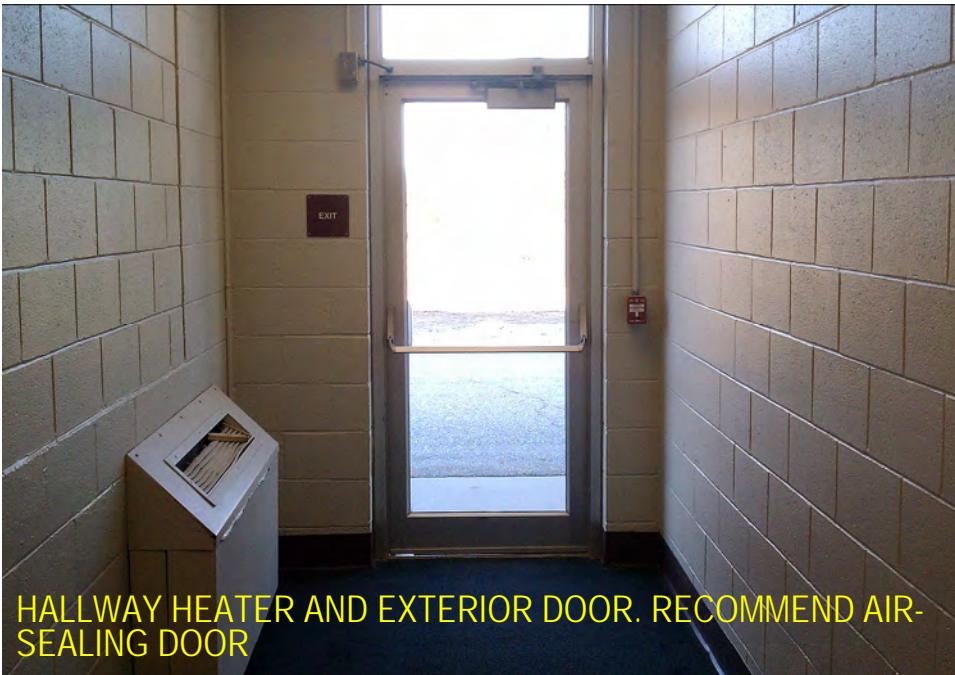
HALLWAY HEATER AND EXTERIOR DOOR. RECOMMEND AIR-SEALING DOOR

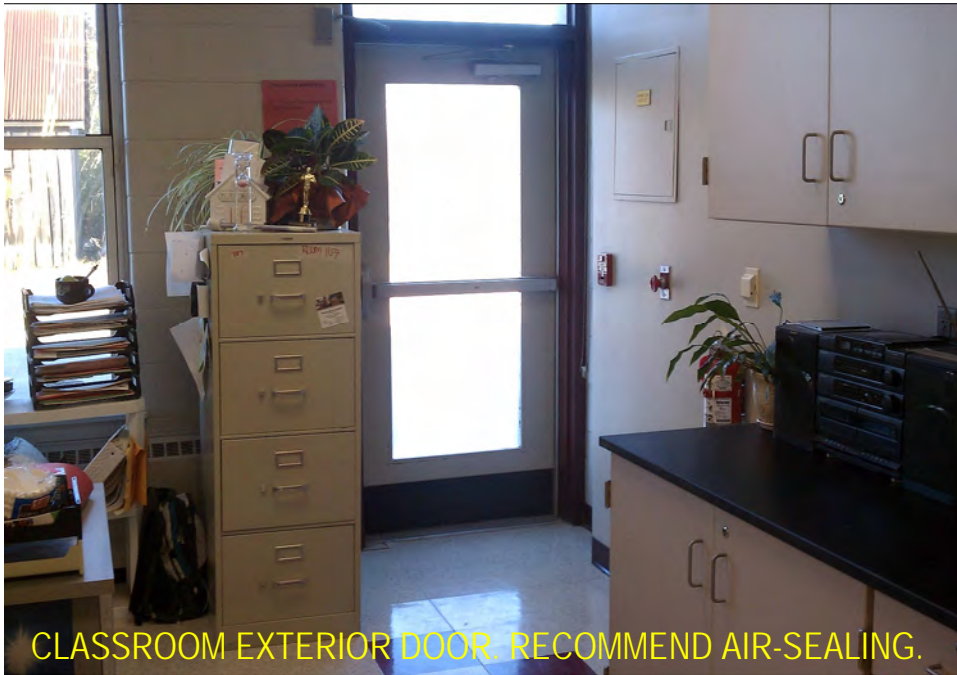
CLASSROOM EXTERIOR DOOR. RECOMMEND AIR-SEALING.

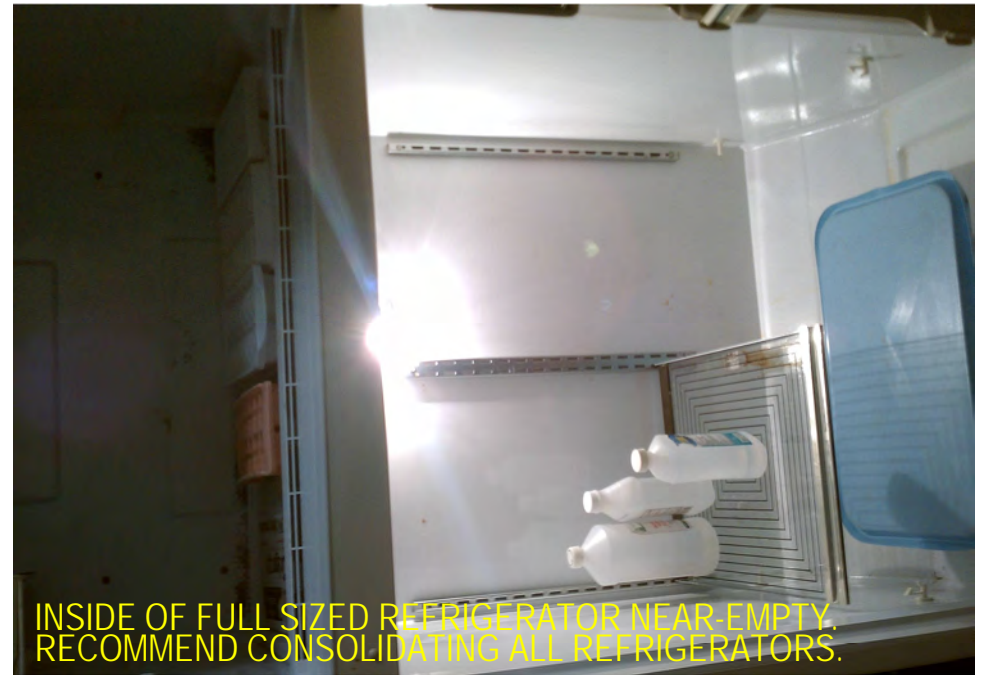
INSIDE OF FULL SIZED REFRIGERATOR NEAR-EMPTY. RECOMMEND CONSOLIDATING ALL REFRIGERATORS.

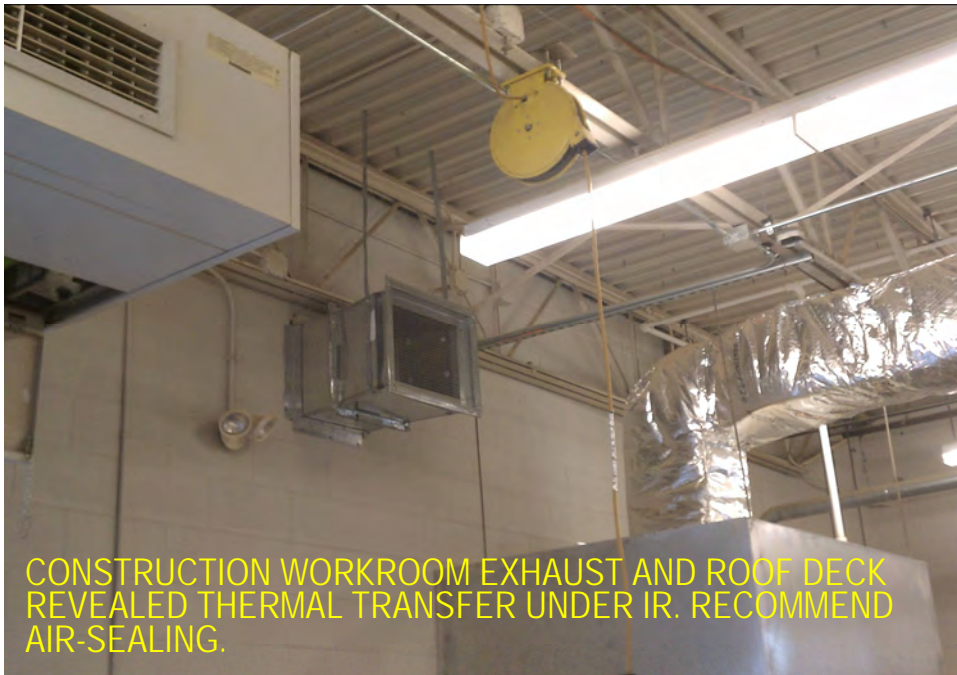
CONSTRUCTION WORKROOM EXHAUST AND ROOF DECK REVEALED THERMAL TRANSFER UNDER IR. RECOMMEND AIR-SEALING.

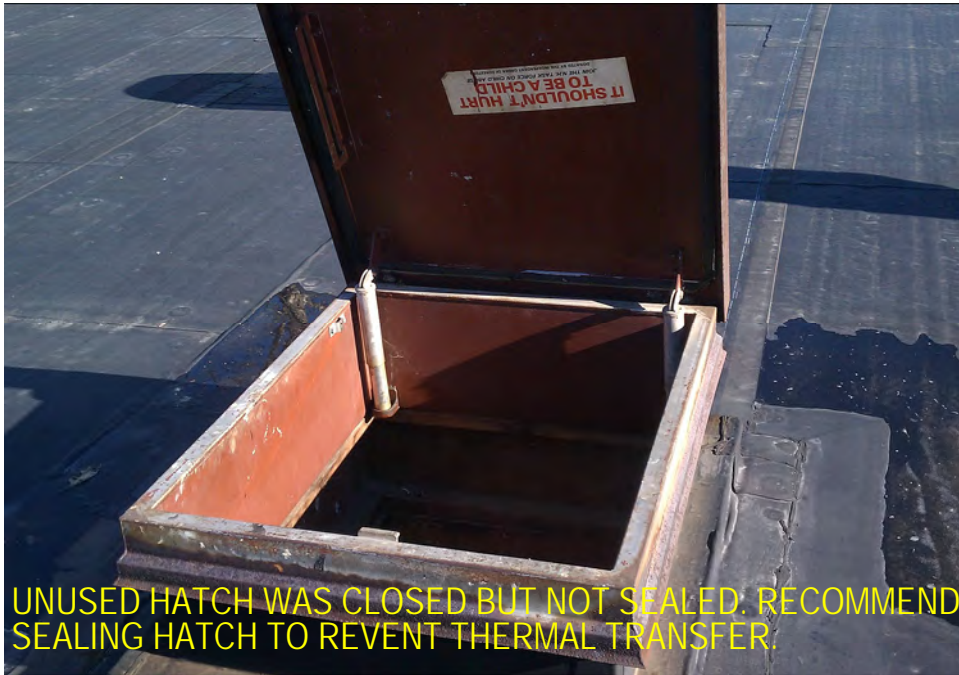
- An unused access shaft to the roof is located in Classroom 101 and has not been sealed shut allowing substantial air leakage.

UNUSED HATCH WAS CLOSED BUT NOT SEALED. RECOMMEND SEALING HATCH TO REVENT THERMAL TRANSFER.
