Facility Audit Report Hollis Social Library

May 2012

Prepared by:
Acadia Engineers & Constructors
90 Main Street
Newmarket, NH 03857

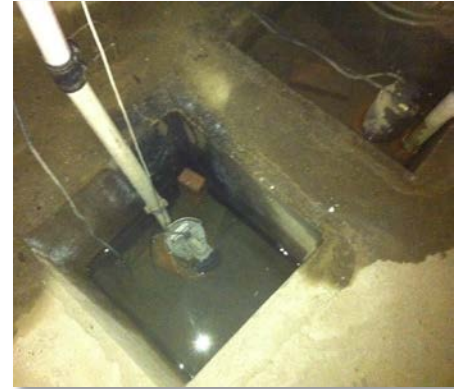
Figure 5: Basement Sump Pumps

- The basement has a persistent problem of flooding, therefore three (3) sump pumps were installed, with two of them running continuously and one as a backup (Figure 5).
- Heating control is zoned and has a nighttime setback.
- With the exception of Sunday's, daily events are scheduled to attract various patrons in addition the regular library activities.

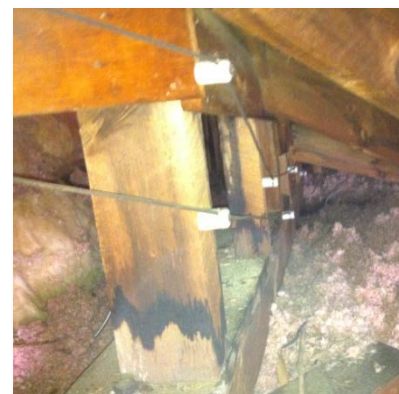
Figure 13: Knob and Tube Wiring in 1910 Attic

overhead transmission lines. The electric meter is located on the southern side of the building to the east of the 1910 original door. Knob and tube wiring was found in the attic of the 1910 building and appears to be disconnected.

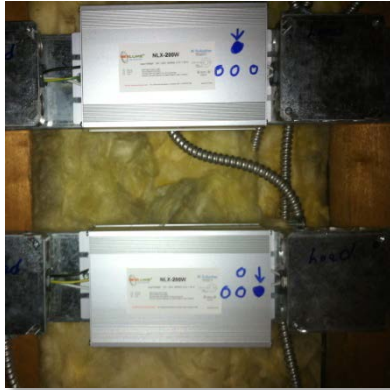
Figure 14: Induction Light Ballasts

As presented in Table 12, there are six (6) different lamp types including: 1) suspended high performance T8 fluorescent fixtures which account for the majority of lighting capacity and provide the main source of lighting; 2) suspended single-bulb induction light fixtures; 3) recessed mounted CFL's in the meeting room, children's library and back office; 4) LED's in the exit sign fixtures; 5) metal halide bulbs in the exterior fixtures; and, 6) one T12 fixture in the 1910 entrance vestibule. The high performance T8 fixtures account for the highest quantity of fixtures (43) and highest total wattage (3,500 watts). CFL bulbs are the second most common fixture with 11 total fixtures and 969 watts. There are a total of 8 induction lighting fixtures which total 320 watts.

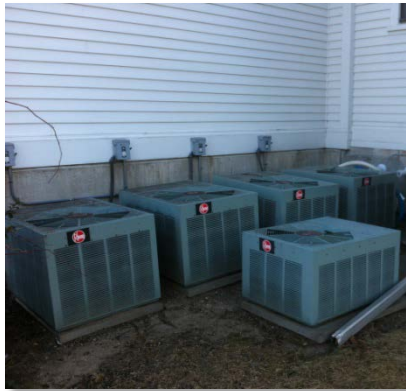
Figure 20: Rheem® Condensers

There are a total of five (5) Rheem® exterior air conditioning split systems on individual concrete pads along the west side of the building (Figure 20). Four (4) of the five (5) units are five-ton units while the other unit is a three-ton unit. All units are charged with R-22. It is noted that the use of R-22 is not permitted for use as a refrigerant in new equipment based on its high ozone depletion potential (per USEPA).

The air conditioning condensers have a low SEER efficiency rating and combined with their age make for an inefficient cooling system. Replacing the condensers with a SEER of 19 or greater would considerably reduce the cooling energy consumption. This EEM is only recommended if T3-7 is not implemented.

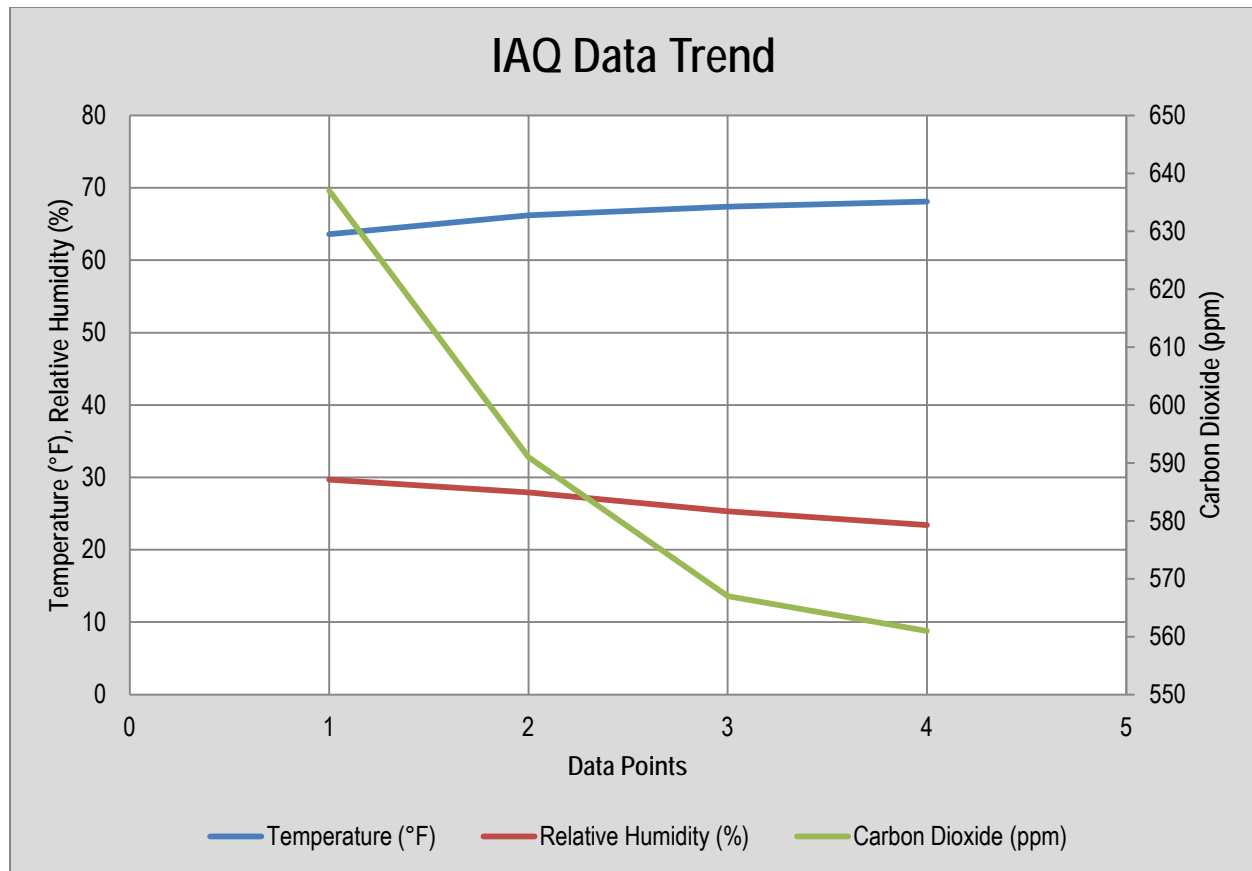
Figure 21: IAQ Data Trends

Figure 21 presents the data trending for the three IAQ parameters. This trending graphically depicts the steady measured IAQ throughout the building.

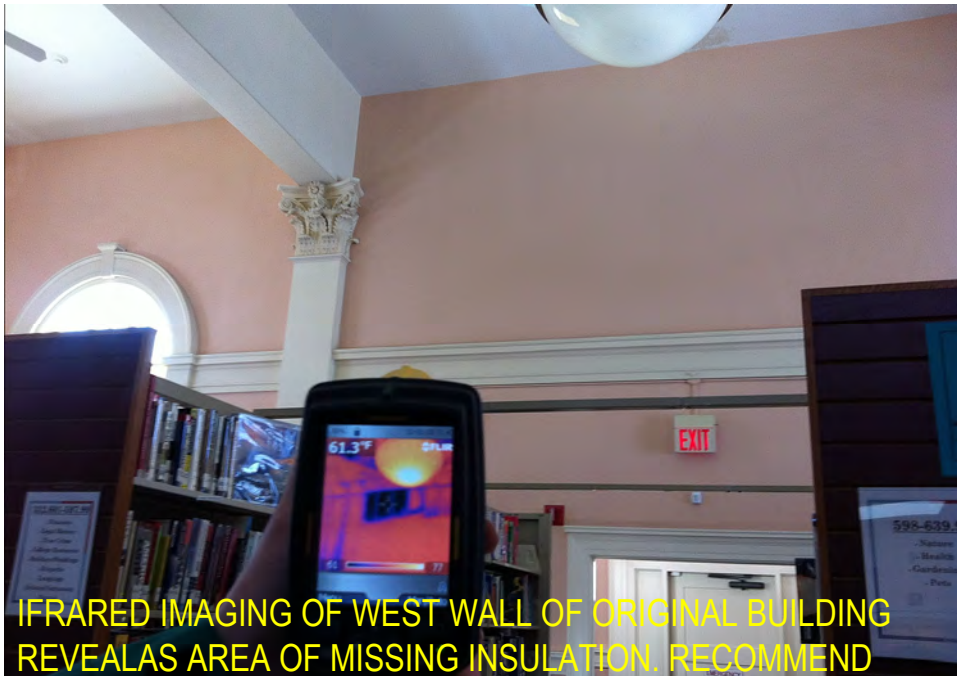
IFRARED IMAGING OF WEST WALL OF ORIGINAL BUILDING
REVEALAS AREA OF MISSING INSULATION. RECOMMEND
