Facility Audit Report Town of Hollis Police Department

May 2012

Prepared by:
Acadia Engineers & Constructors
90 Main Street
Newmarket, NH 03857

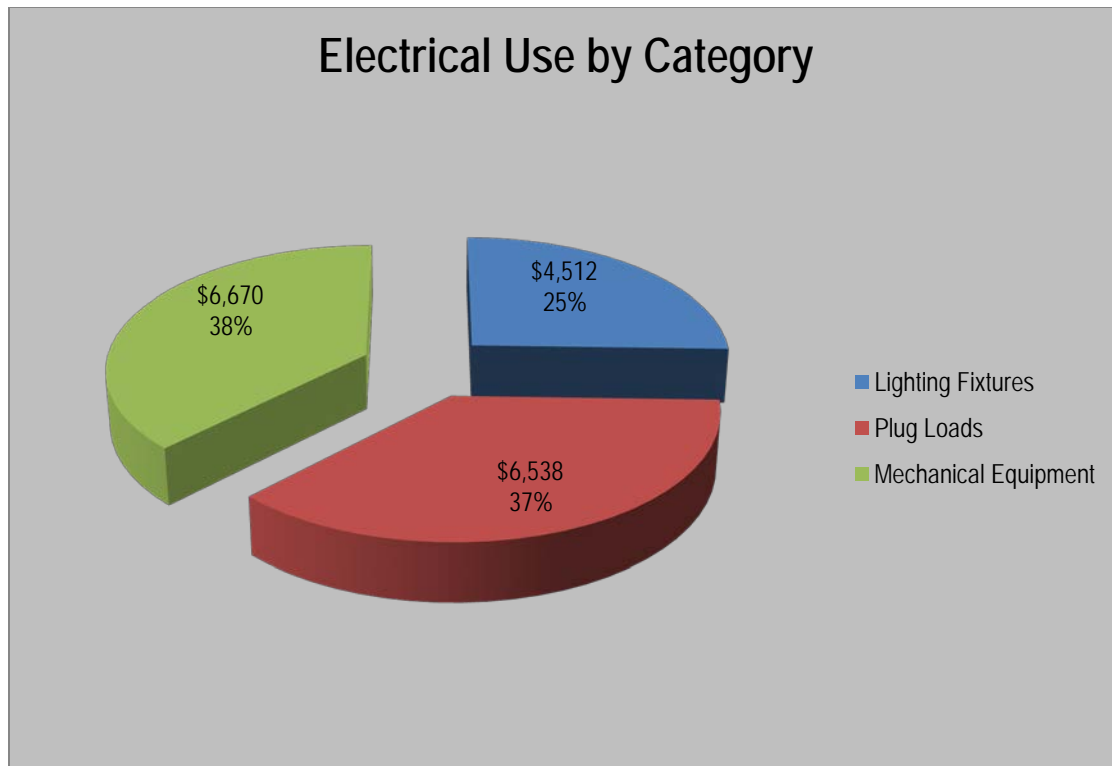
Figure 4: Hollis Police Department Electrical Cost by Category (2011)

Accounting for 38% of electrical energy, mechanical loads consume the greatest amount of electricity at the HPD. This is due in part to numerous air conditioning condensers which account for a significant amount of electrical consumption in the building. At 48,569 kWh per year, plug loads account for 37% of the electrical demand in the building. Lighting systems represent 25% of the annual electrical energy or 33,524 kWh. Figure 4 presents the relative energy use for each of the three categories.

The annual electrical cost for mechanical equipment is \$6,670 (2011). This higher than expected usage is attributable to the inefficient configuration and operation of HVAC systems. Plug loads are also higher than expected and include office equipment, computers, electronics (communication devices battery tenders), and appliances. Lighting fixtures consume a moderate amount of electricity accounting for \$4,512 annually. It is noted that a lighting retrofit project was recently completed (2011) for the building.

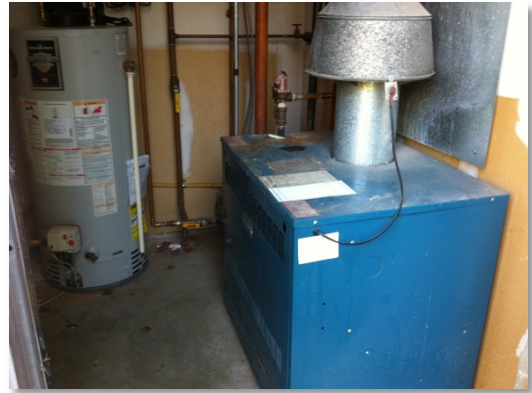
Heating is provided to the building by a single (1) LP fired boiler (Figure 10). The boiler was rated at 82% combustion efficiency when new and considering the age of the unit, the de-rated combustion efficiency is less than 79%. Modern propane fired condensing boiler units can achieve efficiencies up to 96%. Recommendations include replacing the boiler with an ultra-efficient condensing modulating unit and replacing the circulation pumps with NEMA premium efficiency rated units and VFD controls, or, a high-efficiency electric air-source heat pump system. The Sallyport is heated by two (2) suspended gas-fired air convection heaters.

Figure 10: Burnham® LP Boiler

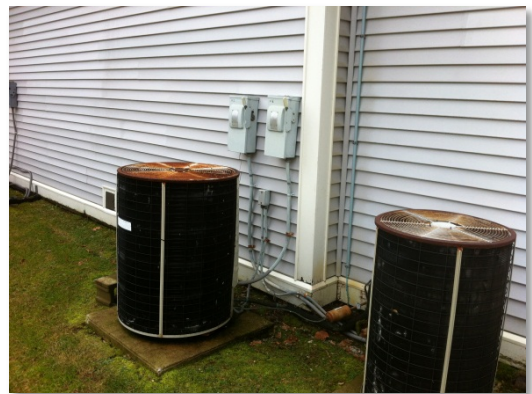
With exception of the Sallyport garage, cooling is provided to the building by nine (9) air condensing units. Two of the nine (9) units appear to be original (1987). Total cooling capacity for the building exceeds 37 tons which appears excessive for the served spaces. Condensers are charged with R-22 refrigerant. It is noted that the use of R-22 is no longer permitted for use as a refrigerant in new equipment based on its high ozone depletion potential (per USEPA).

The Energy Efficiency Ratio (EER) for the larger condensing units is 10 or less. The smaller mini-split units are rated at a Seasonal Energy Efficiency Ratio (SEER) of 11 or less. Operating efficiency tends to decrease with system age. As cooling condensing units fail, they should be replaced with the highest rated equipment available.

Figure 11: Original AC Condensing Units (c. 1987)

As prescribed by the 2009 IECC, the current minimum SEER for smaller cooling systems is 13 and larger units are rated at a minimum EER of 11.2. Modern cooling systems can achieve SEERs up to 24. As example, replacing a unit with a SEER rating of 8 with a new unit rated at 16 would reduce energy consumption by 50% and provide an equivalent cooling capacity.

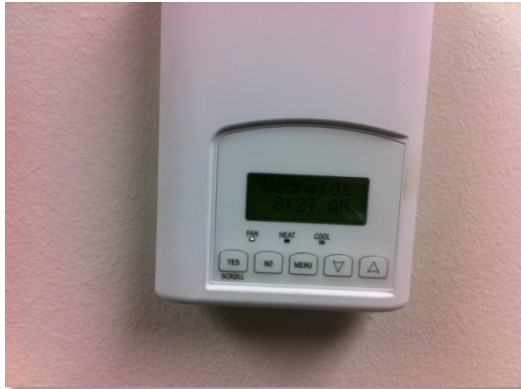
Figure 12: Heating and Cooling Controls

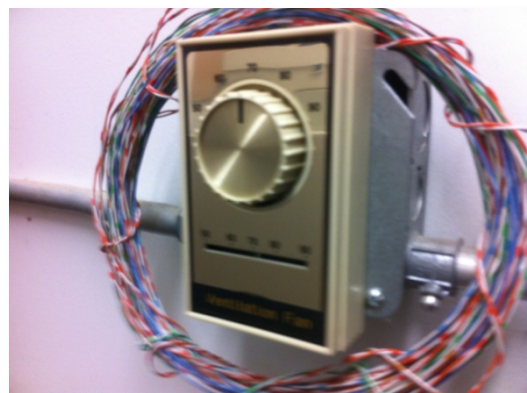
Spaces equipped with exhaust fans are commonly over-ventilated resulting in increased energy consumption. All exhaust controls and rates should be consistent with ASHRAE Standard 62.1. Fan ducting should have pressure actuated dampers to restrict air flow and heat loss when the units are not operating.

Figure 13: Radio Room Exhaust Ventilation Fan Controls

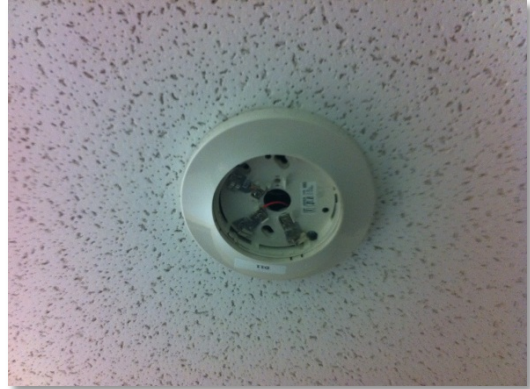
Figure 15: Removed smoke detection device

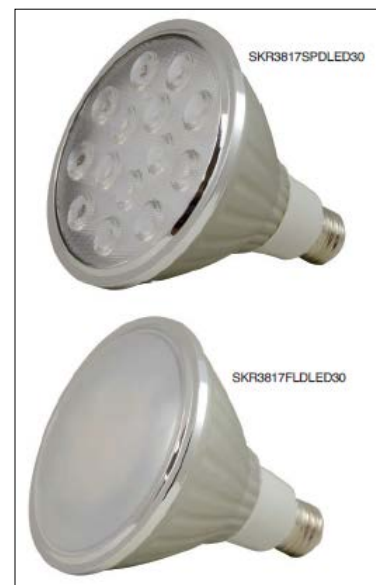
Figure 18: R38 LED Lamps (MaxLite®)

Although the building recently underwent a lighting systems retrofit (2011), there are low-cost measures to further reduce lighting energy consumption. These include augmenting overhead lighting with task lighting with table, desk, and floor lamps. When natural lighting is present, the task light fixtures would provide sufficient lighting and the overhead units could be turned off (this could be facilitated with daylighting controllers). Also, there are two recessed can lighting fixtures (R38) in the communications room that contain high-wattage halogen lamps. These could be easily retrofitted with screw-in LED downlights (Figure 18).

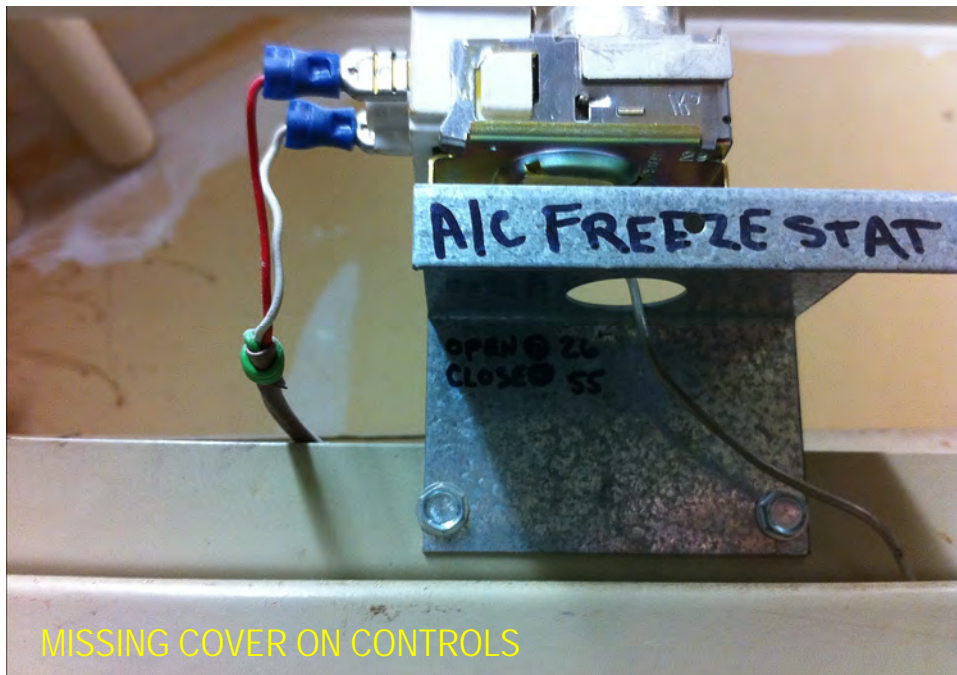
MISSING COVER ON CONTROLS

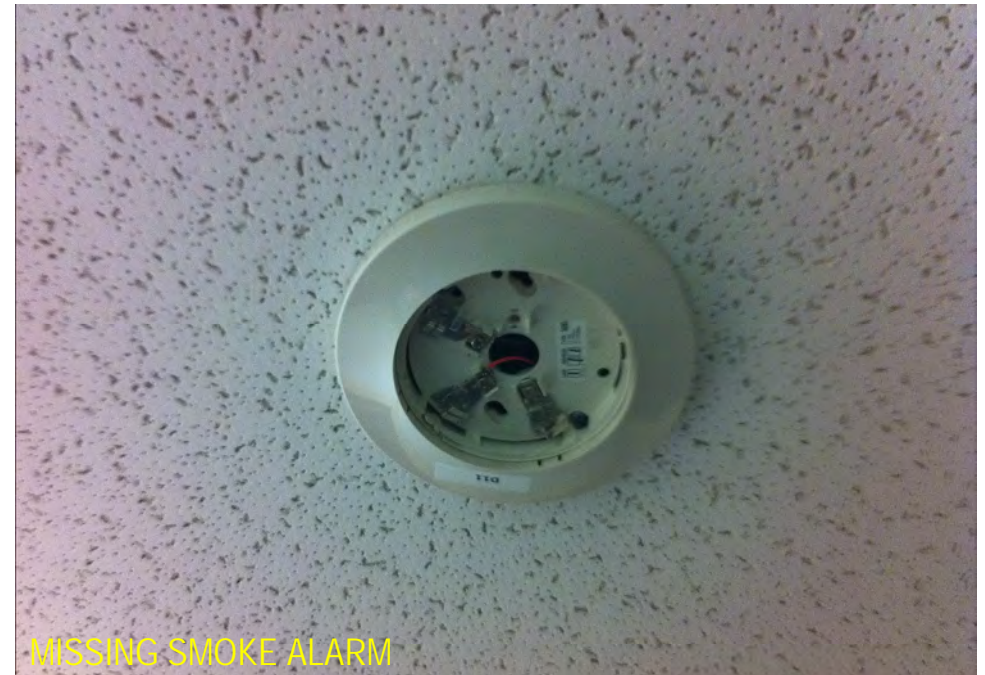
MISSING SMOKE ALARM

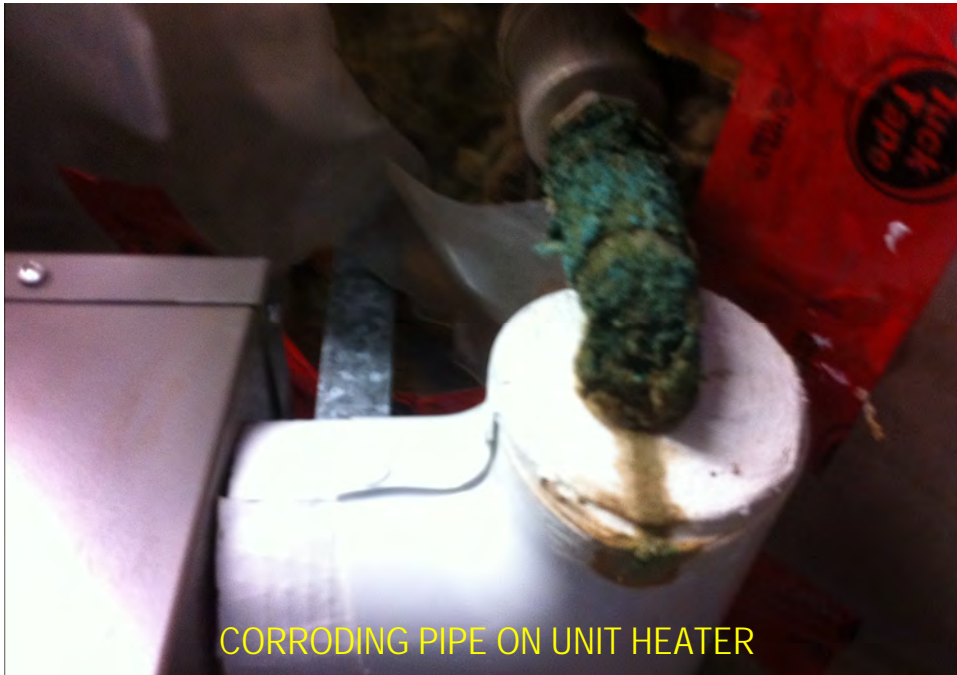
CORRODING PIPE ON UNIT HEATER
