Facility Audit Report

Hollis Primary School – Hollis, NH

May 2012

Prepared by:
Acadia Engineers & Constructors
90 Main Street
Newmarket, NH 03857

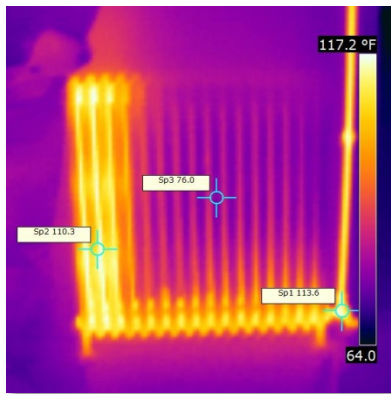
Figure 3: IR Reveals Heat Disbursement from Radiator

- Some of the roof exhaust vents leak because snow accumulates above the height of the vent.
- Heating distribution throughout the corridor is poor with only two (2) old cast iron radiators along the corridors in the single-story section of the building (Figure 3).

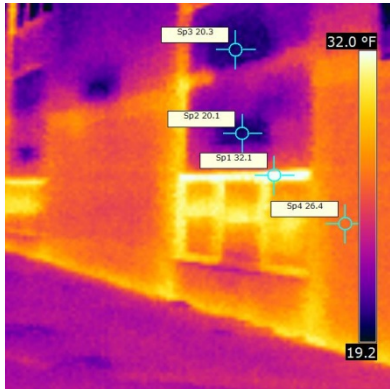
Figure 9: IR Image of West Exterior *Thermal Imaging Survey*

- The thermal integrity of the envelope (walls and roof) is relatively good. Some areas of the exterior revealed more thermal transfer than others (Figure 9).
- Poorly sealed windows and doors provide a significant amount of thermal transfer and air leakage. Recommend installing weather stripping and thermal insulated shades
- The concrete foundation wall extending above grade provides thermal transfer.
- Uninsulated hot water piping throughout results in heat loss to a semi-conditioned space. (Figure 10)
- Cast-iron radiators distribute heat inefficiently.
- Electronic equipment including photocopiers, overhead LCD projectors, and computers/monitors operate at high temperatures and increase heat loading of the building.

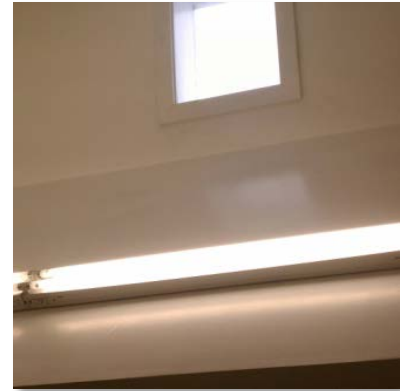
Figure 11: Illuminated Light Next to Window

The T-8 lamp fixtures are relatively efficient units. Adding controls to reduce the frequency of operation is recommended especially in common spaces such as corridors. Time and motion controllers can be used in combination where the timer is the primary control device and the motion sensor is the secondary control –this also provides a security alert function where operating lights would indicate occupancy when the school is closed. Daylight controls could be used to control the light density output of fixtures in spaces which receive an ample amount of natural light through doors, windows, and skylights (Figure 11).

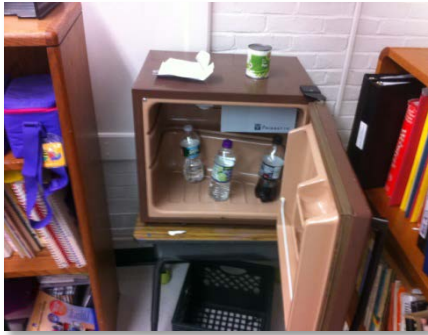
Figure 12: Compact Refrigerator (typ.)

A total of ten (10) compact refrigerators are located in the building (Figure 12). These are energy intensive appliances consuming a substantial amount of energy annually. Recommendations include consolidating these units with fewer standard sized ENERGY STAR® rated units. A total of twenty (20) overhead LCD projectors were inventoried. Sixteen (16) computer printers were observed. A total of ninety-one (91) desktop computers and forty (40) notebook computers were inventoried. While this amount is not high considering the number of occupants (students and staff) for an elementary school, it is still recommended to remove any older and unused computer systems.

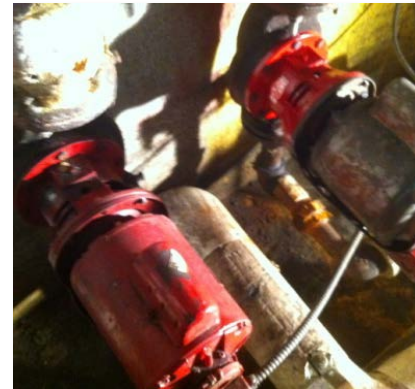
Figure 16: Circulating Pumps in Boiler Room #1

A total of five (5) hydronic pumps exist in the building with motor sizes ranging between ½ HP and 1½ HP (Figure 16). Visual inspection of the pumps revealed they are corroding due to their age. Maintenance of all pumps is recommended to eliminate leaks, increase service life, and to prevent catastrophic failure resulting from a ruptured pressure relief valve or failed valve packing.

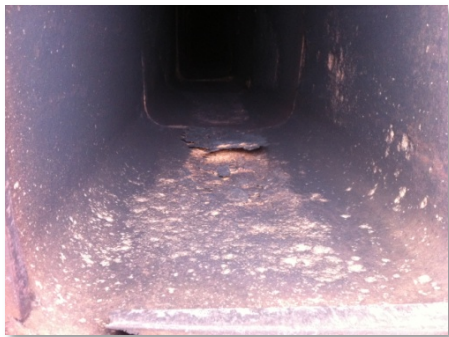
Figure 18: Deteriorating Flue
(note spalling section)

- Lighting densities in several spaces exceed the recommended industry standards for the prescribed space use.
- The chimney cap and flue are deteriorated.

T3-2	Consolidate existing oil-fired boiler units with two (2) new high efficiency units. Re-line flue. Connect the new system into the existing DDC system. Install VFD controls on main circulation pumps.	\$145,245	\$12,567	11.6	1.7
T3-3	Install EIFS (3" foil-faced polyisocyanurate rigid insulation w/ stucco veneer) over exterior wall sections to obtain R-value of +20.	\$162,261	\$7,456	21.8	1.1
T3-4	Replace built-up roof on 1967 addition w/ EPDM system with R-value of +30 (4" of foil-faced polyisocyanurate rigid insulation board) (<i>complete as part of roof maintenance program</i>).	\$91,336	\$2,432	37.6	0.8

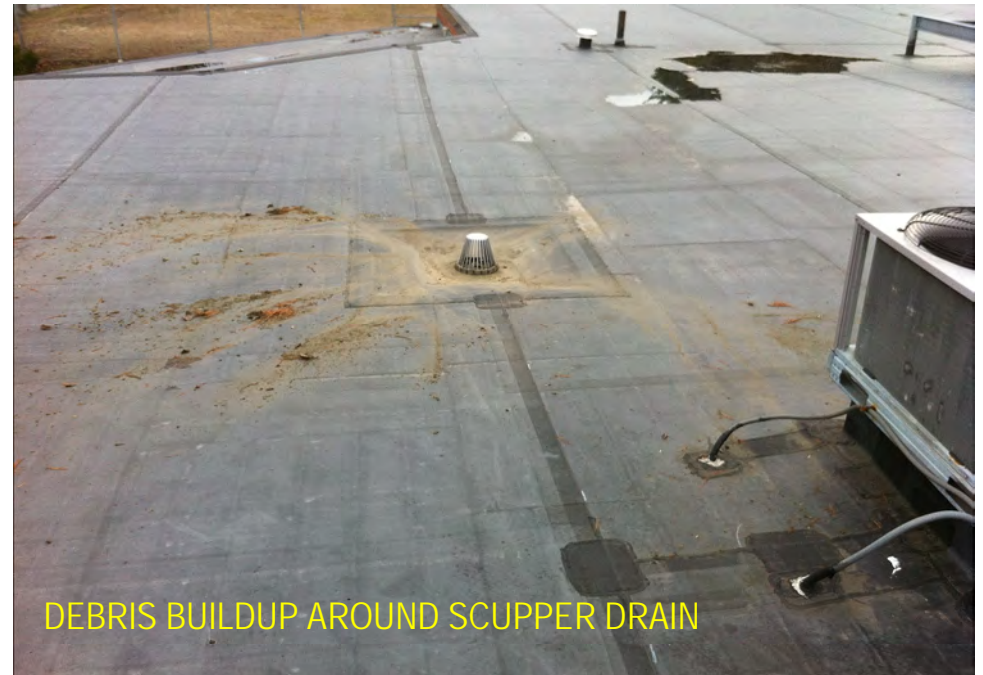
DEBRIS BUILDUP AROUND SCUPPER DRAIN

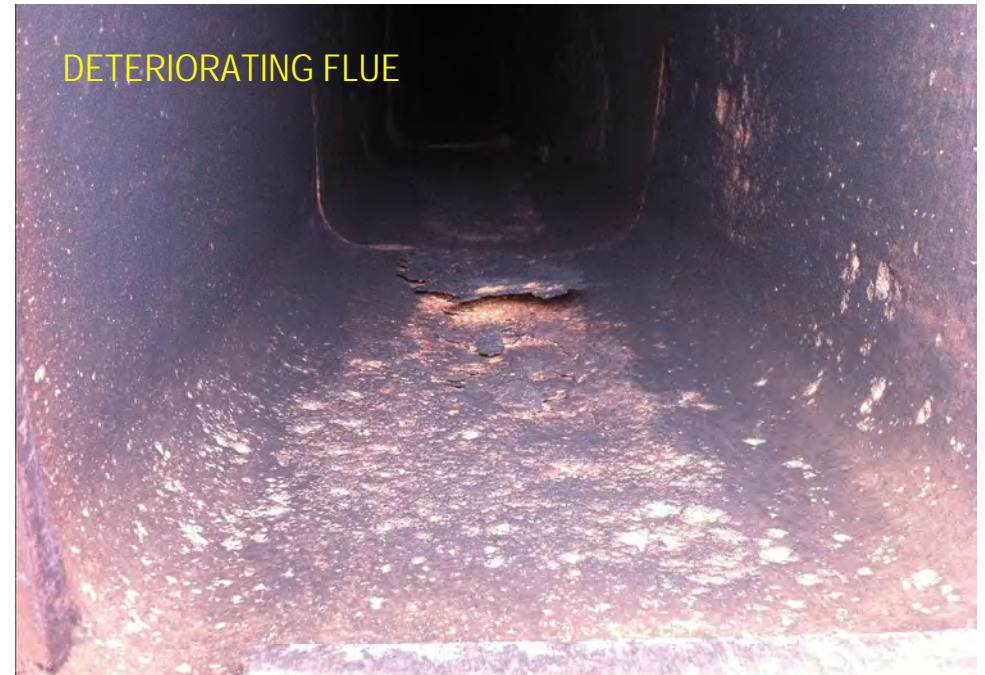
DETERIORATING FLUE

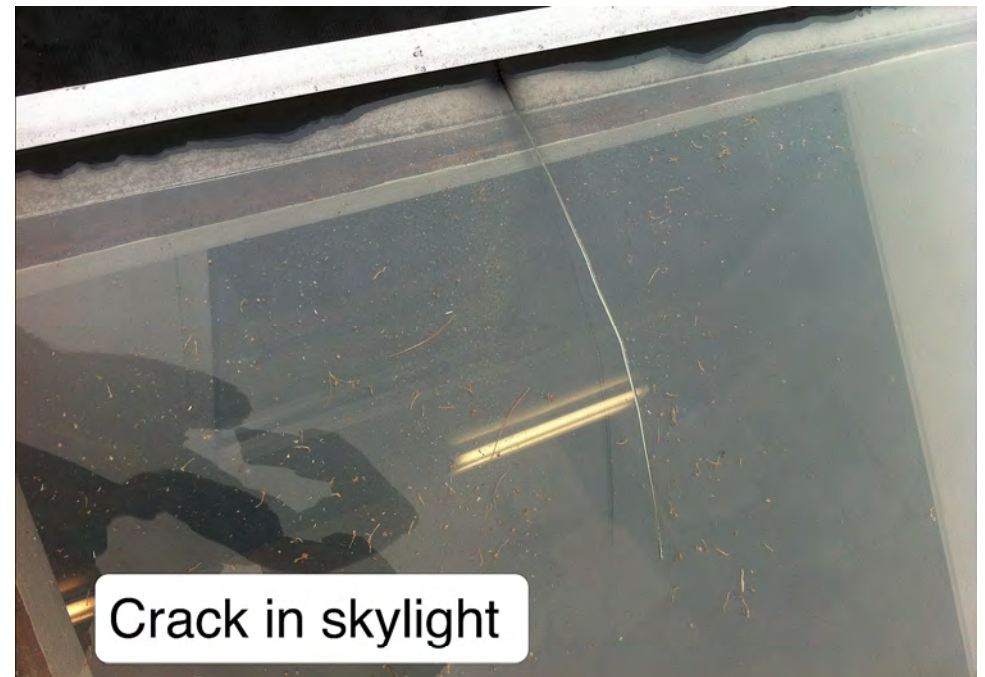
- A roof window (skylight) is cracked.
- The roof exhaust fans extend approximately eight inches above the roof deck. When snow accumulates higher than eight inches and begins to melt, the melting snow goes through the exhaust and leaks into the school.

Crack in skylight

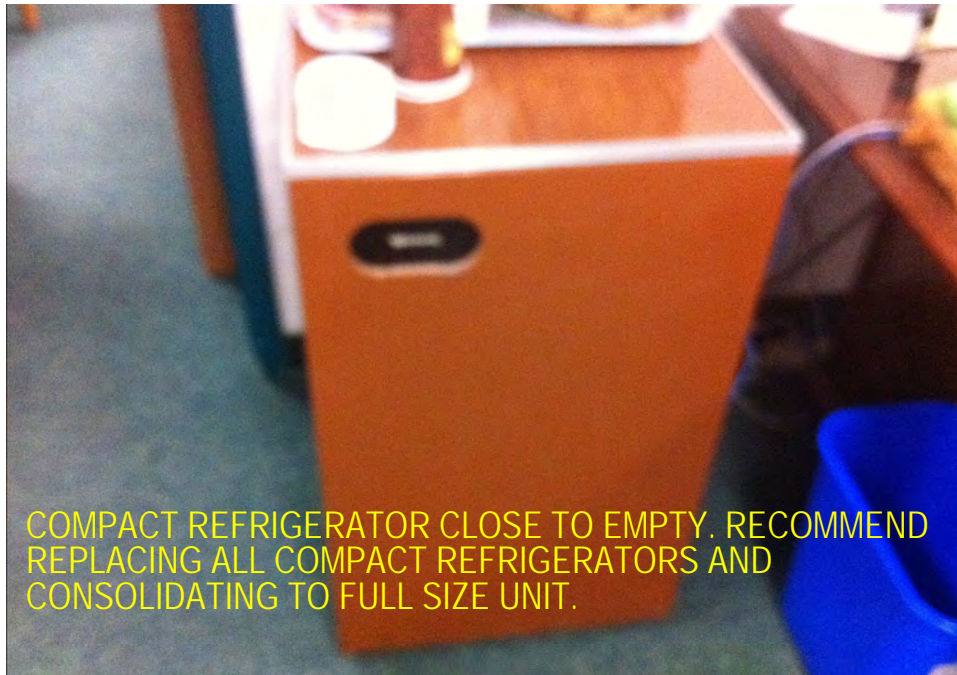
COMPACT REFRIGERATOR CLOSE TO EMPTY. RECOMMEND REPLACING ALL COMPACT REFRIGERATORS AND CONSOLIDATING TO FULL SIZE UNIT.
