Facility Audit Report Hollis Upper Elementary School

May 2012

Prepared for:
Town of Hollis
7 Monument Square
Hollis, NH 03049

Prepared by:
Acadia Engineers & Constructors
90 Main Street
Newmarket, NH 03857

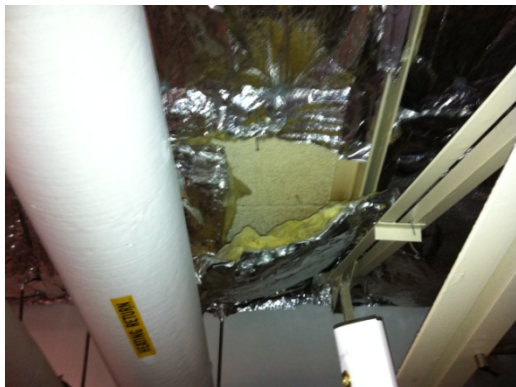
Figure 7: Ceiling Insulation on 1980 Roof

Ceilings throughout the building are suspended acoustical tile (SAT) systems. The above ceiling plenum space is used for routing of ducting, piping, conduit, and electrical cable. Fiberglass batt insulation exists in the ceiling of the loft. The gymnasium on the second floor has a high, exposed ceiling while the multipurpose room on the third level has a SAT system. Substantial air leakage was observed in the pitched ceiling sections on the north side of the 1980 structure. It is recommended that all wall and roof penetrations are sealed to reduce air leakage.

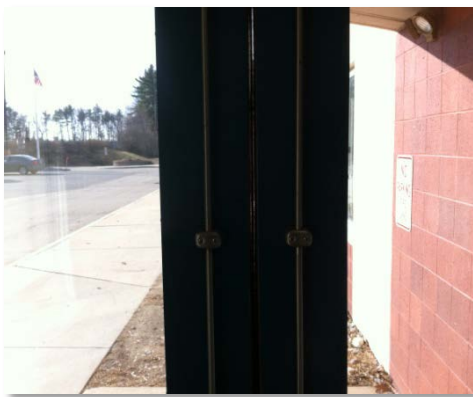
Figure 11: Gap in Door Parting (typ.)

Based on the thermal imaging survey and visual observations, air leakage occurs at roof penetrations (Figure 10), windows, entry doors (Figure 11), and wall to roof interfaces. Although this is typical even for modern buildings, simple measures can significantly reduce air leakage. Recommended measures for windows include: 1) adjusting jamb seals on operating windows; 2) adding weather-stripping; 3) caulking interior frames and moldings; and 4) locking/clasping windows to maintain a complete seal. Air sealing of all door units can be improved with new weather-stripping and sweeps. All door and window units should be regularly inspected (every 2 to 3 years) to ensure

proper operation, identify faulty seals, and to identify any deteriorated caulking requiring replacement.

All wall and roof penetrations should be inspected and entirely sealed at the interface of the conditioned space with a fire-rated sealant/caulking.

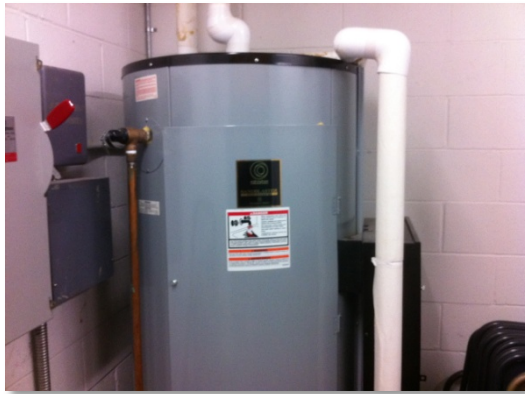
Figure 15: 119 Gallon Domestic Hot Water Tank

Domestic hot water is provided by a single 119-gallon and two (2) 85-gallon electric-fired tank heating units providing a combined capacity of 289 gallons (Figure 15). The two 85-gallon tanks were manufactured in November 2010. The system capacity exceeds occupant demand requirements. Recommendations include replacing the three units with two (2) demand-tankless electric condensing units and insulating the distribution piping.

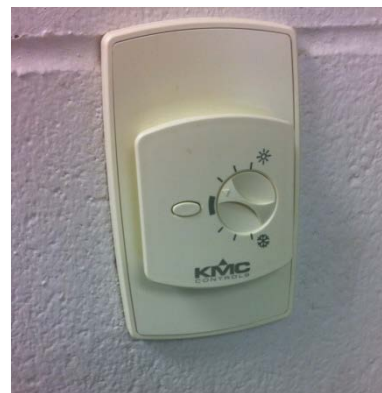
Figure 19: Cooling Controls in Computer Lab

are controlled individually within the rooms (Figure 19). The DDC schedules should continually be optimized according to occupancy schedules. Real time temperatures should periodically be recorded and compared to setpoints within the DDC system to identify any discrepancies and modify DDC setpoints to optimize the system. Eight (8) temperatures were measured throughout the first floor (five of the rooms were unoccupied) and all temperatures exceeded the recommended setpoint range of 67°F to 69°F. The average measured temperature was 73.2°F which is substantially higher than recommended.

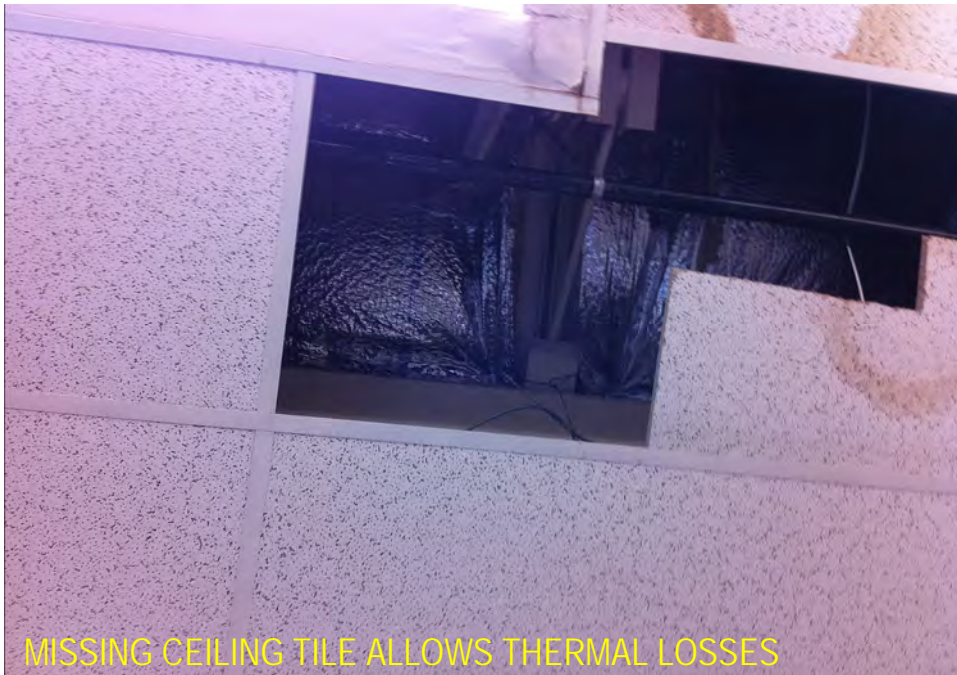
MISSING CEILING TILE ALLOWS THERMAL LOSSES

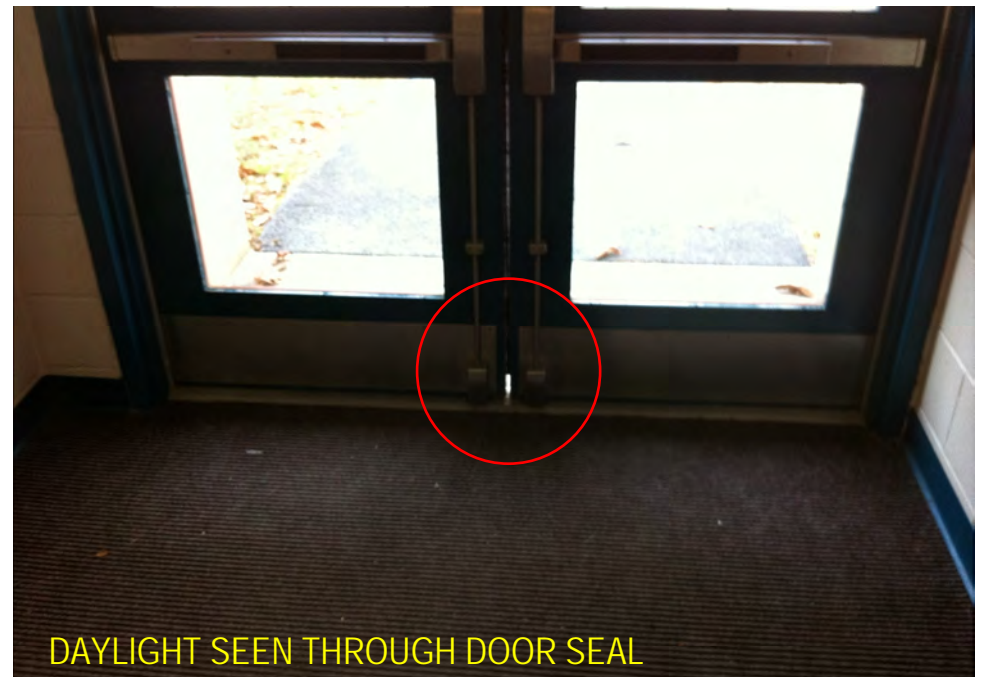
DAYLIGHT SEEN THROUGH DOOR SEAL

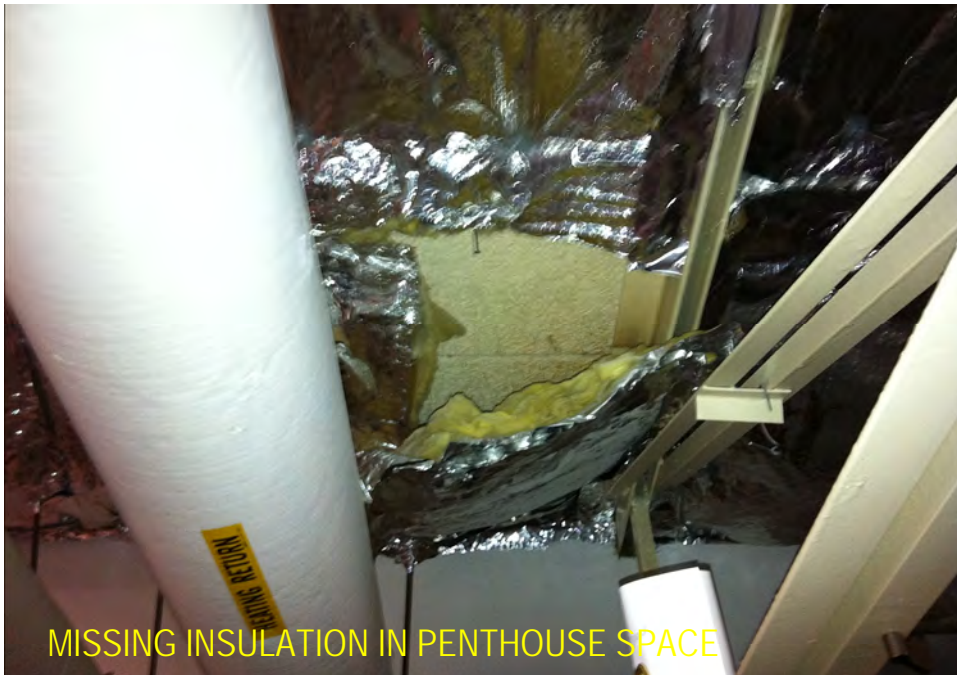
MISSING INSULATION IN PENTHOUSE SPACE
